### <Current situations of contaminated water leakage to the ocean>

### <Contaminated water leakage from an aboveground tank>

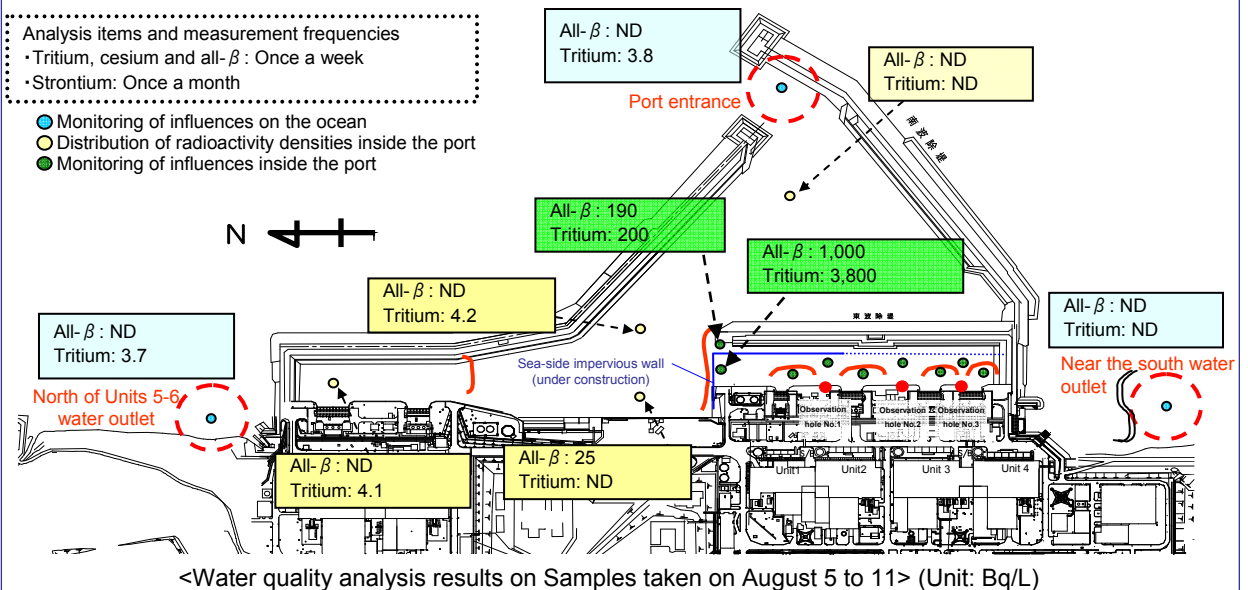
- At the locations in front of the Units 1-4 water intakes (●), the all-β and tritium densities in seawater have been showing repeated ups and downs.
- At the locations inside the port (○), the densities in seawater have been substantially below the detection limit values.
- At the locations near the boundary of the port (●), the densities have been at the same levels or lower levels than those inside the port.
- At the locations 3km and 15km off shore of the power station, and 3km off shore of Ukedo River, the all-β and tritium densities have been below the detection limit values.
