(4) Contaminated Water Leakage from a Tank / Current Status

Current status around Tank No.5 in the H4 area from which water leaked

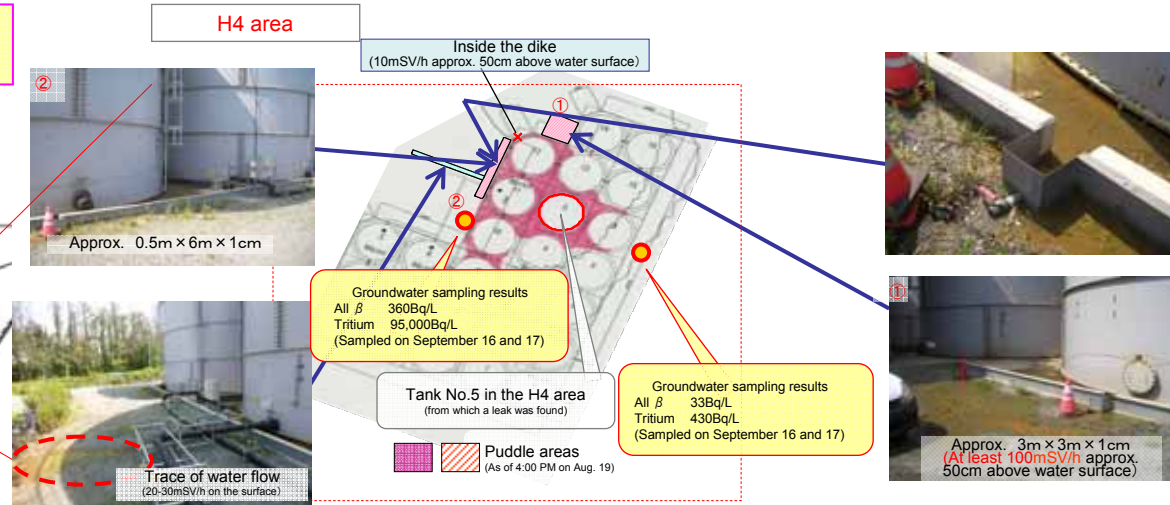
On August 19, approximately 300 tons of highly contaminated water was found to have leaked from a bolted (flange-type) tank (Tank No.5) located in the H4 tank area. It is considered that the majority of the leaked water has penetrated into the ground. The cause of the leakage is under investigation. We have implemented and will implement risk reduction measures including water transfer from Tank No.5 (completed on August 21), and contaminated soil recovery (started on August 23).
