Increases in the Concentration of Radioactive Materials in Seawater and Groundwater on the Ocean Side of the Site: Current Situation and Countermeasures

1. Analysis of Current Situation

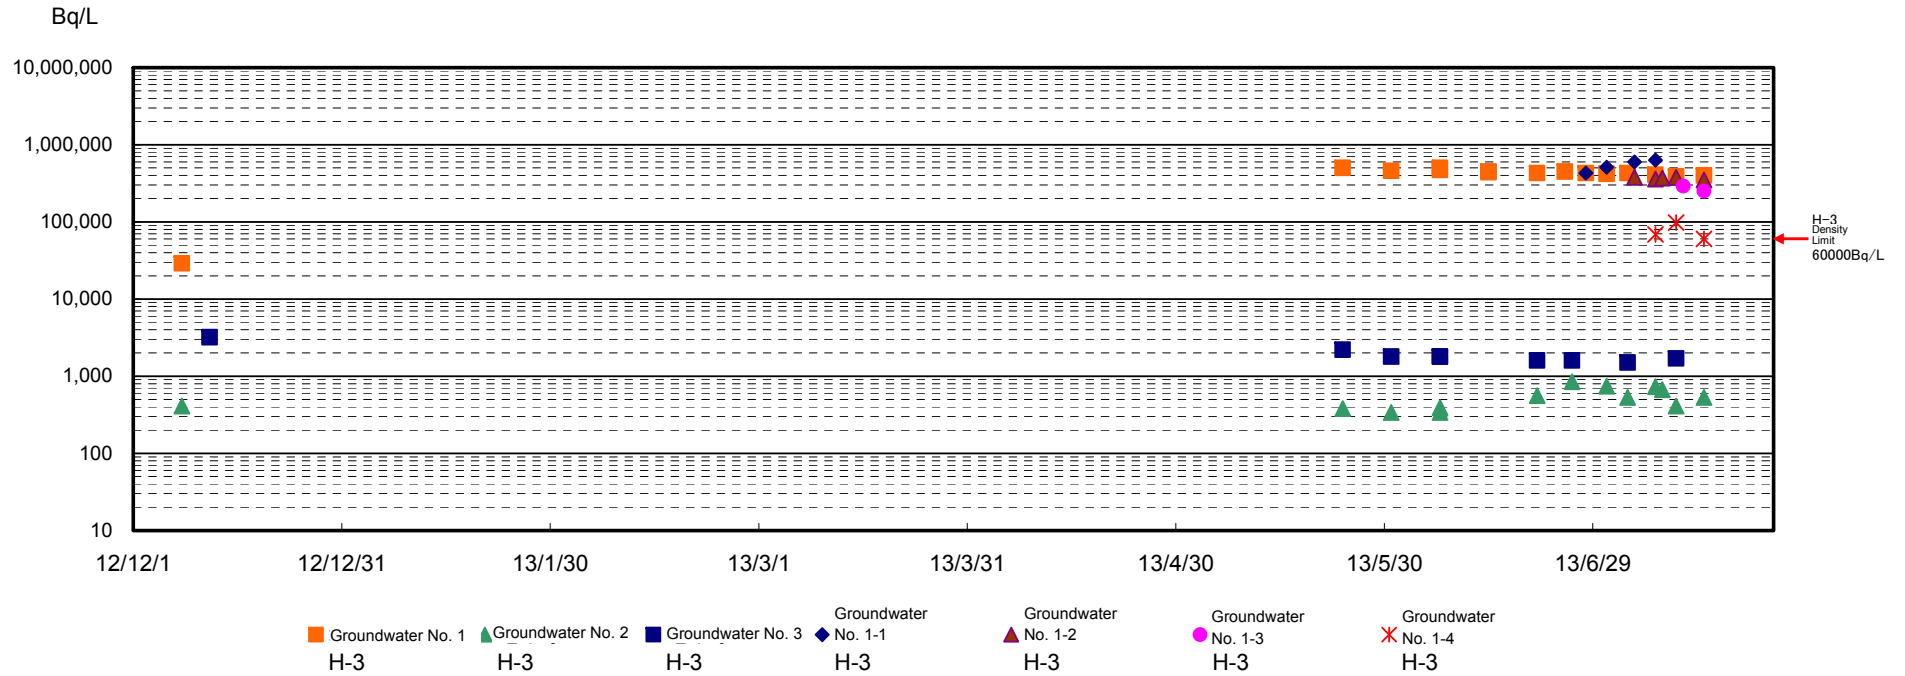
Reference B

- 400,000 to 500,000Bq/L of tritium and 1,600Bq/L of all beta radiation were detected from the No.1 groundwater observation hole between Unit 1 and 2. **(Reference B)**

Trends in Groundwater Tritium Concentrations

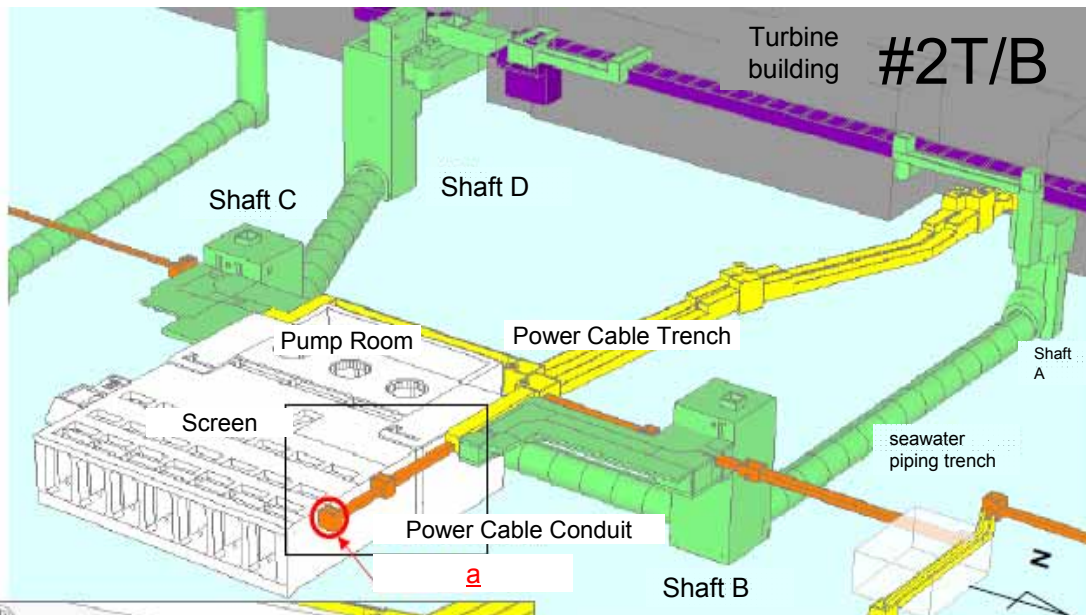
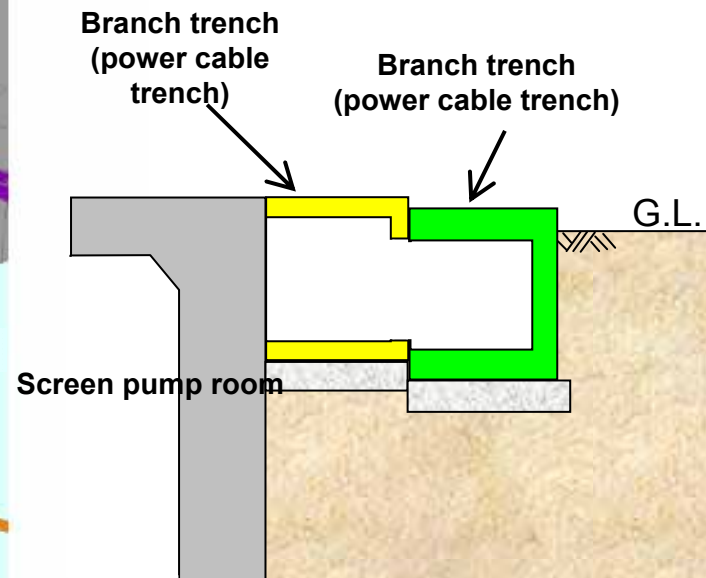
Leak locations/Estimated leak paths (Unit 2 ocean side trench location diagram)

- Extremely high concentrations of radioactivity have been detected at the No. 1-2 observation hole, which is closest to the area in which a leak of contaminated water from the Unit 2 screening room was discovered two years ago (April 2, 2011). High possibilities of either residual highly concentrated contaminated water from the countermeasures implemented two years ago slowly seeping around and leaking out, or the leak stopping countermeasures from two years ago degrading with time, were assessed.

Therefore, a survey of the contaminated water inside the branching trench (power cable trench), which may be residual highly concentrated contaminated water from countermeasures implemented two years ago, is underway and the contaminated water will be drained and the concerned trench sealed by the end of October.

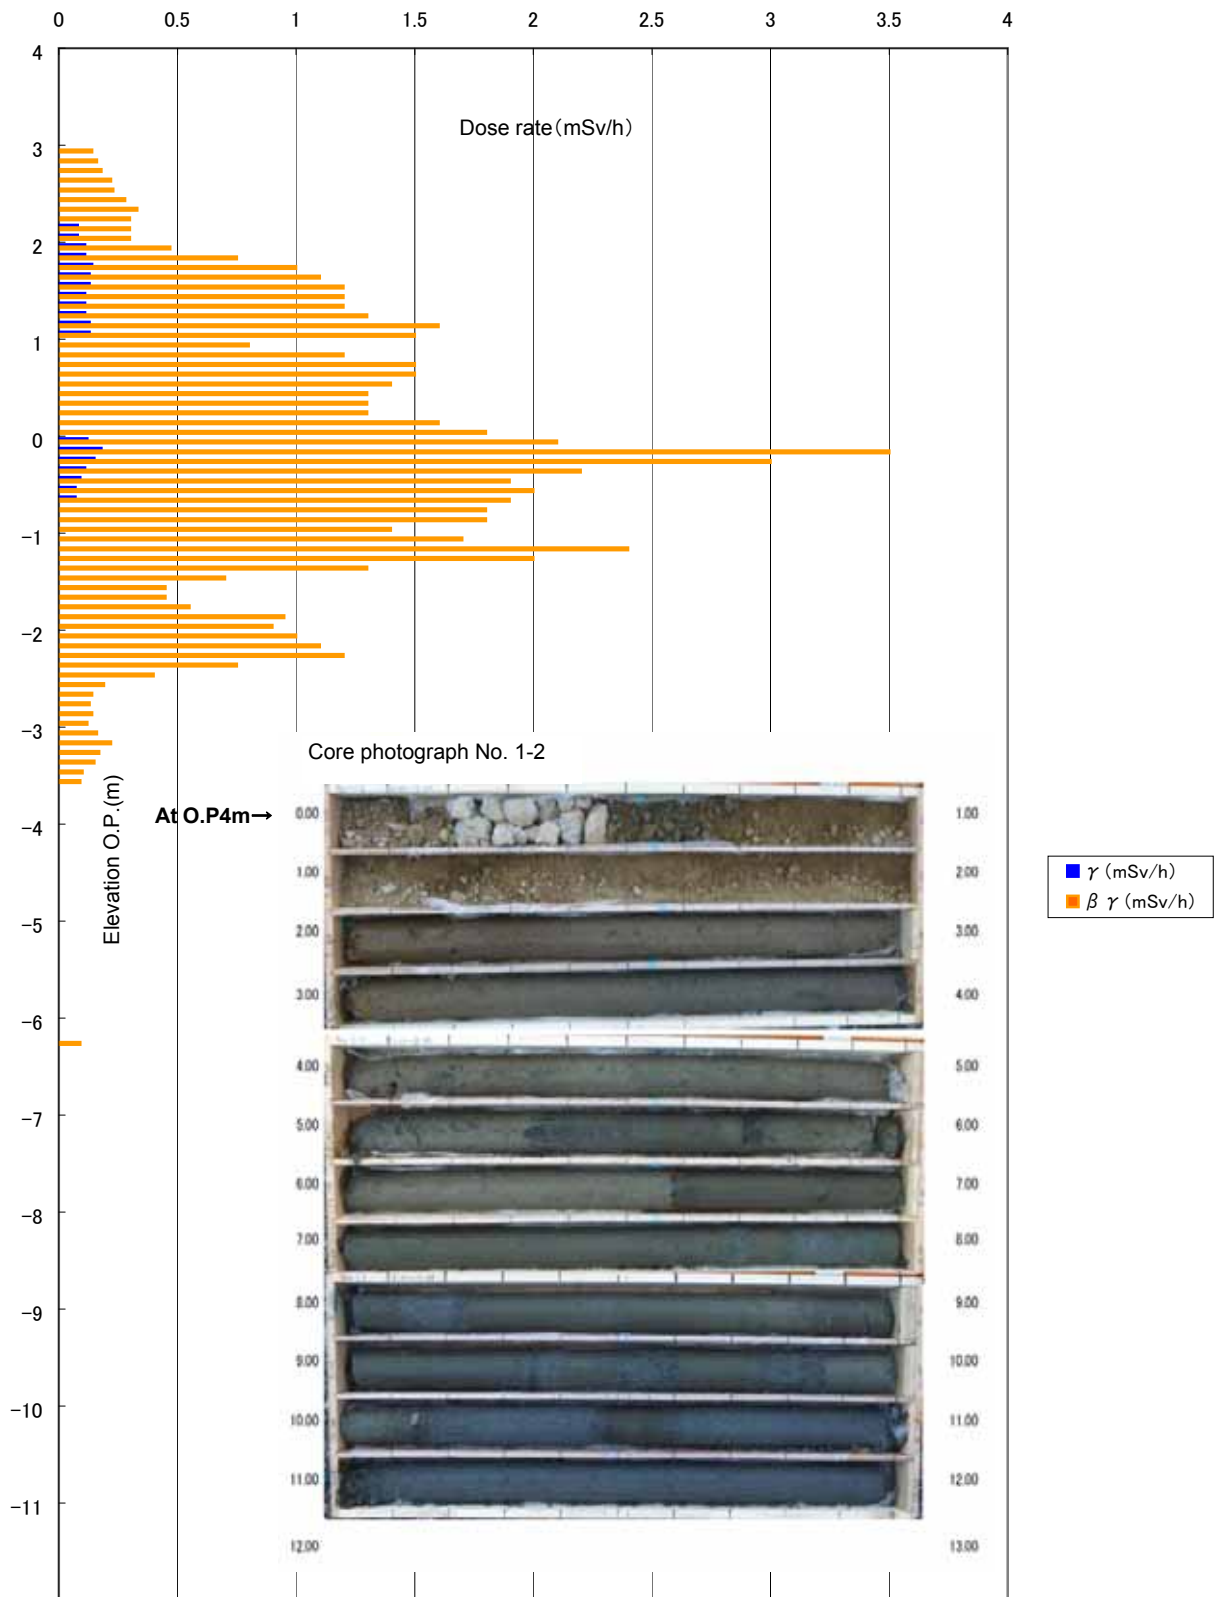
Reference D

- The No. 1-2 hole is prominent in the boring core analysis as well, but this is assessed to be the result of past leaks, since high concentrations of cesium were found in terms of height within areas near to the past leak points. **(Reference D)**

Dose Rate Distribution for Boring Cores from Ocean Side Groundwater Observation Hole No. 1-2

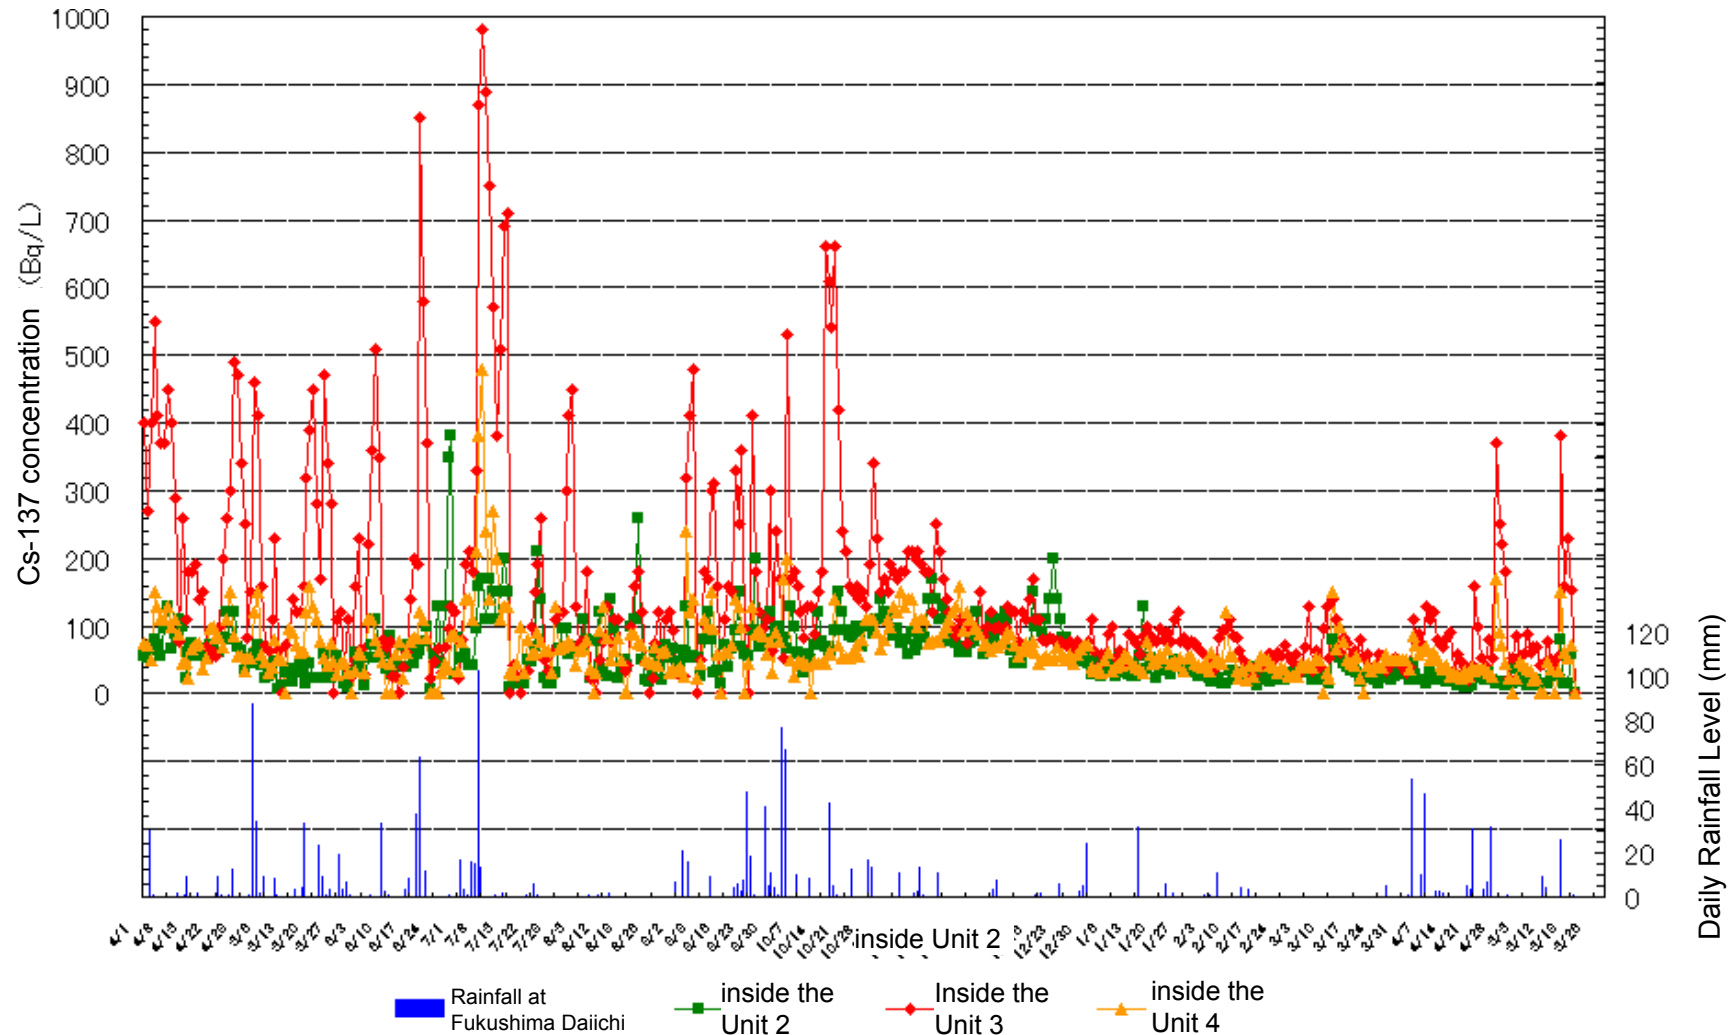
Reference H

- Fluctuations in radioactive material concentration caused by rainfall can also be seen on the inner side of the silt fence. In particular, these trends are remarkable on the inner side of the Unit 3 silt fence. Therefore, a survey of the area around the Unit 3 intake will be progressed. **(Reference H)**

Concentration of Cs-137 inside Fukushima Daiichi Unit 2,3,4 Silt Fence on Ocean Side + Rainfall Level (Fukushima Daiichi)

○ A correlation can be seen between the increase in the concentration inside the Unit 3 silt fence and rainfall

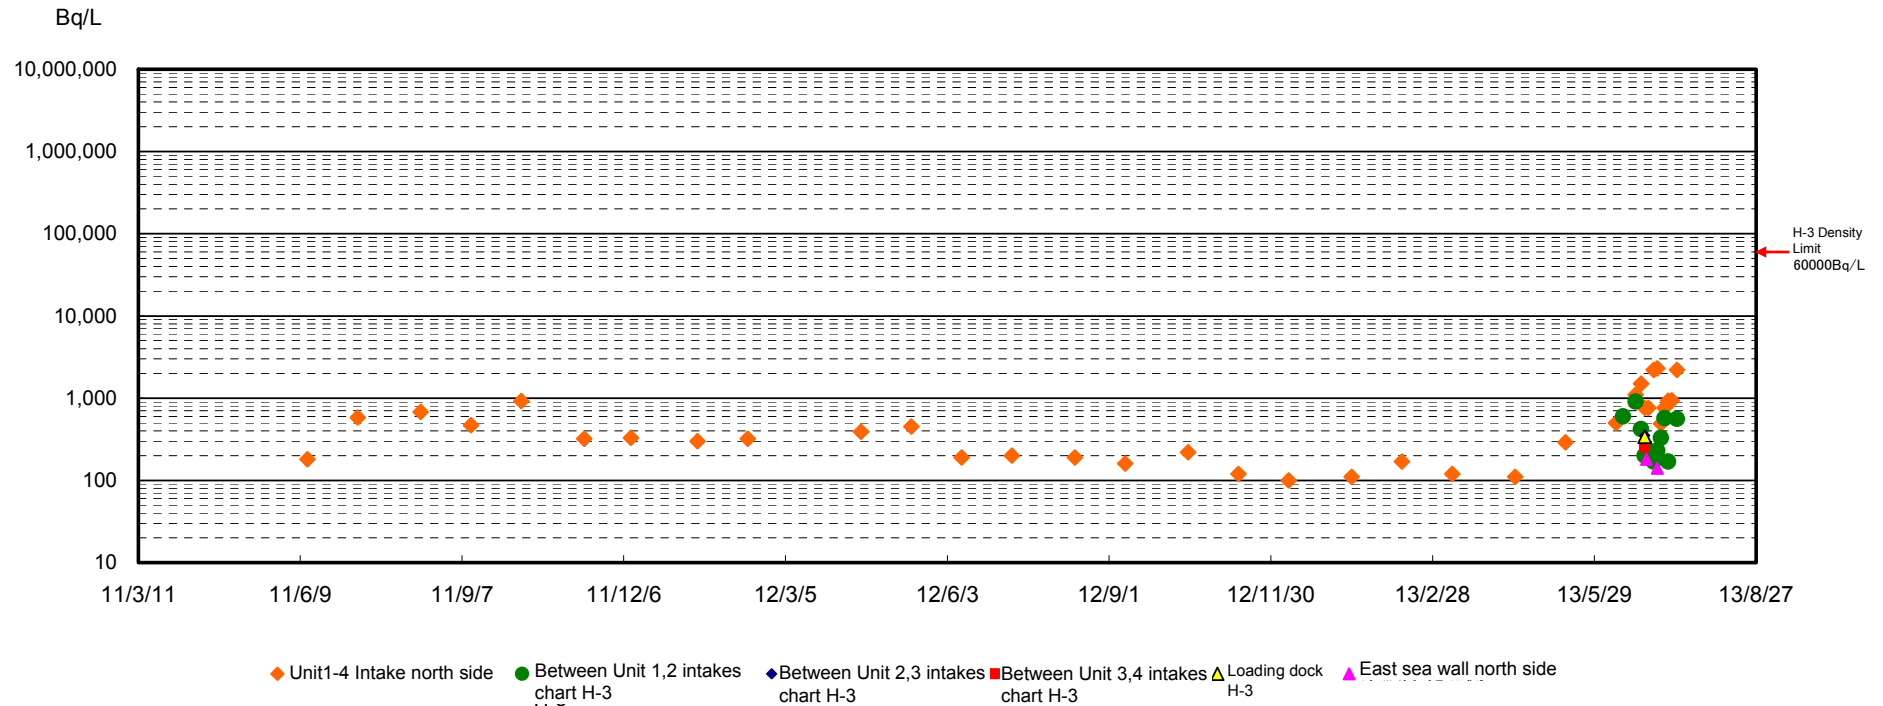
Reference I

- The concentration of tritium in the seawater in the port has risen to 2,300Bq/L on the north side of the Unit 1-4 intake channel. There are possibilities of fallout leakage, such as from rain from the seawall, or leaking of groundwater. Also, the concerned observation points are in an area that has already been installed with impermeable walls on the ocean side, and it is possible that these impermeable walls have been hindering flow. However, since concentrations in the seawater do not just rise, but also fall, it is assumed that dispersion into seawater is limited. Furthermore, analysis results from a newly established observation hole on the outer side of the impermeable wall on the ocean side (north side of east breakwater) are approximately the same as observation results taken on the north side of the Unit 1-4 intake. **(Reference I)**

Trends in tritium concentration in seawater

- In order to confirm the impact from groundwater leaking into the port, additional holes will be bored on the north side of the Unit 1 intake and a survey will be conducted.

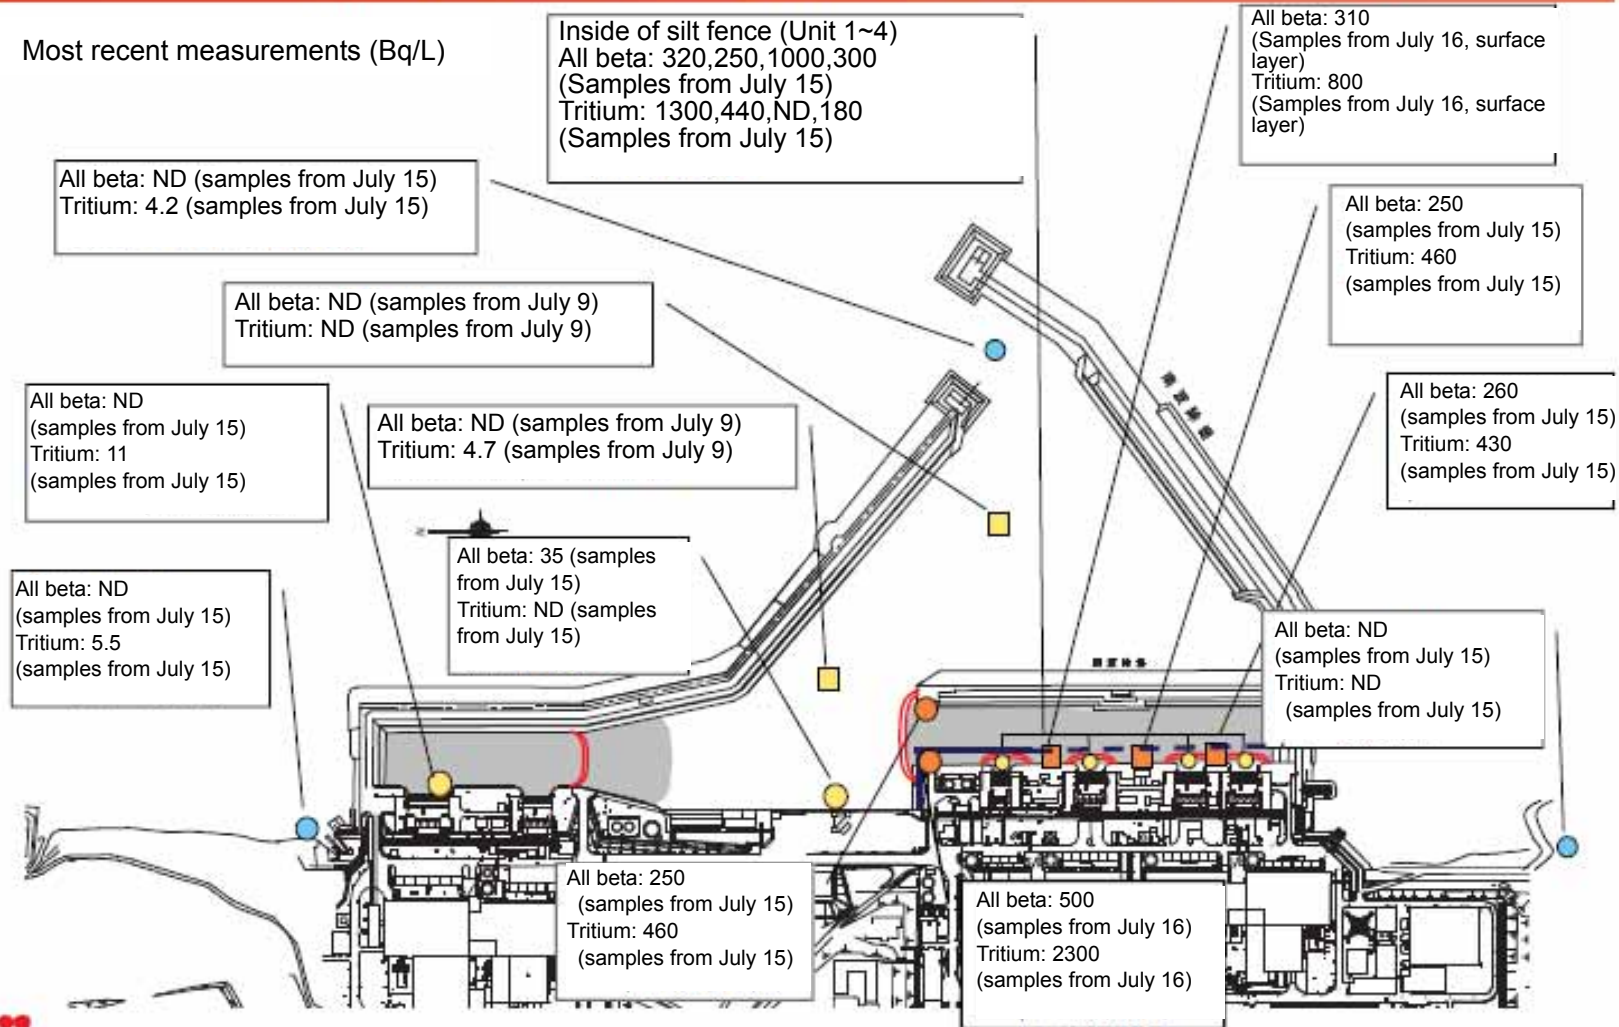
Reference J

- Concentrations of tritium and all beta radiation inside the port on the outer side of the Unit 1-4 intake open culvert are almost below detectable limits (ND) (several tens Bq/L at most), and this appears to have no impact on the concentration fluctuations on the inner side of the Unit 1-4 intake open culvert. **(Reference J)**
- In the vicinity of the border of the port (port entrance, north intake, near the south intake) the concentration of tritium is almost below detectable limits (ND) (several tens Bq/L at most), and all types of all beta radiation are below detectable limits (ND) according to the most recent observation results, thereby showing concentrations to be the same or lower than those inside the port.

Seawater Measurements from inside and outside the Port
