Investigation utilizing an underwater camera was performed to examine the condition of the fuel handling machine mast* which sunk into Unit 3 spent fuel pool while removing steel truss debris from the upper part of the pool on February 6, 2013.

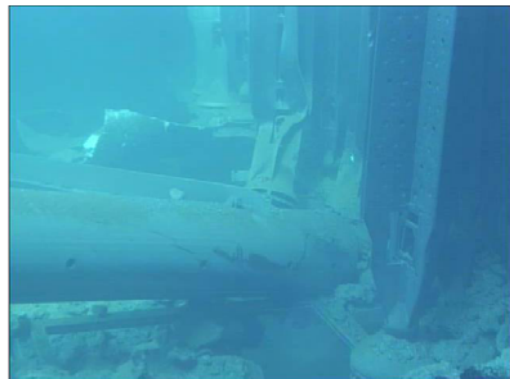
The fuel handling machine mast* was found on the fuel rack and was not directly contacting the spent fuel storage rack and the liner.

Condition of the fuel handling machine mast (Lower edge)
(Photo taken on February 13, 2013)

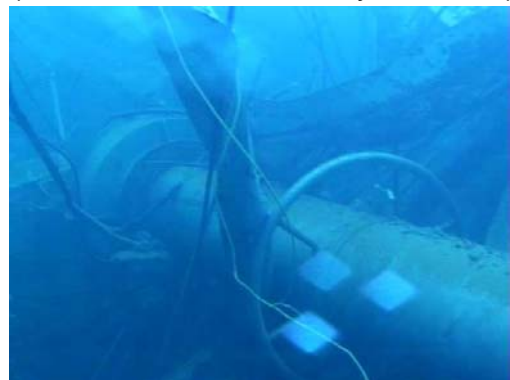
Condition of the fuel handling machine mast (Upper edge)
(Photo taken on February 13, 2013)

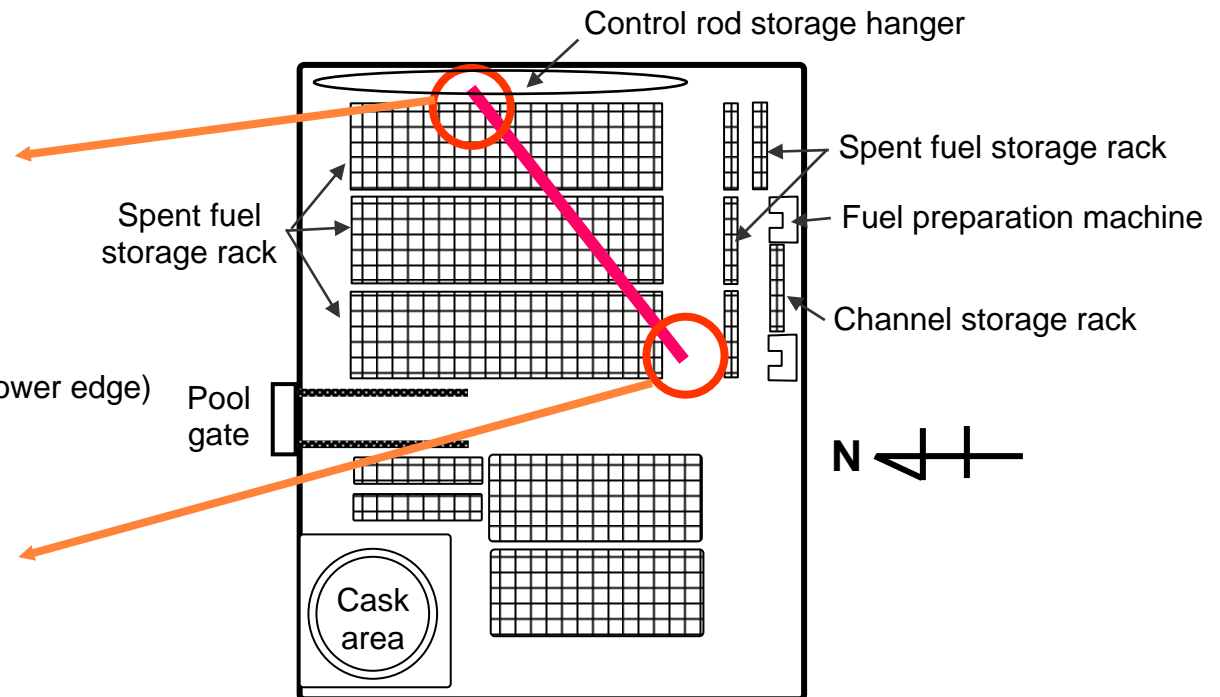
The area investigated by an underwater camera and the location of the fuel handling machine mast
(February 13, 2013)
