Simulated Images of the Spent Fuel Pool and the Duct at Unit 1 of Fukushima Daiichi Nuclear Power Station

< Reference >
 February 18, 2013
 Tokyo Electric Power Company

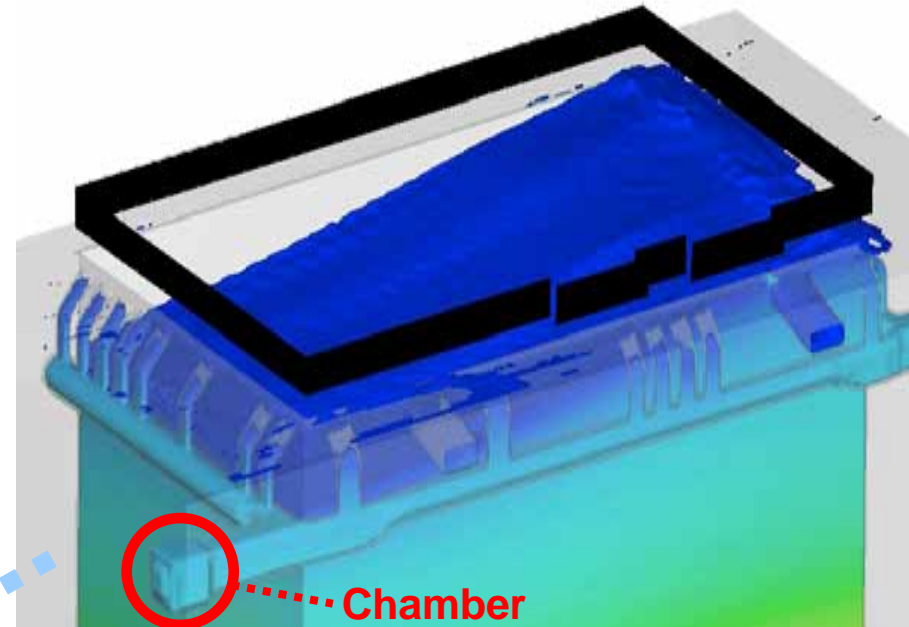
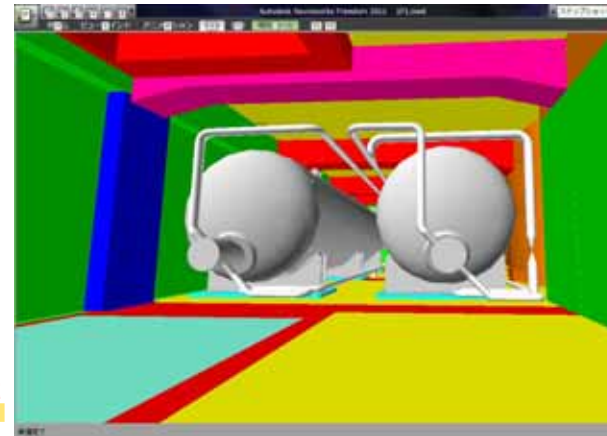
Water leakage location witnessed by the investigative panel appointed by the parliament

- The duct installation location and the water leakage location witnessed were found to be about the same.
- The water leakage on the fourth floor is assumed to have been caused by pool water generated by sloshing going through the air conditioning duct and overflowing from the chamber for overflow prevention.

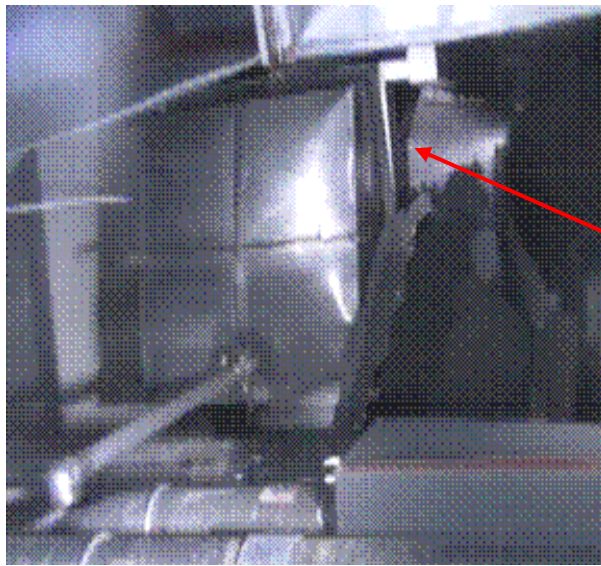
South surface of the chamber (closure panel)

- The conditions of the overflow prevention chamber were as follows.
 - Major deformation was found on the closure panel installed on the south surface and an opening has been generated as a result.
 - The panel on the north surface has been deformed (bulged from the inside).
 - The inspection opening flange on the west surface could not be confirmed visually.
- Though the insulation material on the most part of the emergency condenser vent line pipe (in the upper part of the spent fuel pool wall near the overflow prevention chamber) has come off, no major damage (which can be easily found visually) was found on the pipe itself.
