< Reference > March 13, 2013
Tokyo Electric Power Company

Outline

SARRY will be suspended in order to perform the following for reliability improvement.

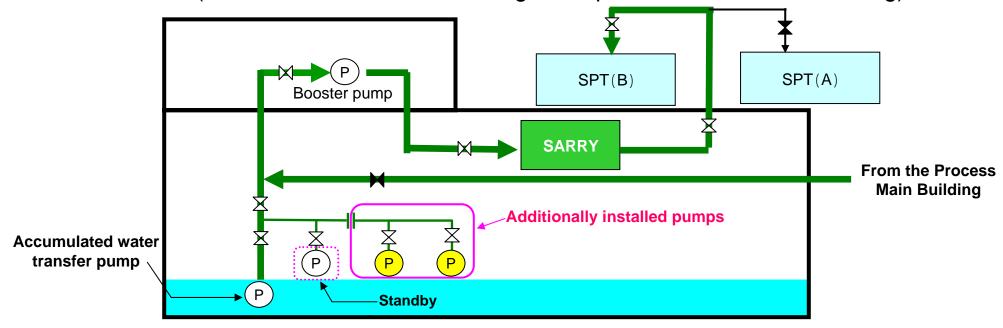
■Work overview (Overview of SARRY in the High Temperature Incinerator Building)

Though two accumulated water transfer pumps (underwater pumps) (one of which is a standby) are currently installed in the High Temperature Incinerator Building to avoid major impact on the accumulated water transfer in the case of a failure, two additional standby pumps will be installed in order to further enhance the reliability of accumulated water treatment, considering the difficulty to perform maintenance on a regular basis. During the first phase of work, the pipes and valves have been installed for the additional pumps.

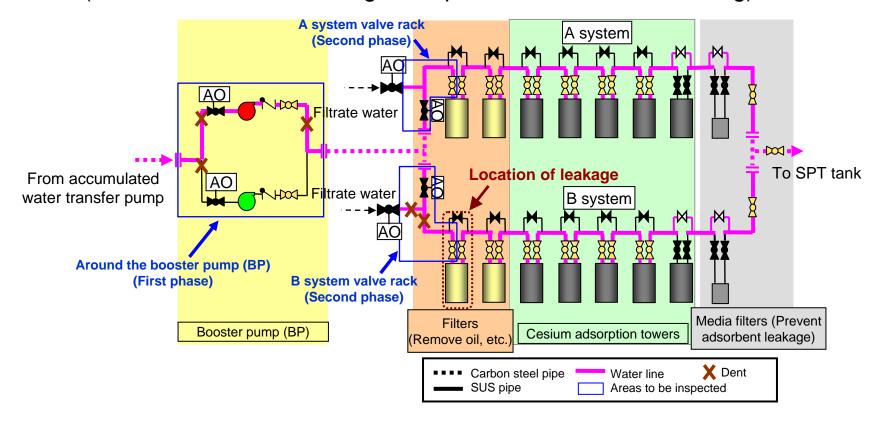
Overview (SARRY installed in the High Temperature Incinerator Building)

In response to the leakage caused by crevice corrosion near the welded part of SARRY course filter outlet pipe which occurred in February 2012, non-destructive inspection (RT) is performed* on the similar areas for the purpose of soundness confirmation. During the inspection, dent was found on welded areas (at 5 locations). As a follow-up inspection (about half a year has passed since the previous inspection), non-destructive inspection will be performed on the dent at 3 locations (-) found in the first phase.

*The inspection was performed in two steps (First phase (around the booster pump): September-October 2012, Second phase (around the valve rack): January 2013). As no major corrosion was found as a result, the soundness was confirmed and no problem which may affect the continuation of SARRY operation was found. A follow-up inspection will be done on the dent on the welded areas (at 5 locations) found during the previous inspection.

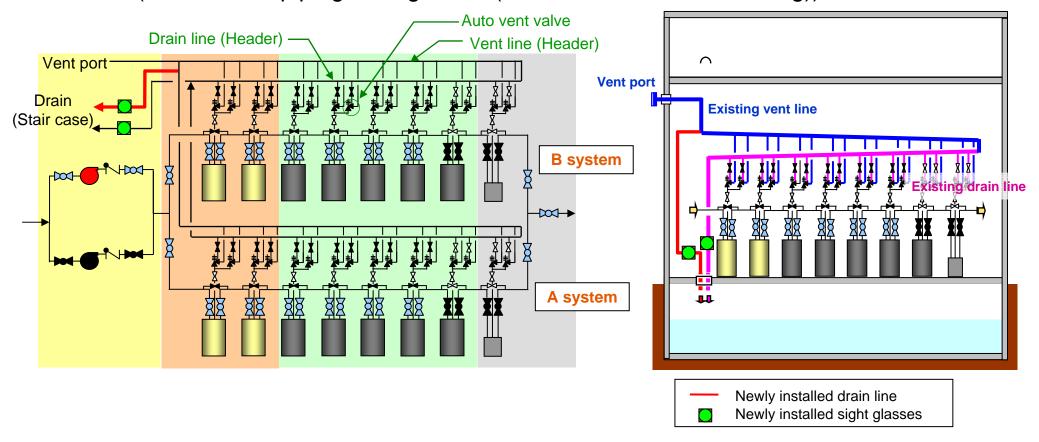
Overview (SARRY and piping arrangement (Cross-section of the building))

In November 2012, leakage from the vent port occurred due to the vent pipe being full of water as a result of closing the drain line for reliability improvement work. In response to this incident, a new drain line and sight glasses allowing for checking the drainage status will be installed during the apparatus suspension for recurrence prevention.
