Results of Investigation of the Lower Part of Unit 2 Vent Pipe at Fukushima Daiichi Nuclear Power Station

March 14, 2013 Tokyo Electric Power Company

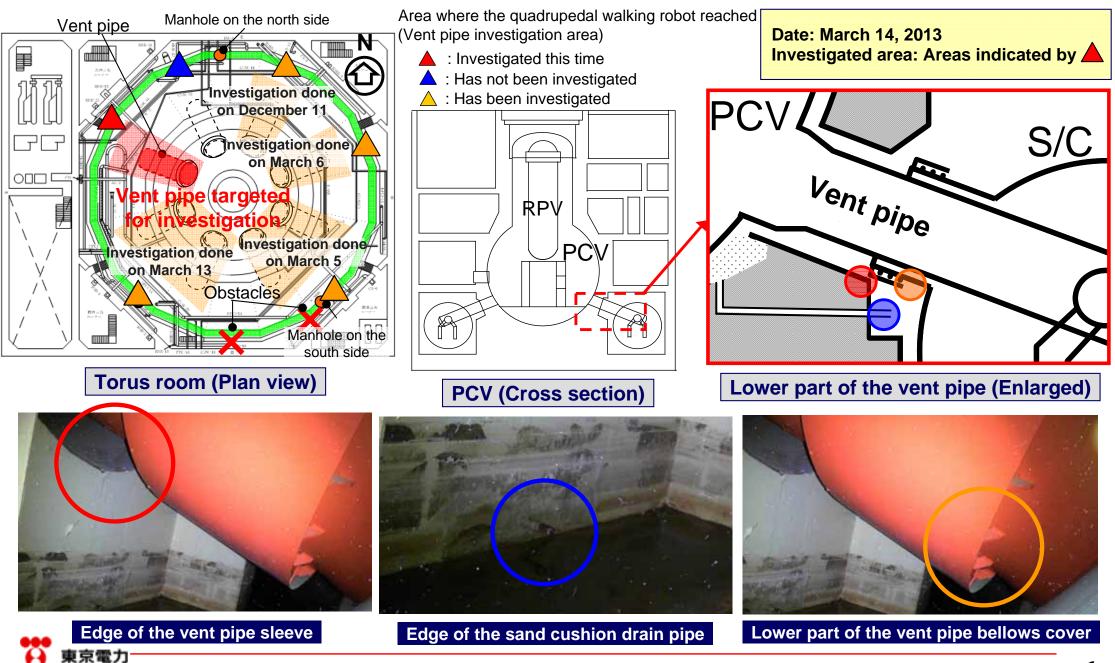
Investigation Locations and Current Conditions (West-northwest Vent Pipe)

- 1. As for the west-northwest vent pipe subject to today's investigation, no water leakage was found at the edge of the vent pipe sleeve, the edge of the sand cushion drain pipe and the lower part of the vent pipe bellows cover.
- 2. As a result of directing the camera towards the north-northwest vent pipe, the investigation of leakage could not be performed due to the distance being too long. The area is to be investigated tomorrow (March 15).
