Work Performed Today (April 17) in Response to the Leakage from the Underground Reservoirs Tokyo Electric Power Company

Cause Investigation of the Leakage

Measures to Prevent the Expansion of Contaminated Water Leakage from the Underground Reservoirs

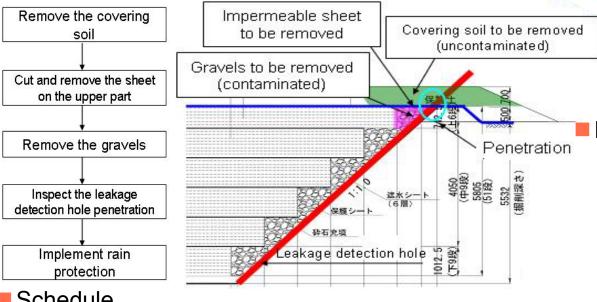
- Outline
 - Visually inspect the conditions of the impermeable sheet and the leakage detection hole in the leakage detection hole penetration in the northeast side of the underground reservoir No. 2 where the leakage is suspected.
- Work performed today
 - Restoration work of the leakage detection hole penetration The soil covering is scheduled

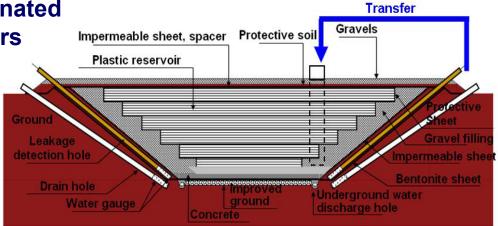
In order to prevent the leaked water in the leakage detection holes from leaking into the ground in the surrounding area, the water in the leakage detection holes will be returned to the underground reservoirs.
