Failure on a Charger Panel of the Air-cooled Gas Turbine Generator Vehicle (No.1) Due to Entrance of a Small Animal Tokyo Electric Power Company Fukushima Daini Nuclear Power Station

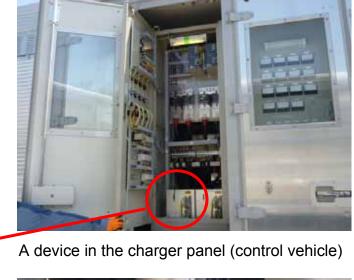
Air-cooled gas turbine generator vehicle (No.1) (Near side: generator vehicle, far side: control vehicle)

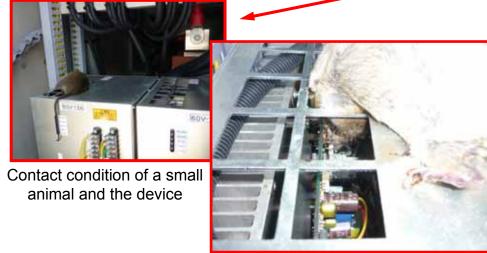
Contact condition of a small animal and the device (enlarged view)
