# Results of Soundness Inspection of Unit 2 TIP Guide Pipe (2nd Day)

July 9, 2013

Tokyo Electric Power Company

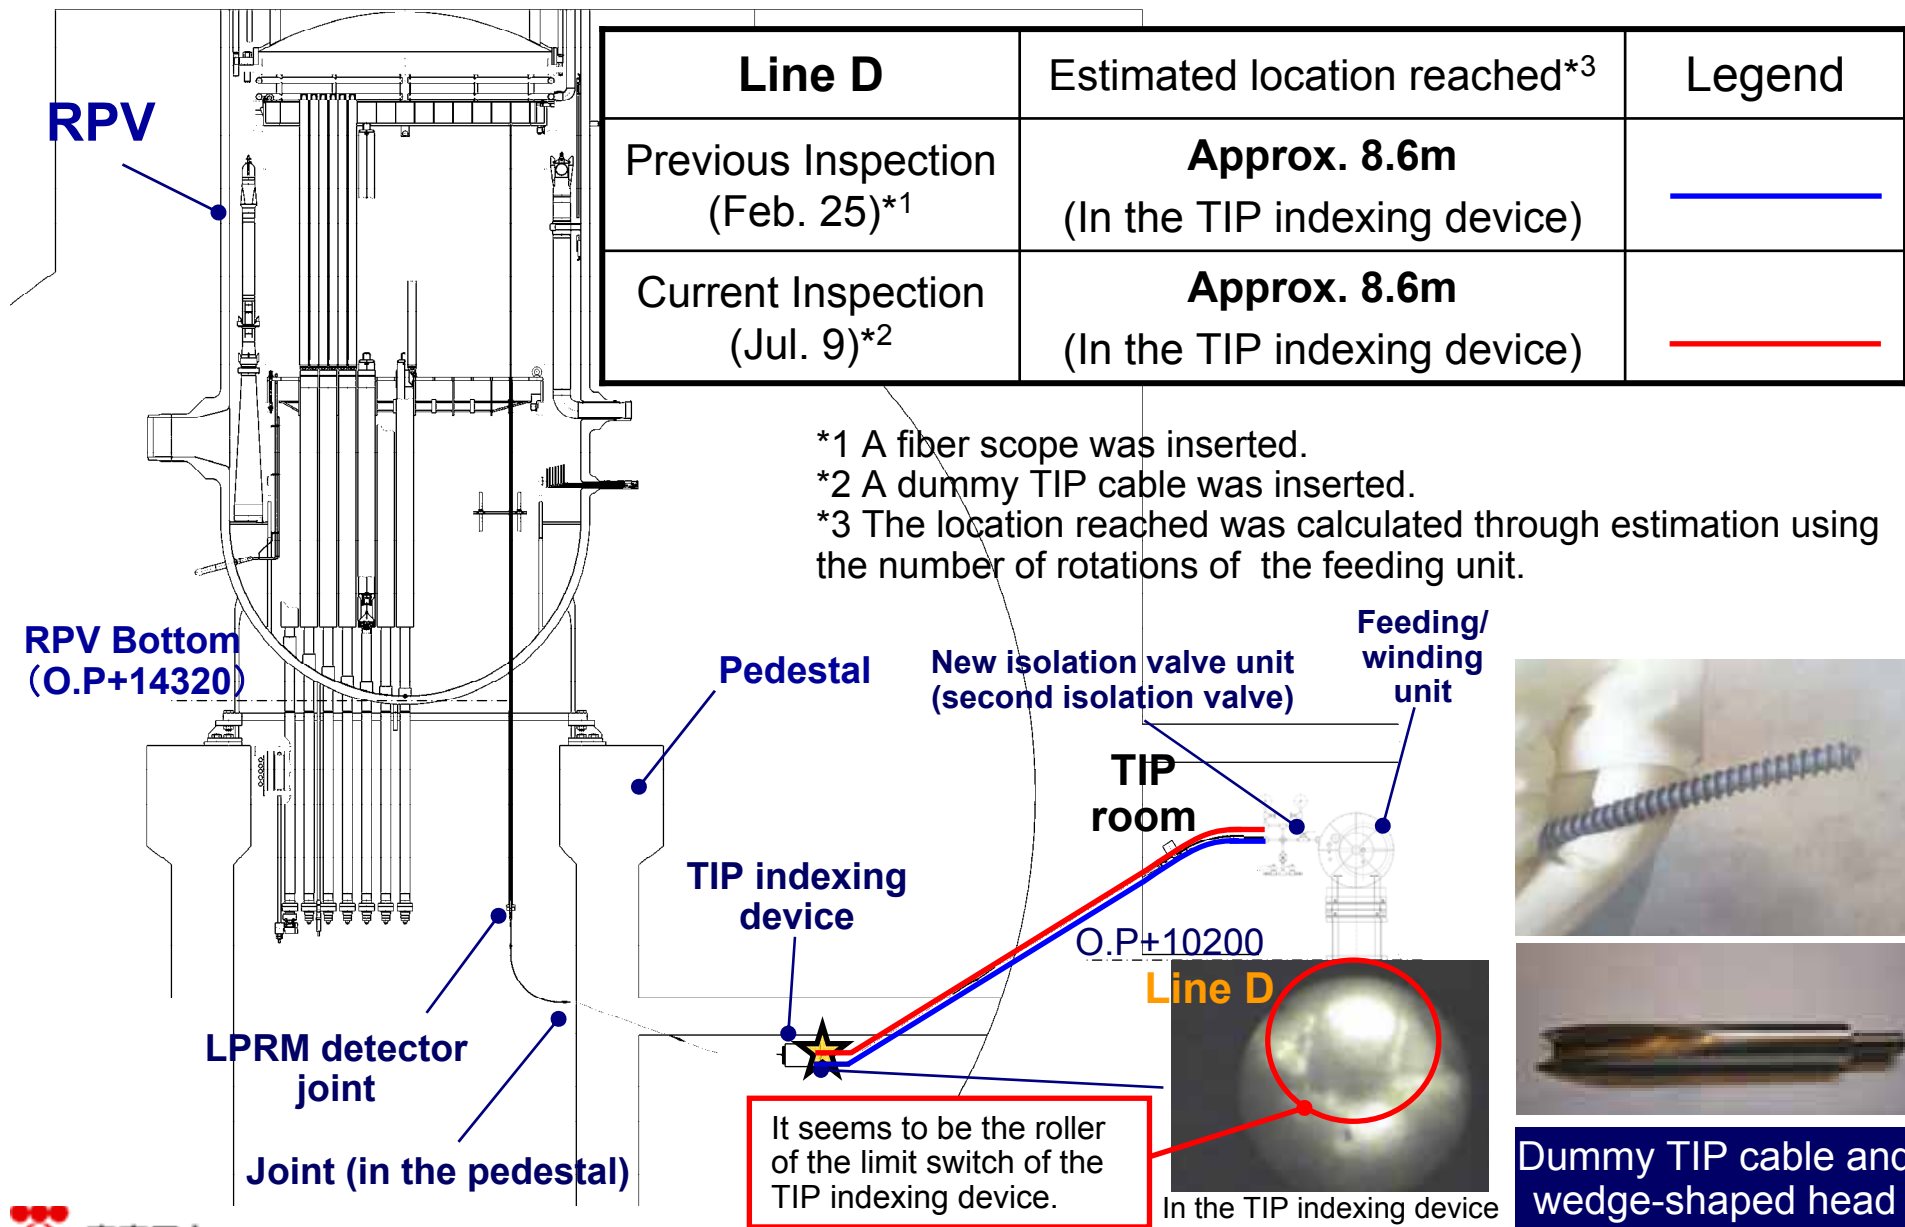
# 1-1. Contents of Work

- Radiation exposure received by workers  
Highest dose: 0.72mSV (Planned dose: 3mSV)
- Results
  - Dummy TIP cable was inserted and reached approx. 8.6m from the second isolation valve inlet flange of Line D. Insertion of the cable became impossible at about the same location as in the previous inspection.
  - After the dummy TIP cable was pulled out, attached substances were found on the head.  
( $\gamma$ -ray: 14.0mSv/h,  $\beta$ - and  $\gamma$ -rays: 30mSv/h)
  - Inspection of Line D was completed. Inspection of Line C will be conducted tomorrow.

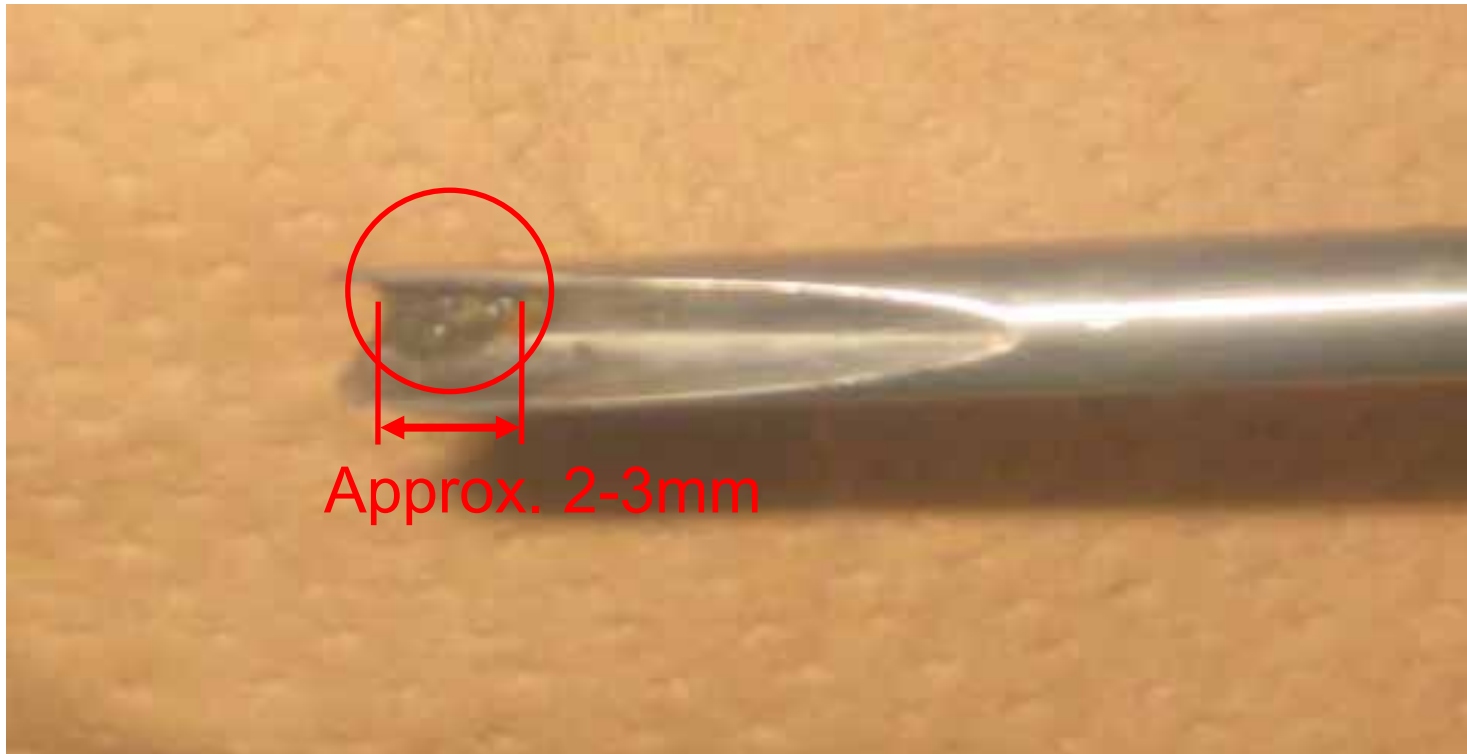
### ■ Dummy TIP cable head

- After the dummy TIP cable was pulled out, attached substances were found on the head.  
 $\gamma$  -ray: 14.0mSv/h,  $\beta$  - and  $\gamma$  -rays: 30mSv/h
