- Overview of the incident

During a patrol on Unit 6 emergency diesel generator (B) (hereafter D/G6B) in the morning on July 23, a TEPCO operator found that a valve gear oil injection tank was in irregularly high level, and oil was leaking on the floor.

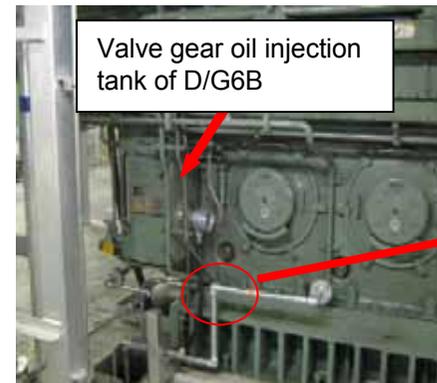
Valve gear oil injection tank of D/G6B

6:25 AM - 6:40 AM Oil level of valve gear oil injection tank was found to be irregularly high, and an oil supply valve was found to be slightly opened. The oil supply valve was closed immediately. Oil leakage of approx. 3m x approx. 2m x approx. 1mm (approx. 6 liters) was found on the bottom of D/G6B. Oil was leaking continuously in a string-shape (a pencil lead sized). A drain receiving pan was dislocated.

The oil supply valve was opened from the morning on July 22 to 10:30 AM on July 23. It is estimated that the oil was overflowed from the valve gear oil injection tank, since lubricant oil was supplied gradually while a priming pump automatically operates for 10 minutes every hour.

1. Chain lock will be used to ensure the closing of the supply valve of the valve gear oil injection tank.
2. Fixing tool, which is fixed at the similar valve, will be installed.
3. Chain lock will be used to ensure the closing of the similar valve.
4. A guide will be installed in order to prevent the drain receiving pan from dislocation.
5. Locking management of the door at the D/G Building, etc. will be enhanced.

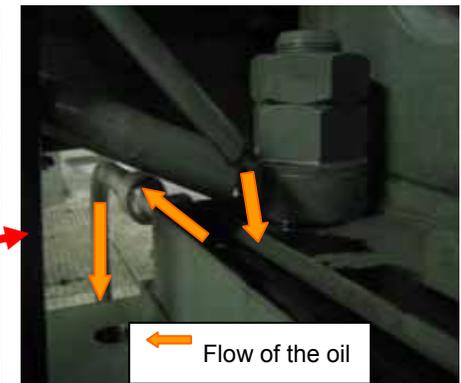
Flow of the oil

(Information as of July 11: The oil supply valve was not completely closed when oil supply of the valve gear oil injection tank was performed on July 11. In addition, the oil was supplied gradually due to the temperature setting of supply line (35°C - 40°C) and the pressure of lubricant oil priming pump, which automatically operates for 10 minutes every 50 minutes. The cause of the oil leakage is estimated that the lubricant oil priming pump was in continuous operation status in the night before due to the decrease of air temperature in the past week, and the leakage occurred from a overflow line since oil surface of the valve gear oil injection tank was surged.

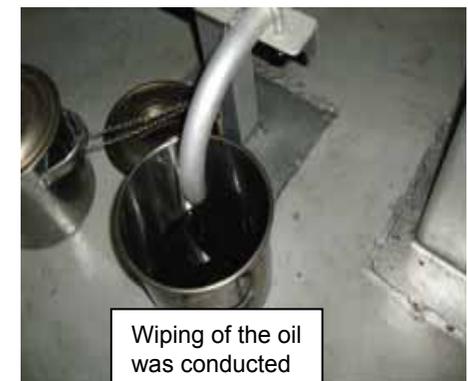
Wiping of the oil was conducted

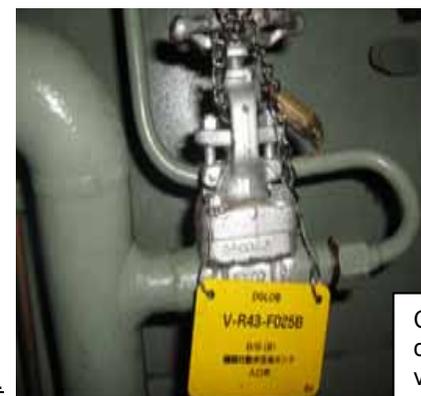
Chain lock used to ensure the closing of the supply valve of the valve gear oil injection tank
