1. Finding of the tank from which water has leaked

Survey Results Related to Leak from the RO Tank

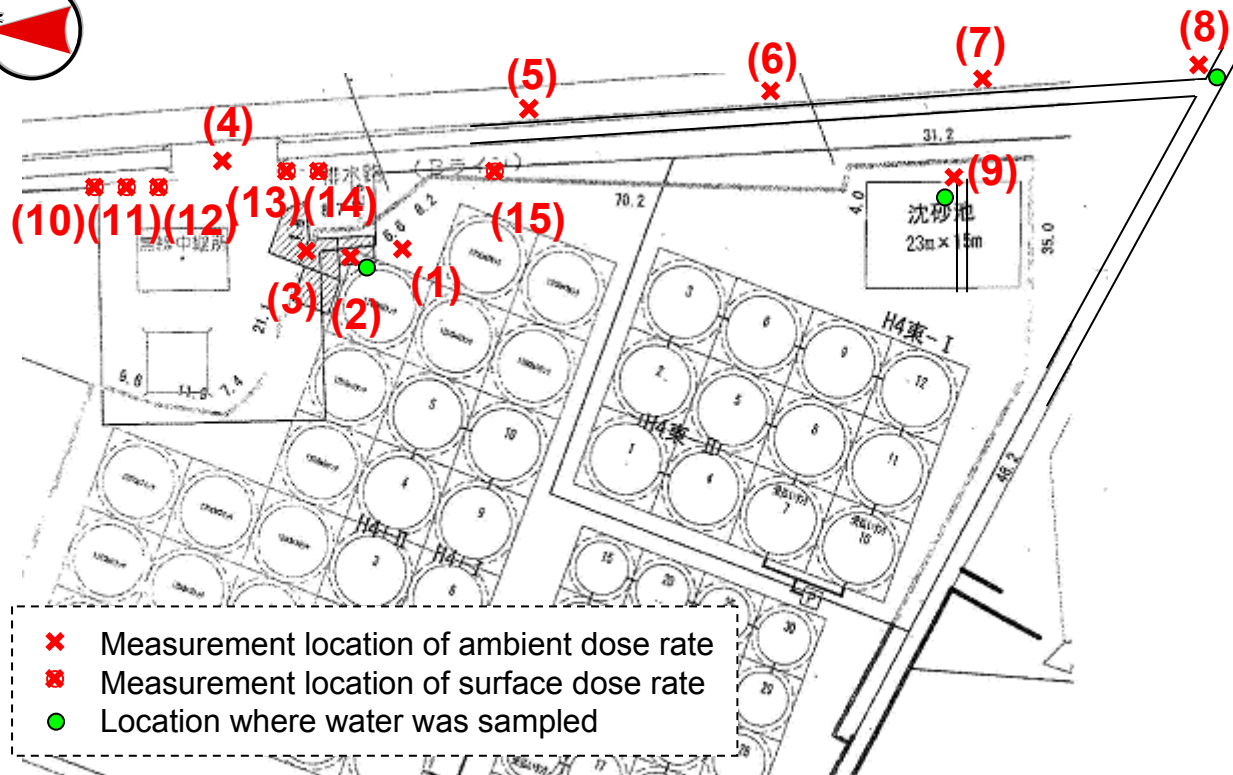
- We found water spread at the bottom part of the area near the No.5 (H4-I-5) tank in the area. Therefore, we checked the water level of this tank, and found out that the water level has fallen to approximately 3m 40cm from the top of the tank.

- We confirmed that the current water level is lower by approximately 3m than the normal level, given that the water levels of the neighboring tanks are approximately 50cm from the top of the tanks. Further, we are checking the water levels of the surrounding tanks. Note that the amount of water corresponding to this approximately 3m fall in water level is approximately 300m³.

Measurement result of dose rate

Date of measurement: August 19, 2013
Unit: [mSv/h]

Measurement point	Dose rate	
	$\gamma + \beta$ ray	γ ray
(1)	>100	1.5
(2)	5.5	0.1
(3)	0.08	0.05
(4)	0.04	0.04
(5)	0.06	0.06
(6)	0.06	0.06
(7)	0.045	0.045
(8)	0.06	0.06
(9)*	0.15	0.015
(10)	90.0	0.36
(11)	96.0	0.45
(12)	90.0	0.35
(13)	0.35	0.07
(14)	0.12	0.11
(15)	0.024	0.015

Analysis results of sampled water

Measurement point	γ nuclide (Bq/cm ³)					All β (Bq/cm ³)	Chloride (ppm)
	Cs-134	Cs-137	Co-60	Mn-54	Sb-125		
Leakage water	4.6E+1	1.0E+2	1.2E+0	1.9E+0	7.1E+1	8.0E+4	5,200
Sand sedimentation pond	<2.0E-2	<2.6E-2	<1.3E-2	-	-	4.1E+1	-
Side ditch	<1.9E-2	<2.7E-2	<1.4E-2	-	-	1.3E-1	-
