Radiation Sealing Test in H3 area Tanks

< Reference >
September 5, 2013
Tokyo Electric Power Company

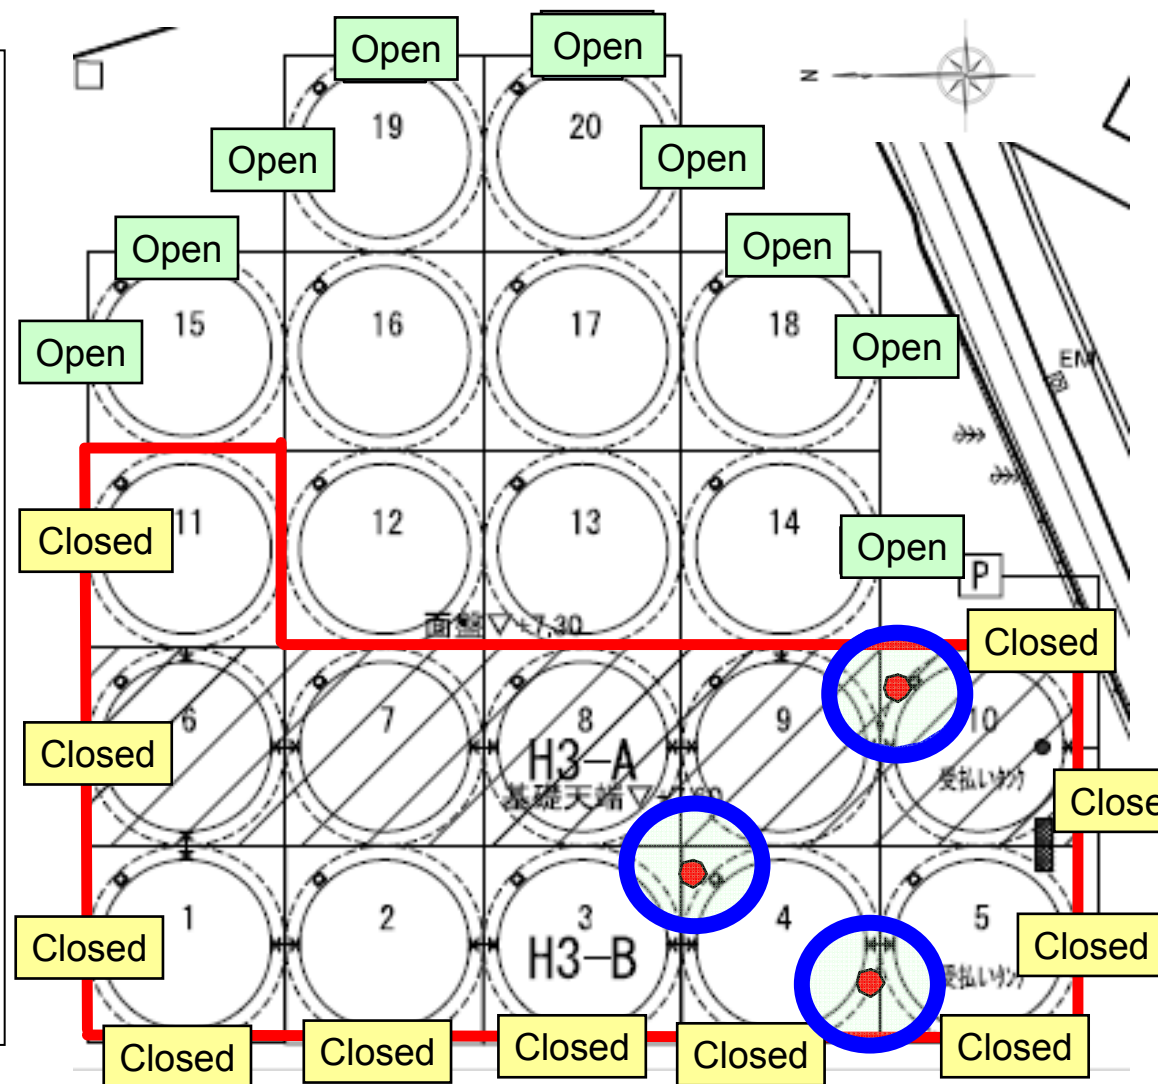
- On September 3, radiation sealing tests were performed at the bottom flanges on the north, south of No.4 Tank in B Group in H3 area, and on the north of No.10 Tank in A Group in H3 area, where high dose was detected (blue circles).
- Covering was performed with sealing materials and acrylic sheets used inside tanks, and rubber mats were laid on the concrete base in front of high dose parts in order to test the efficacy.
