**Causes and Countermeasures for  
Dust Concentration Increases and  
Bodily Contamination in front of the  
Fukushima  
Daiichi Nuclear Power Station's  
Seismic Isolated Building**

**September 12, 2013  
Tokyo Electric Power Company**

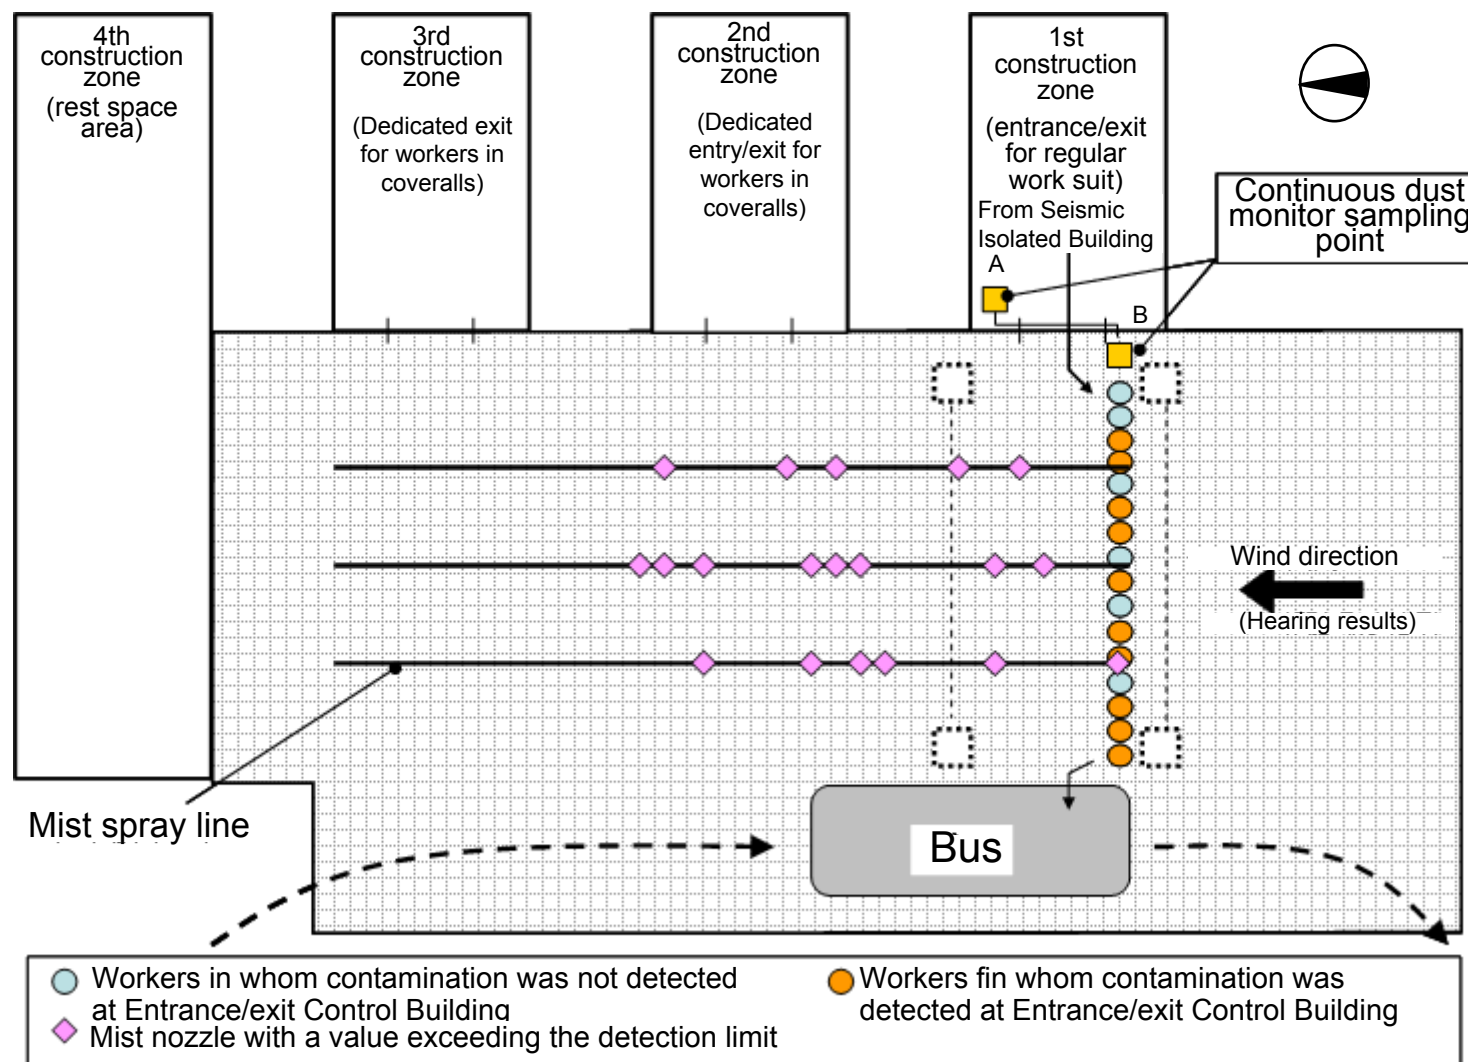
- Equipment: Ordinary work clothes + shoe covers + cotton gloves + surgical mask worn
- The 10 contaminated workers were standing in a line along with the other six passengers between 12:25 and 12:30 PM on the south side of the front of the #1 construction area in front of the seismic isolated building in order to catch the 12:35 bus headed for the entry/exit management building.
- The order of the contaminated workers in the line at the bus stop was 1-3, 5·6, 8,10·11, 13·14.  
(All 16 passengers had been in the same line but monitoring values for the other six workers were below values that require decontamination according to company decontamination management policies(Below 4Bq/cm<sup>2</sup>)\*

\*Exit standards from controlled areas is 40Bq/cm<sup>2</sup> but company policy requires that decontamination be implemented for bodily contamination that exceeds 4Bq/cm<sup>2</sup>

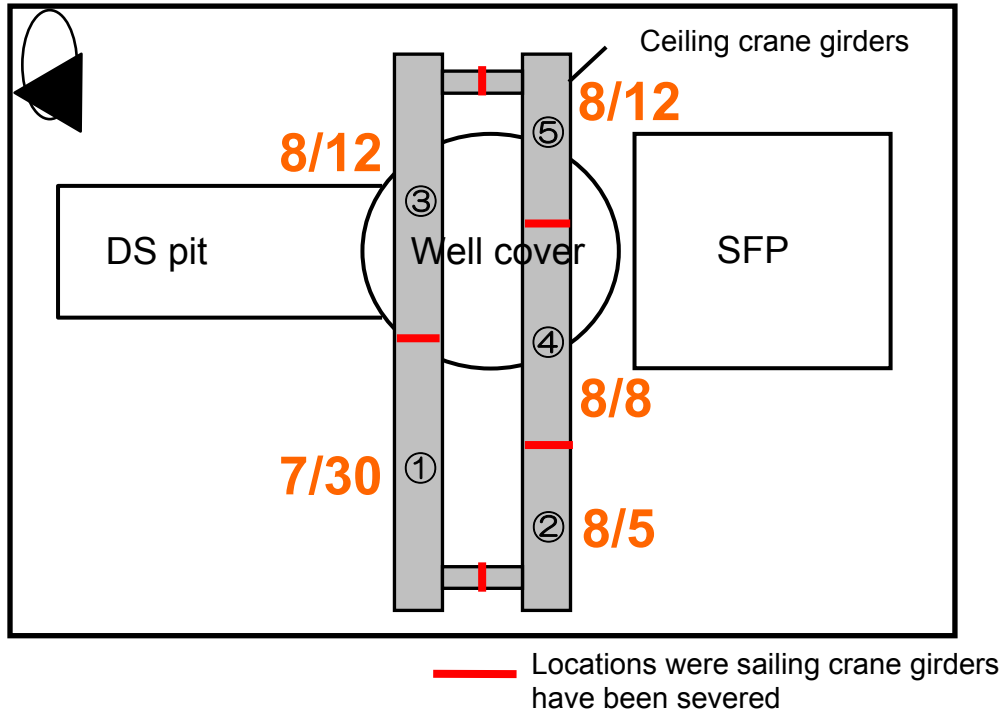
- 7/30: Ceiling crane girder ① removed
- 8/5: Ceiling crane girder ② removed
- 8/8: Ceiling crane girder ④ removed
- 8/12: Ceiling crane girder ③⑤ removed**

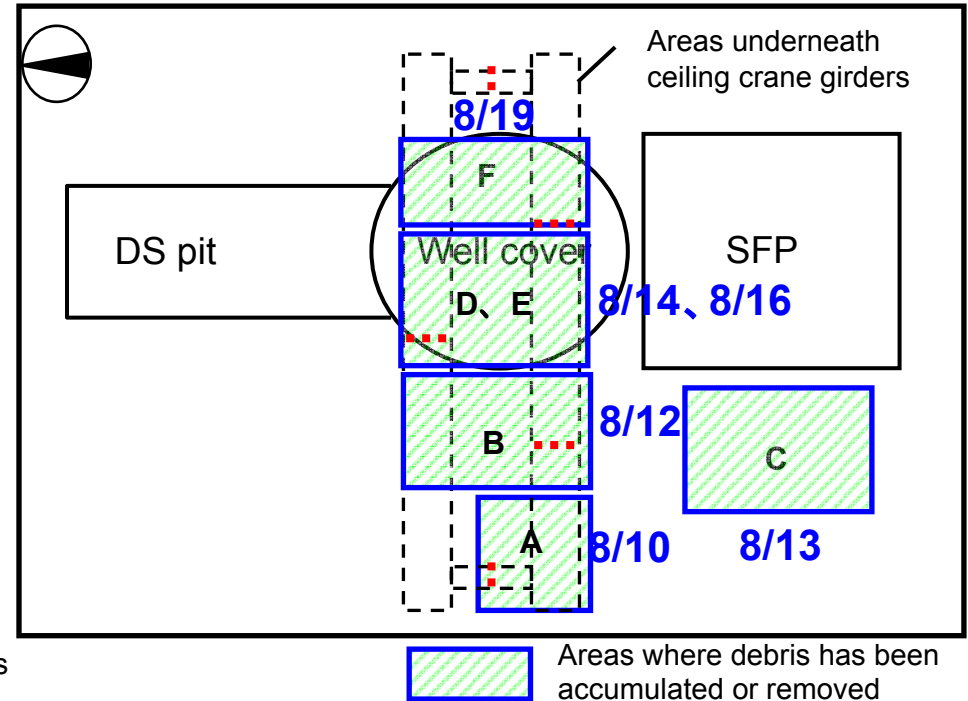
- 8/10: Debris gathering/removal A
- 8/12: Debris gathering/removal B
- 8/13: Debris gathering/removal C
- 8/14: Debris gathering/removal D
- 8/16: Debris gathering/removal E
- 8/19: Debris gathering/removal F**

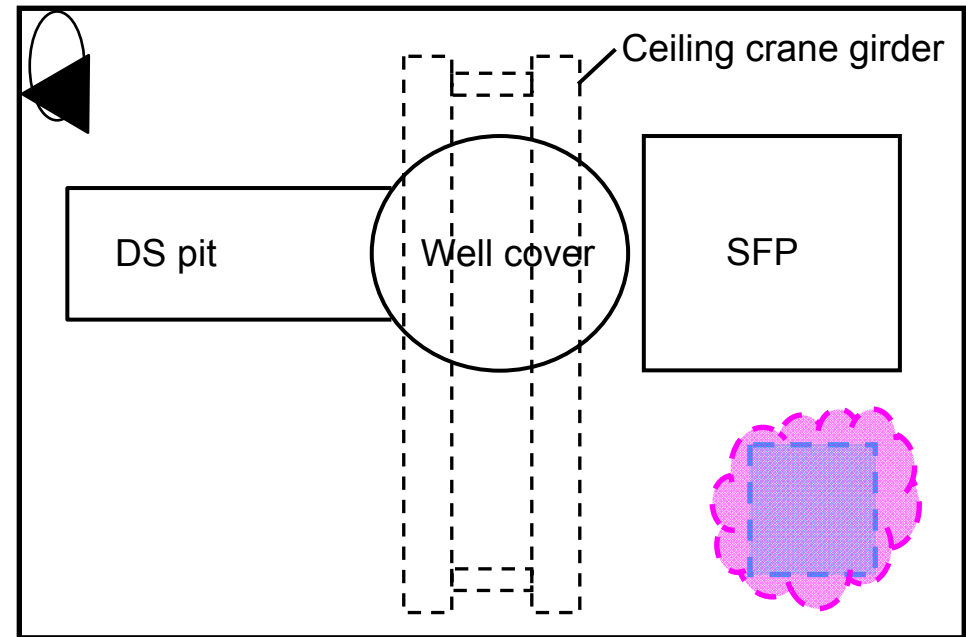
Concept image of 5<sup>th</sup> floor of the reactor building

When performing work to remove debris from the top of reactor buildings dispersion prevention agents had been dispersed **prior to the work in the area of new debris removal** in accordance with the progress of debris removal in order to prevent dispersion of dust

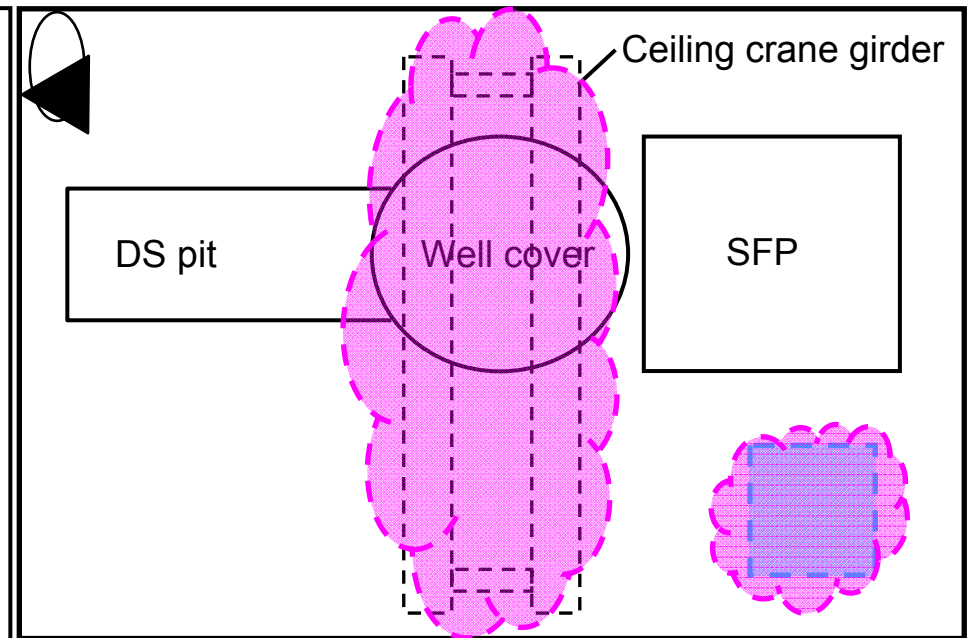
Concept image of the 5th floor of the reactor building

Dust that had accumulated underneath the ceiling crane girders and had not been subjected to rain or wind was turned up when the ceiling crane girders were removed

- There were no alarms during debris removal work exposed to outside air until July
- On July 30 debris that had been under the ceiling crane girders was exposed to the outside air for the first time during removal work. (the debris was under the ceiling crane girders making it impossible to spread with dispersion prevention agents)
- During July the air was quite humid but at the beginning of August sunny days allowed the debris to dry.

In addition to the area of debris removal, dispersion prevention agents are now being spread where dust is accumulated under ceiling crane girders prior to and following debris removal work everyday.

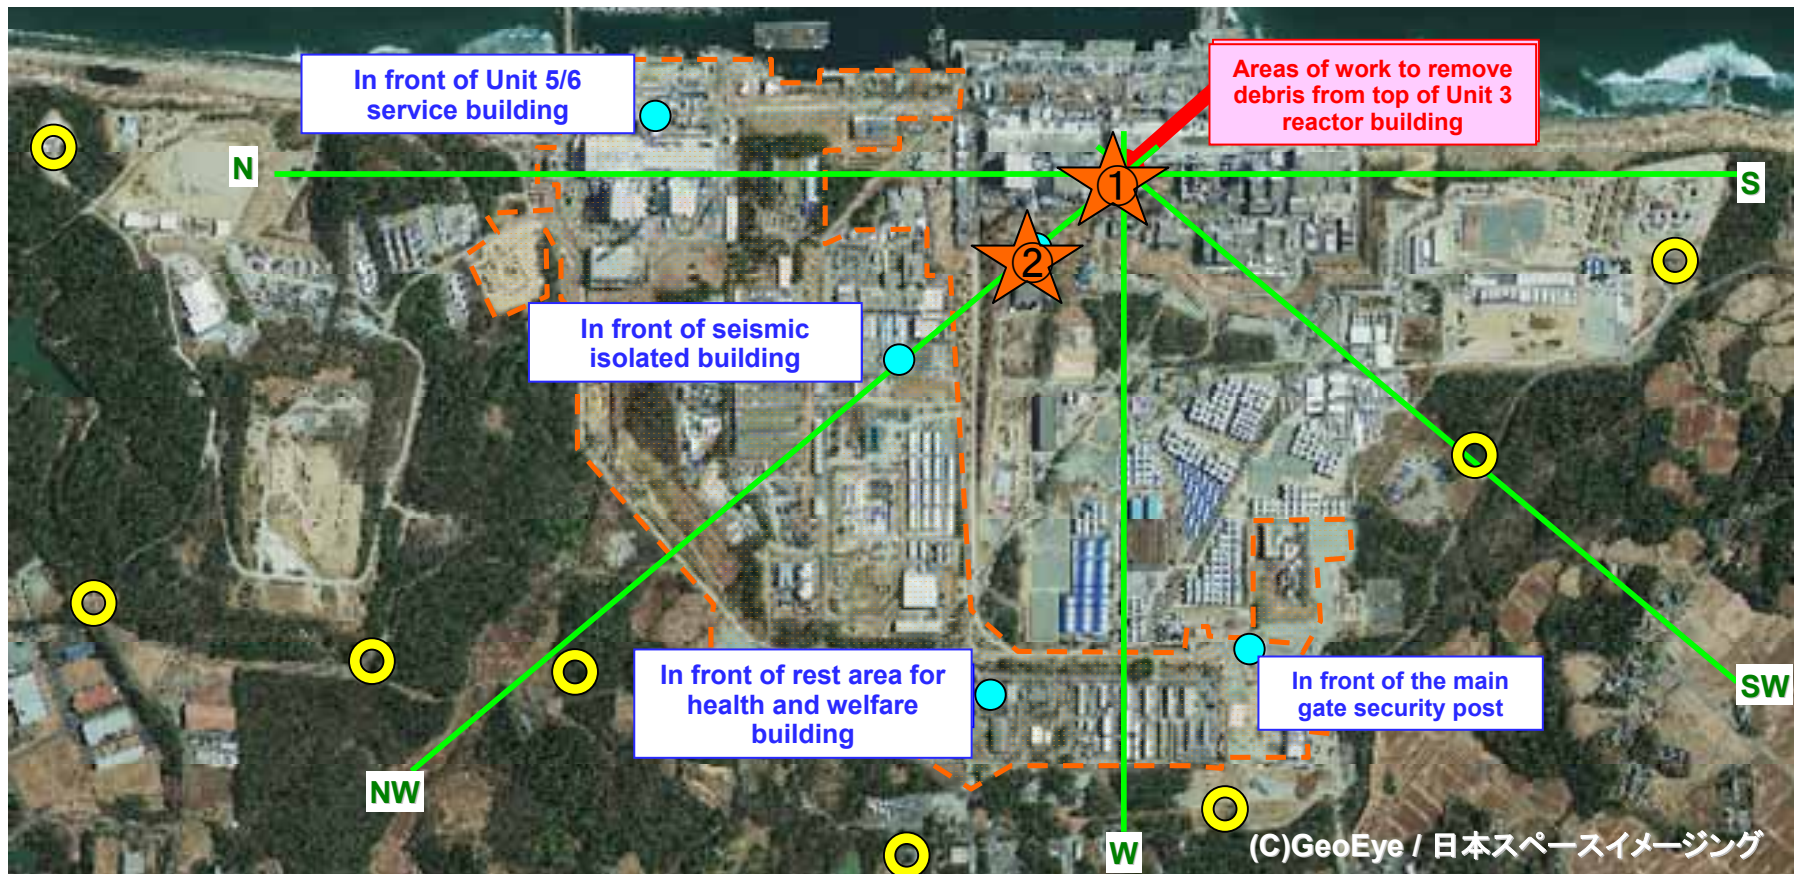
In addition to monitoring using continuous dust monitors installed inside (●) monitoring has been enhanced at ① and ②.

- ★ ① Continuous monitoring of dust during debris removal work on top of reactor buildings  
→When an alarm sounds, the status of dispersion of dispersion prevention agents is checked as well as the values of continuous dust monitors on the slope
- ★ ② Continuous dust monitors have been installed on the top slopes near the Unit 3 reactor building in order to detect dust increases as early as possible  
→When an alarm sounds, work is temporarily suspended and fluctuations in other continuous dust monitors (●) and MP (○) are checked, after which work is resumed only in consideration of wind speed/wind direction and the status of dispersion of dispersion prevention agents

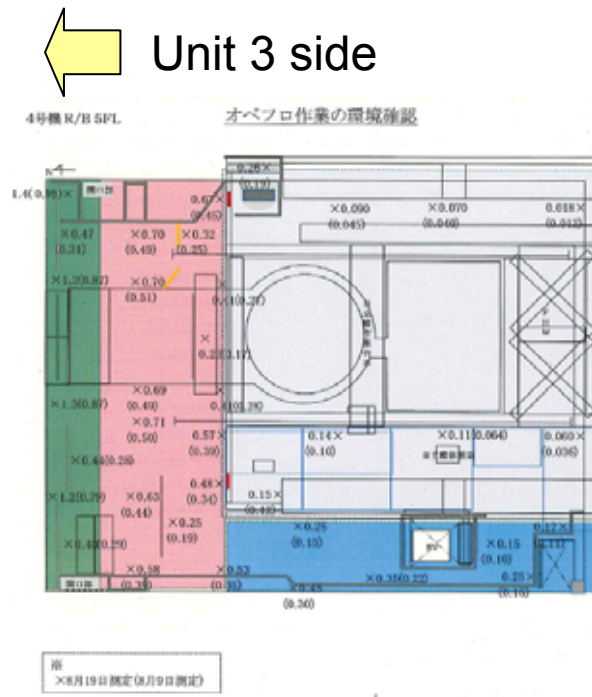
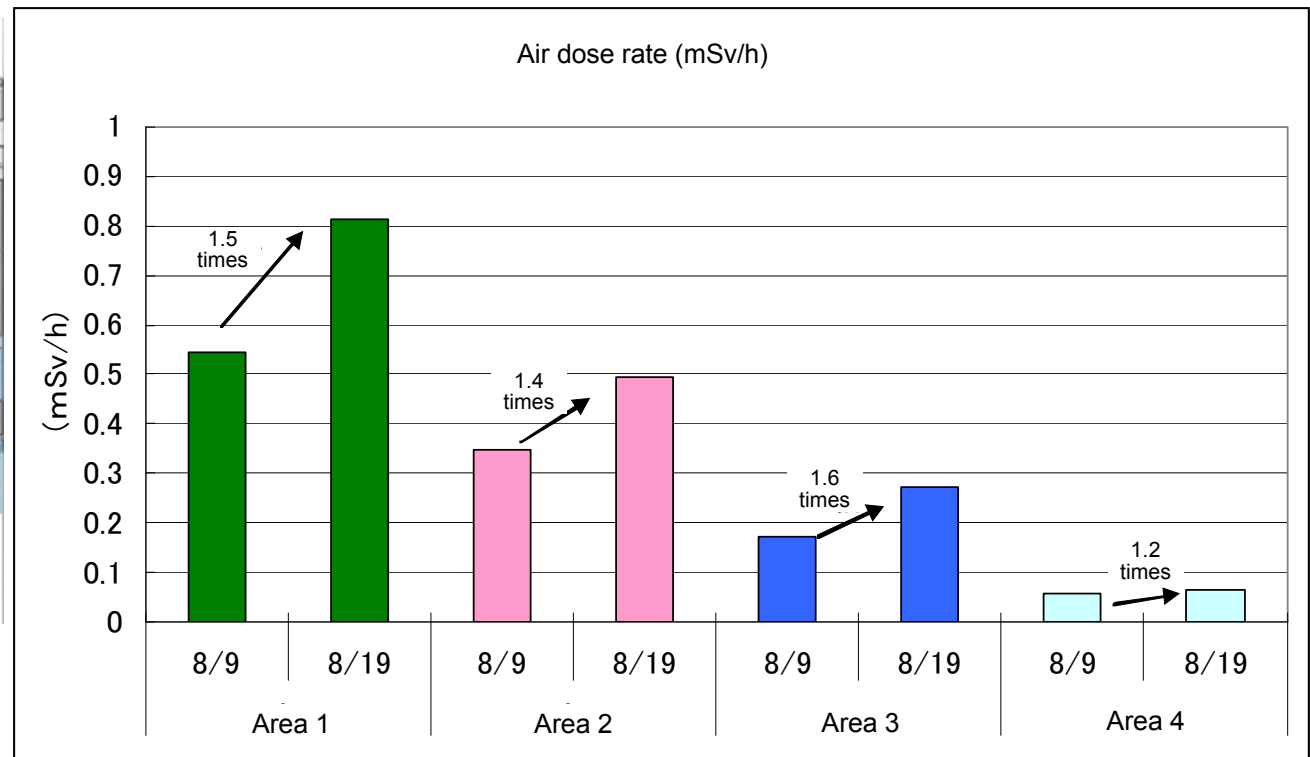
Air dose rate on the 5<sup>th</sup> floor of the Unit 4 reactor building rose by 1.2- 1.6 times between August 9 and August 19 assumedly due to the impact from Unit 3.

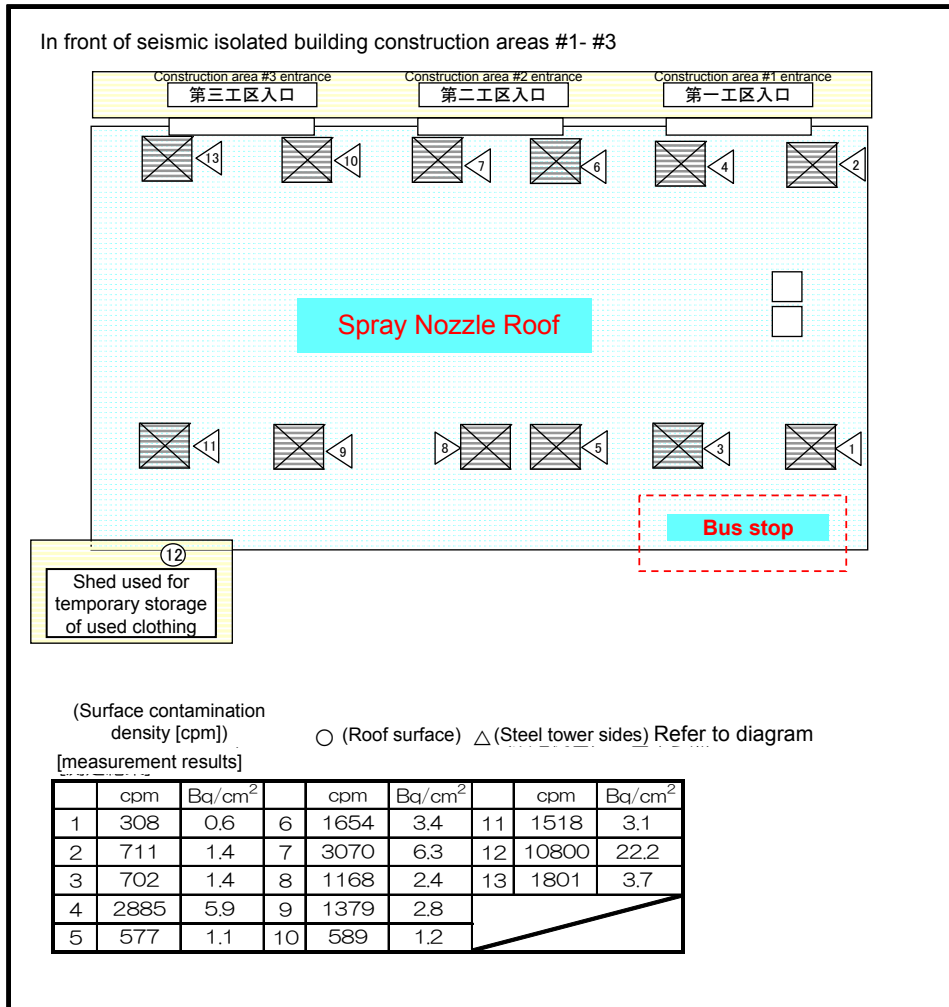
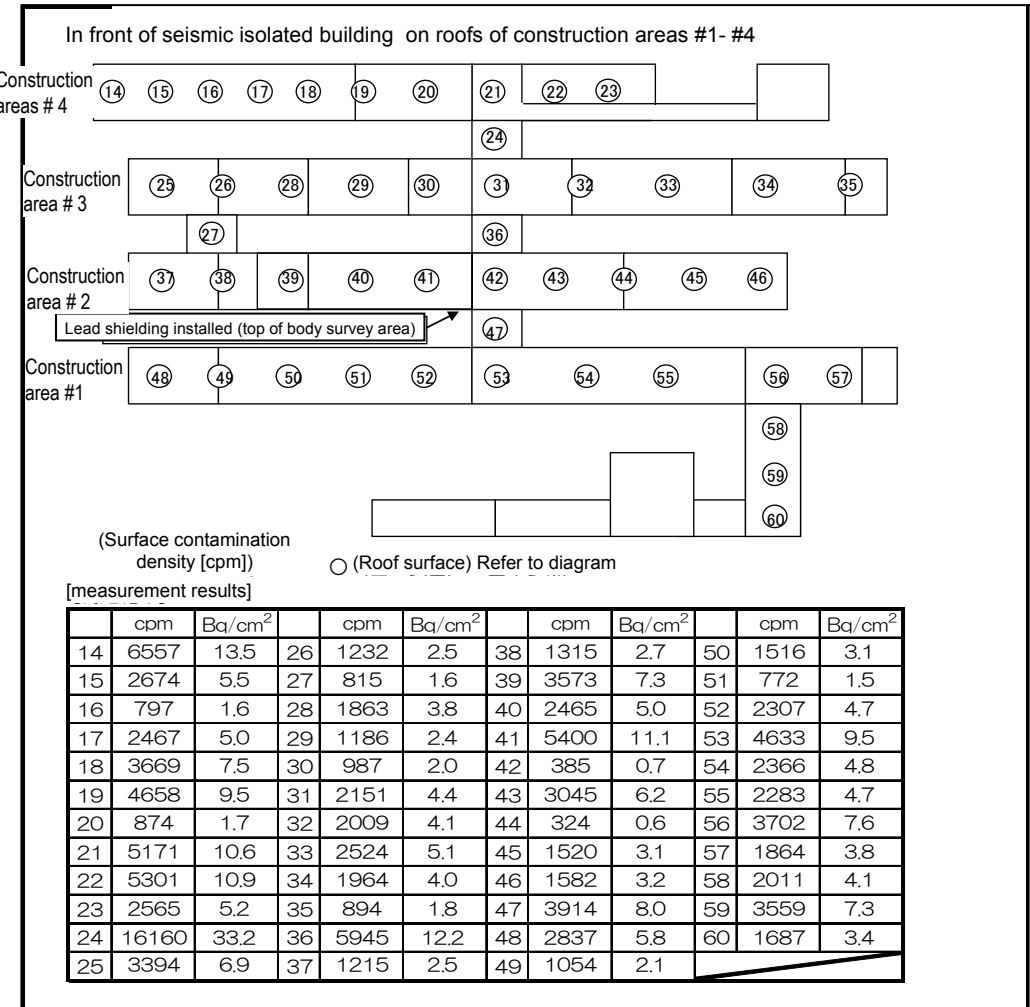
Contamination levels are approximately Bq/cm<sup>2</sup>-33Bq/cm<sup>2</sup> and about the same as the parking lot in front of the Seismic Isolated Building

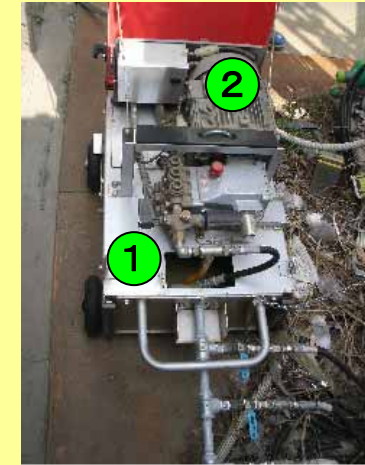
• Contamination levels inside the cover was approximately the same as that outside

Measurement point ① (Near the tank opening) ①	Measurement point ② (Dirty areas) ②
Cs-134	$2.7 \times 10^0$	$7.2 \times 10^0$
Cs-137	$6.2 \times 10^0$	$1.6 \times 10^1$
All Beta	$6.2 \times 10^0$	$1.8 \times 10^1$

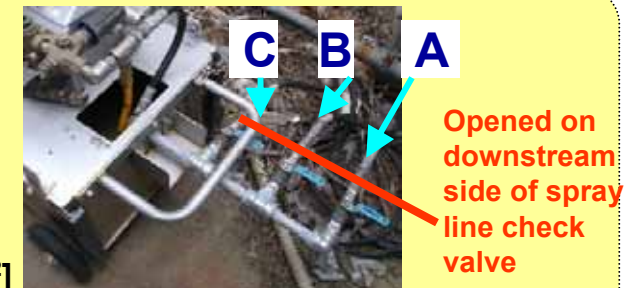
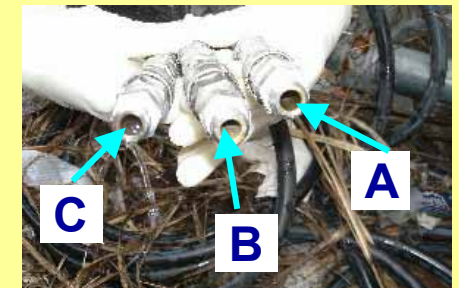
• Levels inside the spray line were below detection limits

Spray line A	Spray line B	Spray line C
Cs-134	$< 3.7 \times 10^{-1}$	$< 3.7 \times 10^{-1}$	$< 3.8 \times 10^{-1}$
Cs-137	$< 4.9 \times 10^{-1}$	$< 4.8 \times 10^{-1}$	$< 4.9 \times 10^{-1}$
All Beta	$< 5.1 \times 10^{-2}$	$< 5.1 \times 10^{-2}$	$< 5.1 \times 10^{-2}$
