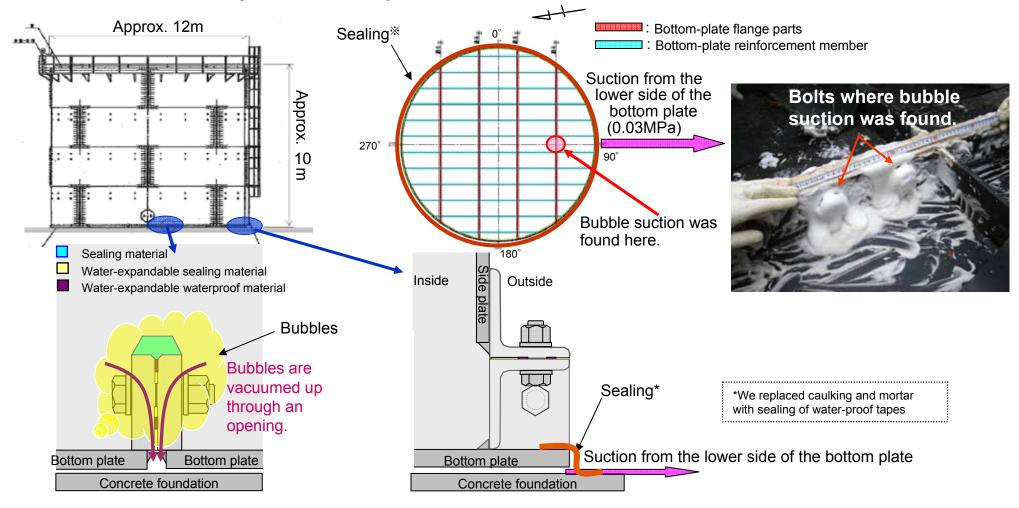
- We will specify the location of the opening through which bubbles are vacuumed, by applying bubbles to the flange parts etc. and conducting suction from the lower side of the bottom plate.
- On September 20, vacuum test for the tank bottom plate was conducted, and we found leak from caulking and mortar installed around the bottom-plate (in-leak), therefore we found no bubble suction.
- On September 25, after treating the accumulated water under the tank bottom plate, and re-conducting sealing, we found the two adjacent bolts through which bubbles were vacuumed up.
- We continue the investigation into leakage.
