Results of Investigation around Lower Parts of Unit 1 Vent Pipes at Fukushima Daiichi NPS (First Day)

**November 13, 2013
Tokyo Electric Power Company**

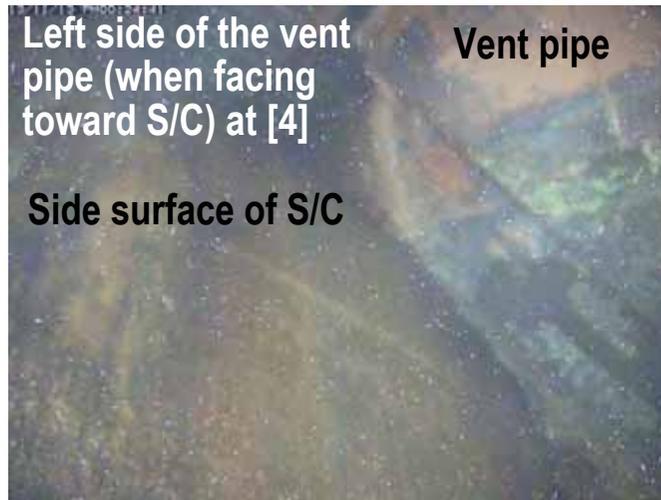
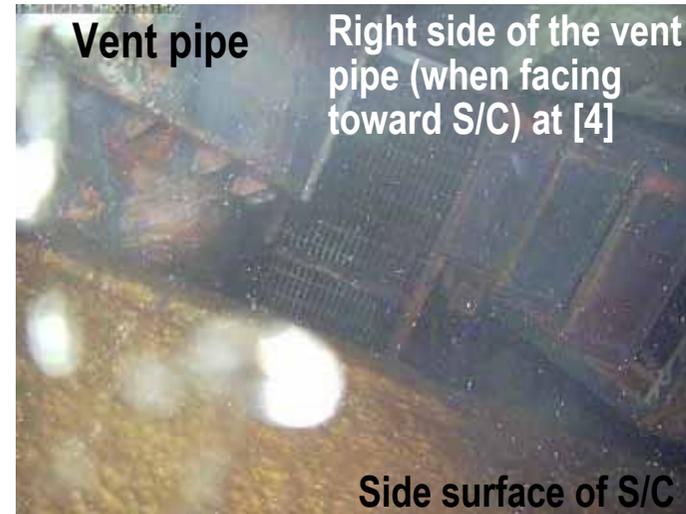
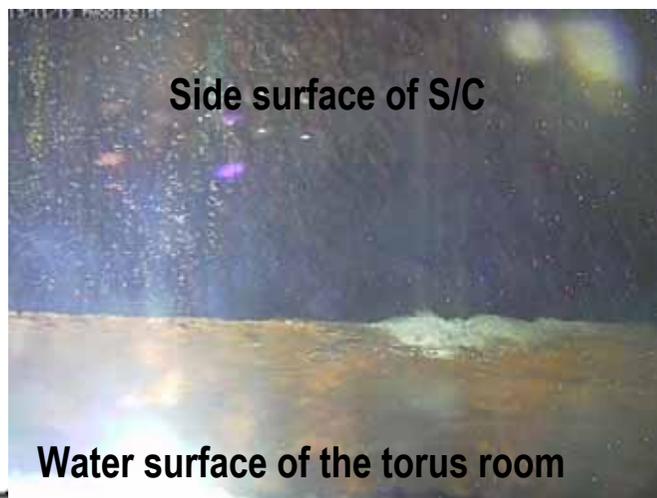
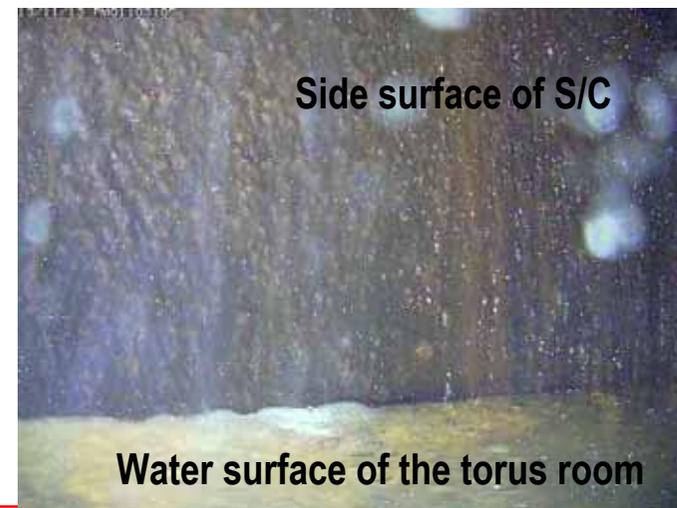
Investigation results on the lower parts of the vent pipes:

- Leakage from the upper part of the S/C facing side of the vent pipe at the location [4] was found.
- No leakage was found at the locations [1] to [3]

- Leakage from the upper part (of the S/C facing side) of the vent pipe at the location [4] (X-5E) was found.
- Leakage from the sand cushion drain pipe of the vent pipe at the location [1] (X-5B) was found.

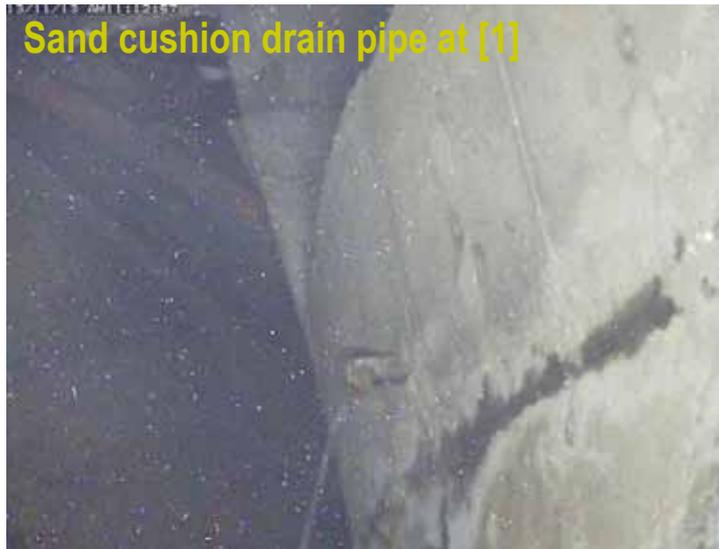
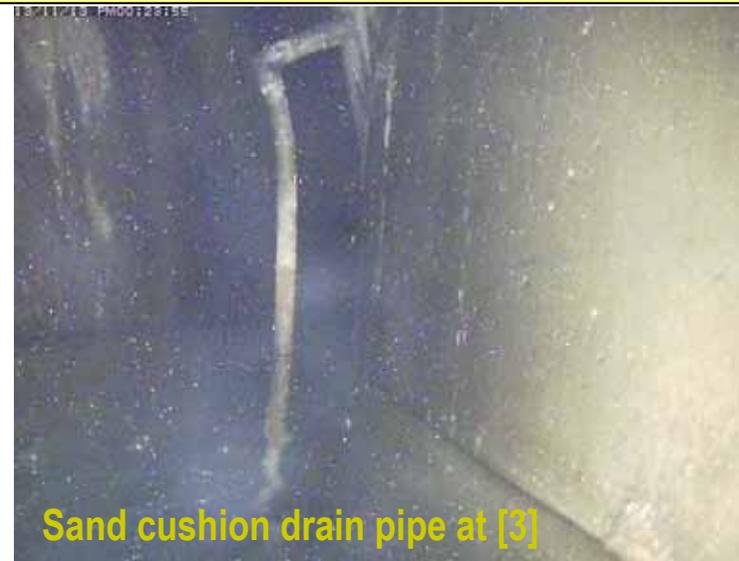
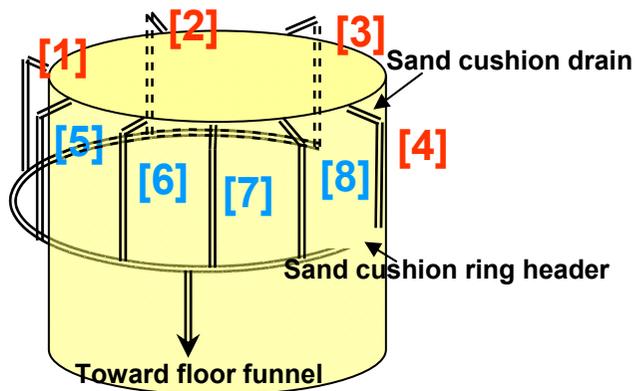
Investigation results on the sand cushion drain pipes:

- The sand cushion drain pipe at the location [1] has been damaged, and leakage was found there.
- At the locations [2] to [4], there has been no coming off of the drain pipes in the air-surrounded part, and therefore, no leakage was found.
