Cracks Found during Inspection on Fuel Assembly Having Deformation in Fukushima Daiichi NPS Unit 4 Spent Fuel Pool

< Reference >
December 27, 2013
Tokyo Electric Power Company

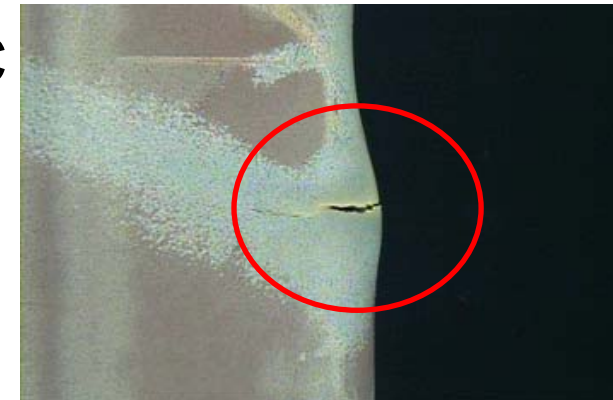
Side C

- Regarding a fuel assembly having its handle/channel box deformed (*) due to mishandling in the past, an inspection of the shape was conducted to know the degree of deformation. During the inspection, cracks were found in the channel box of the fuel assembly. We consider these cracks were caused when the channel box was deformed in the past. During this inspection, there was no change in the radioactive material concentrations in water of the spent fuel pool and the doses obtained by area monitoring.

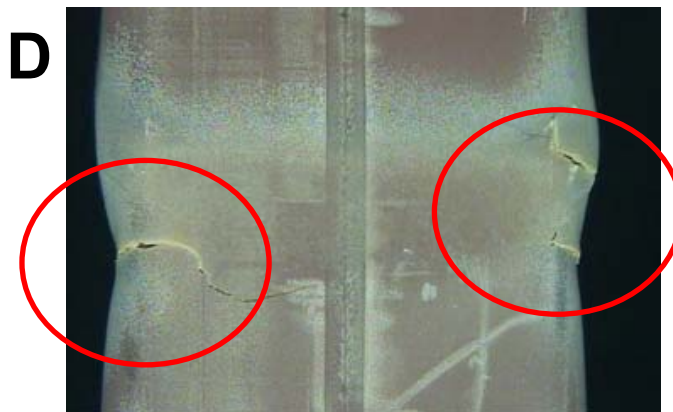
Side D

* Deformation on the side D (the valley-shaped side)
