Results of Building Frame Inspection on Fukushima Daiichi NPS Unit 3 Reactor Building after Debris Removal at Upper Part

February 14, 2014

Tokyo Electric Power Company

Attachment 1. Inspection results on the operating floor (5th floor)

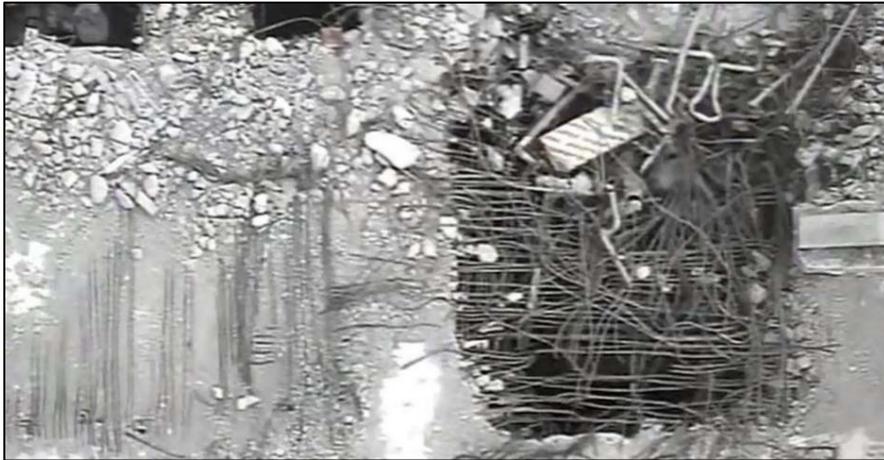
Photo ①: Damage to the floor slab

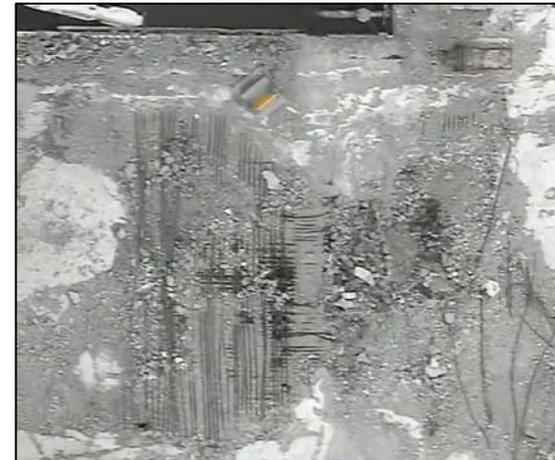
Photo ②: Reinforcing bars exposed due to damage to the upper end of concrete

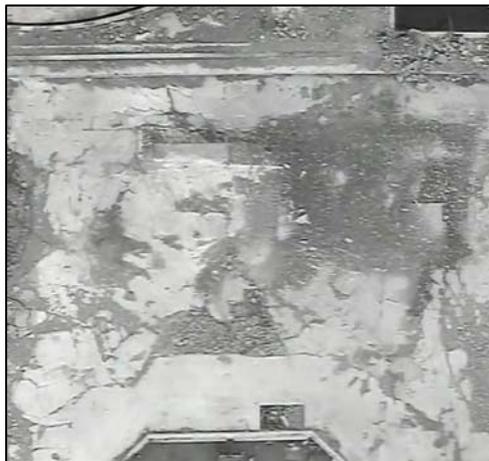
Photo ③: Damage to the surface layer of concrete

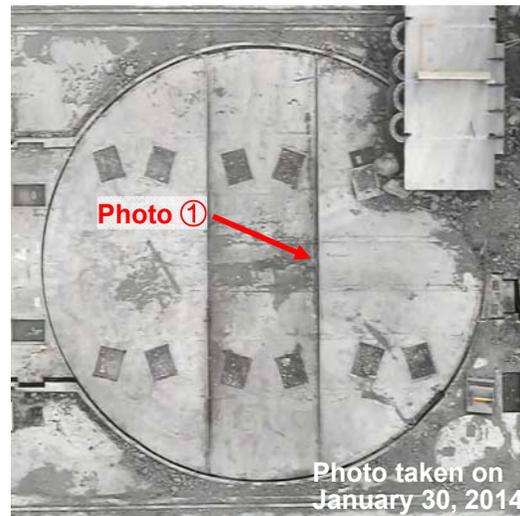
After decontamination (collection of small pieces of debris) progressed

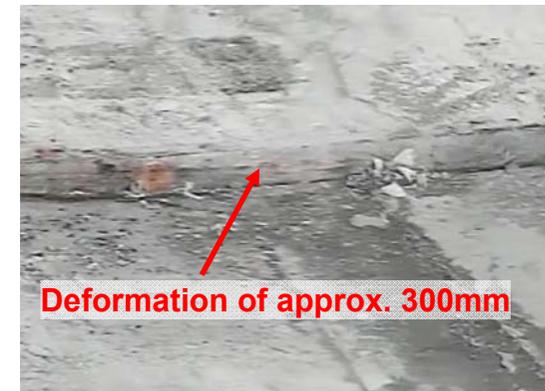
- ・ Although the shield plug is not a structural member and therefore has no impact on earthquake safety evaluations, deformation of approx. 300mm was found in the central part of the shield plug.
- ・ A load (a main winding hook, debris, etc. weighing at least about 8 tons) that had been mounted on the shield plug was already removed, and further progress of the deformation is therefore thought very unlikely.

- Before the debris removal work, there were small pieces of debris piled up on the shield plug, and the detailed conditions were unavailable.
- The conditions on the shield plug surface were inspected after the small pieces of debris were collected and removed. Then, the deformation (approx. 300mm) was found in the central part of the shield plug.

Photo ①: Deformation state of the shield plug

Presumed causes include “a hydrogen explosion” and “falling of something like an overhead traveling crane”. However, it is highly unlikely that a hydrogen explosion resulted in the deformation of the shield plug (made of reinforced concrete and of 3 layers each being approx. 60cm in thickness), based on the fact that the floor slabs (30cm and 60cm in thickness) around the shield plug have no damage. Additionally, although the main body of the overhead traveling crane that fell down did not make direct contact with the shield plug, there was a trolley over the plug. It is therefore presumed that something like a main winding hook hit the plug and deformed the shield plug.

- A shield made of steel (250mm in thickness) is to be placed on the shield plug after the completion of decontamination, which is expected to work as a protection against fallen objects. Therefore, additional damage due to a fallen object is thought impossible.

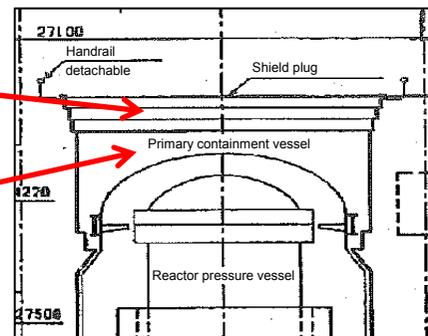
Cross-sectional view of the shield plug

Shield plug includes 3 layers

The thickness of 1 layer = approx. 600mm

Each gap in the plug = approx. 10mm

Distance between the shield plug and the PCV head = approx. 1,200mm

- Even with approximately 300mm deformation of all of the 3 shield plug layers, breaking of reinforcing bars inside the concrete is highly unlikely. It is therefore presumed that the shield plug has not fallen off.
- There is an approximately 1,200mm distance between the shield plug and the PCV head. It is therefore presumed that even deformation of all of the 3 shield plug layers would not bring the plug in contact with the PCV head.
- The plant parameters have been stable.

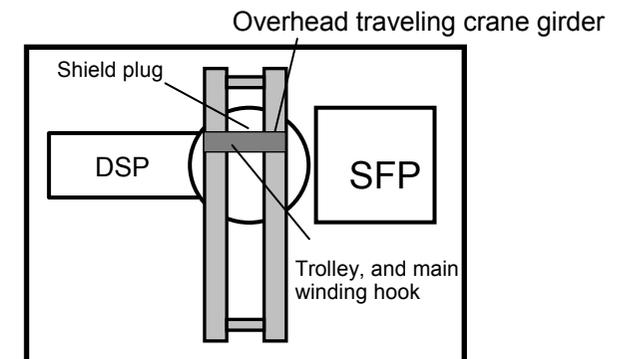
Situation that resulted from the falling down of the overhead crane girder

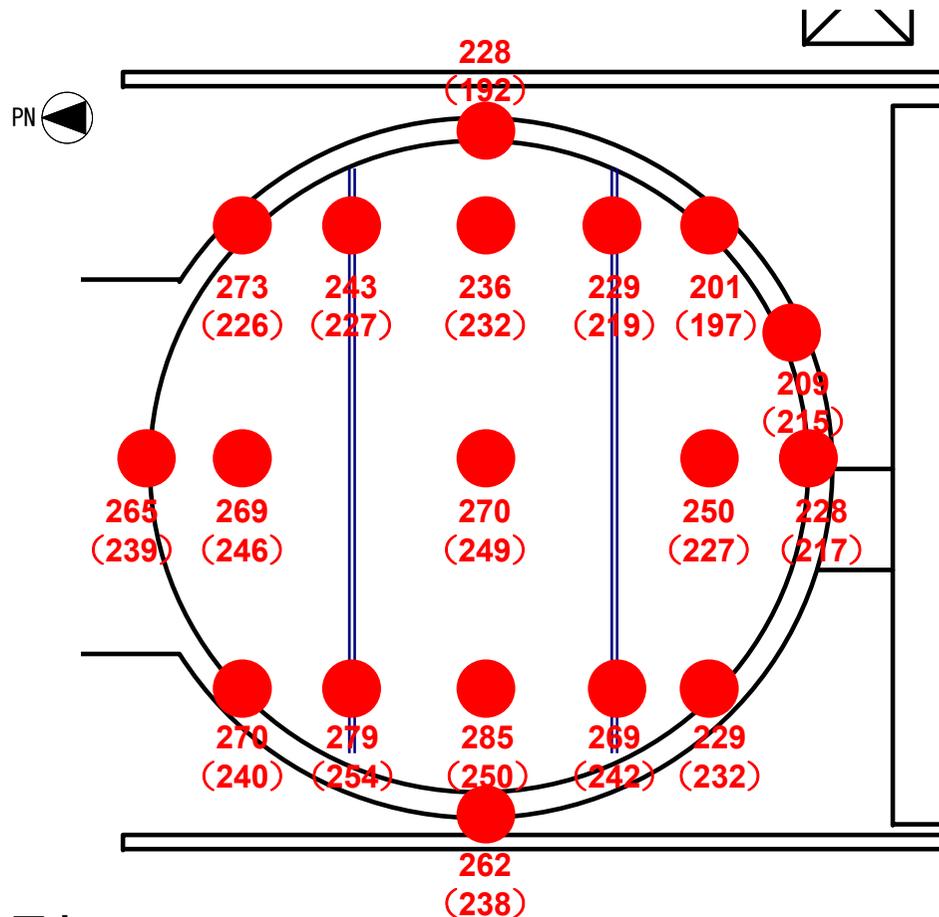
- Measurement of dose rates on the shield plug has been conducted at certain stages of the progress for checking effects of the decontamination. No significant changes have been found in the gap part that suffered deformation and its surroundings.

Figure in the upper line:
Atmosphere dose rate at 5 m (mSV/h)
measured on December 14, 2013
Figure in parenthesis in the lower line:
Atmosphere dose rate at 5 m (mSV/h)
measured on January 27, 2014

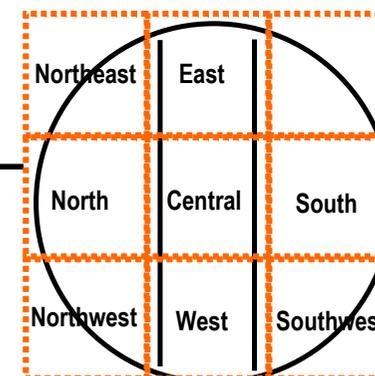
- Measurement of the concentrations in dust has been conducted using a tent-form dust sampler, which is 4 meters square, and no significant changes have been found in the gap part that suffered deformation and its surroundings.

Northeast part	Cs-134	2.2E-6	East part	Cs-134	ND(2.4E-6)			
	Cs-137	4.0E-6		Cs-137	3.3E-6			
	Total	6.2E-6		Total	< 5.7E-6			
North part	Cs-134	ND(2.4E-6)	Central part	Cs-134	5.9E-5	South part	Cs-134	9.3E-5
	Cs-137	ND(3.4E-6)		Cs-137	1.4E-4		Cs-137	2.1E-4
	Total	< 5.8E-6		Total	2.0E-4		Total	3.0E-4
Northwest part	Cs-134	3.3E-6	West part	Cs-134	7.7E-5	Southwest part	Cs-134	6.4E-4
	Cs-137	6.7E-6		Cs-137	1.7E-4		Cs-137	1.4E-3
	Total	1.0E-5		Total	2.5E-4		Total	2.0E-3
