Measures for Leakage from the Top Plate of the Upper Part of H6 Area Tank

February 28, 2014

Tokyo Electricity Power Company

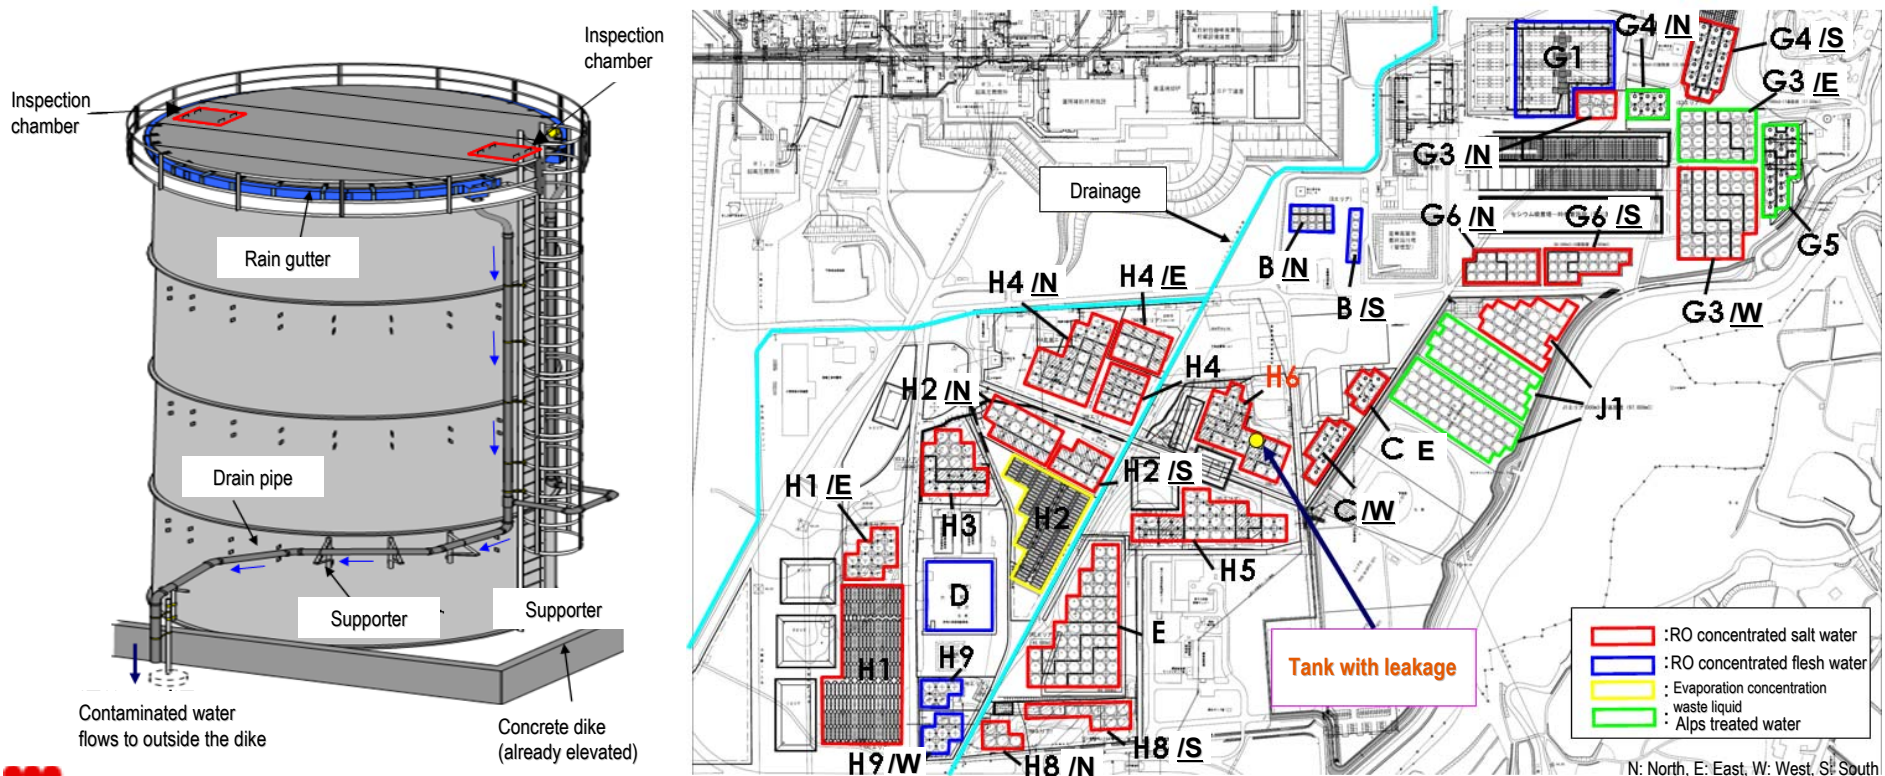
【Leakage from the top plate of the upper part of H6 area tank (leakage status)】

- ◆ On February 19, at around 23:25, a worker of TEPCO's cooperative company found the leakage on patrol around the tank area.
 - ① Leaked from the top plate of the upper part of the tank and flowed along the rain gutter to outside the dike. Estimated amount of leakage: approx. 100m³
 - ② Radioactivity density of leaked water was Gross β 2.4×10^8 Bq/L at max. (Leakage outside the dike). It is estimated that no leaked water was flowed into the ocean as there were no water discharge channels in the area and preventive measures for spreading leakage have been taken.
 - ③ The leaked water remained on the ground in the amount of 43m³ and the neighboring soil in the amount of approx. 130m³ have been collected.

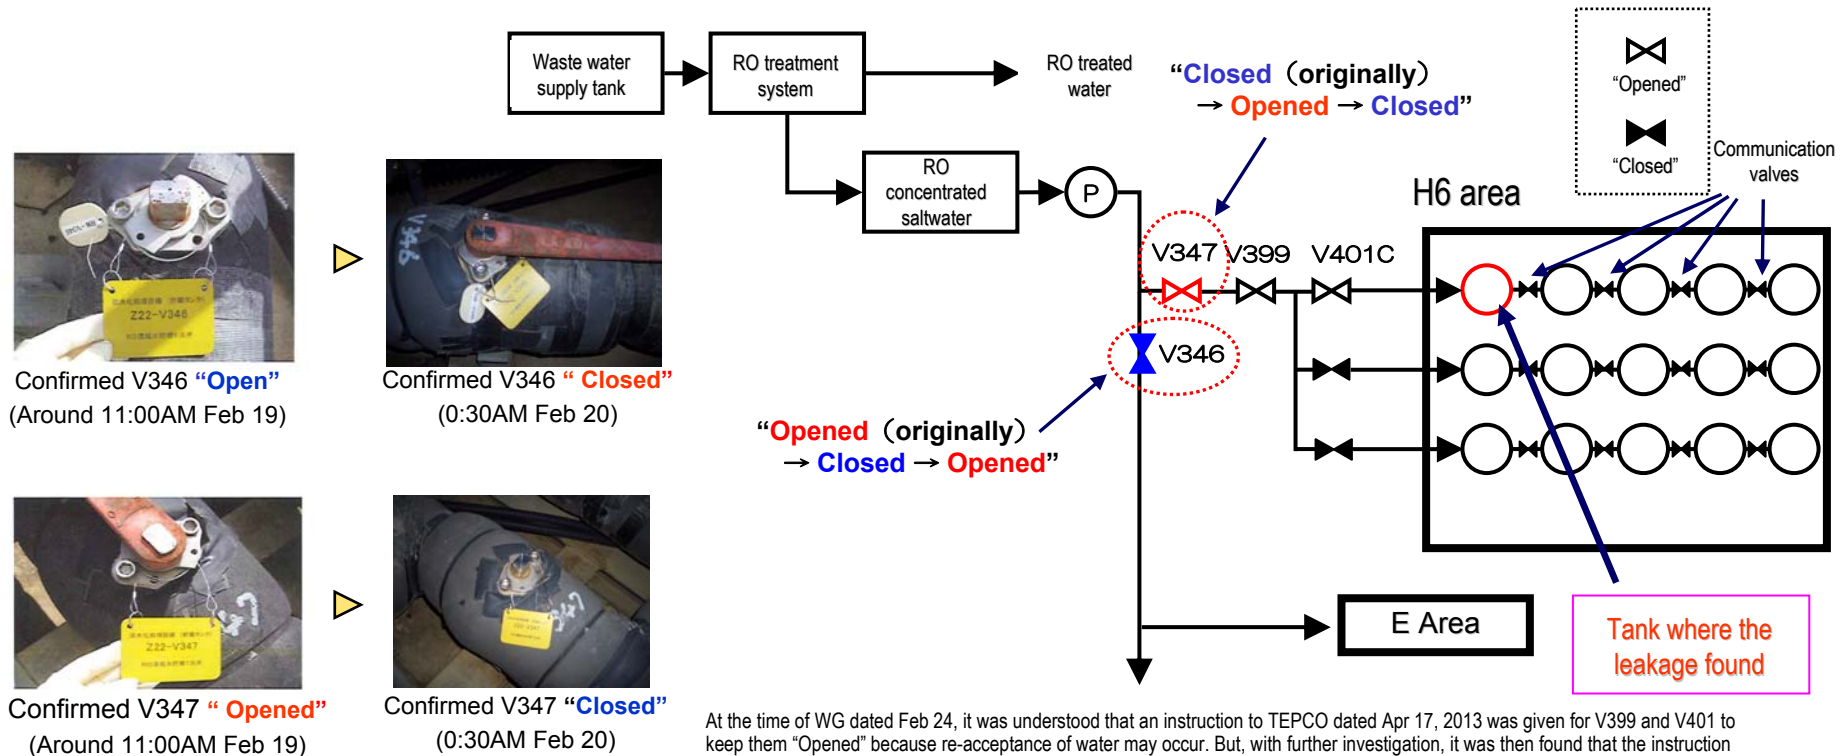
[Leakage from the top plate of the upper part of H6 area tank (Cause)]

◆ Contaminated water was originally designed to be transferred to the tank in E area. But at the time the leakage occurred, the system was switched to the design the water to be transferred to the first tank of H6 area, that is, the valve for E area (V346) was “closed” while the valves for H6 (V347) were “opened”.

To note, at the time the leakage was confirmed, the system had been back to the original the water to be transferred to E area.

At the time of WG dated Feb 24, it was understood that an instruction to TEPCO dated Apr 17, 2013 was given for V399 and V401 to keep them "Open" because re-acceptance of water may occur. But, with further investigation, it was then found that the instruction meant the communicating valves of a group of tanks. As for the opening-closing status of V399 and V401, investigation is ongoing.

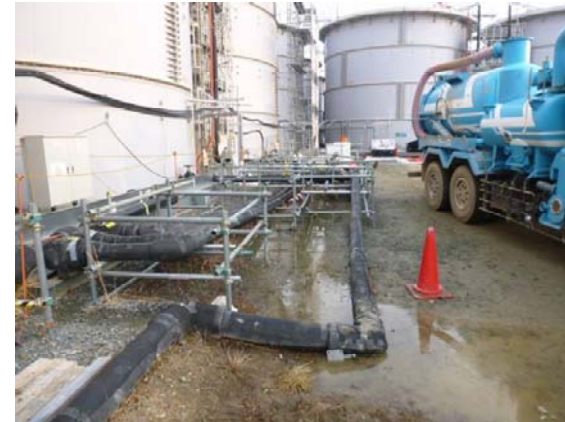
Leakage status (① area)

- Water overflowed outside the dike (Approx. 100m³)
 - ① Around the H6 tank area dike.
 - ② U-shaped gutter where electric cables are stored.
 - ③ Area where the desalination system (evaporative concentration) is installed.
 - ④ Side dike (no links to drainage)

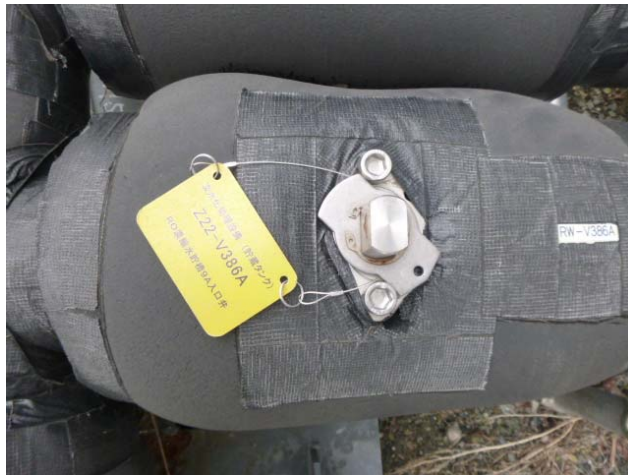
Before locking

As a background factor of having brought this accident, it can be taken up that the circumstances had allowed an easy operation of opening and closing the valves. To prevent recurrence of a similar type of the leakage in future, the following measures will be taken to stop easy access to the valves for opening and closing.

- **Implementation of locking control of the valves (planning to be implemented early in March)**
 - ◆ Lock the valves not to be able to be opened easily.
 - ◆ Handling of the corresponding key is limited to the person in charge of the operation.
