Survey on torus room wall in Unit 1 of Fukushima Daiichi Nuclear Power Station

June 13, 2014

Tokyo Electric Power Company

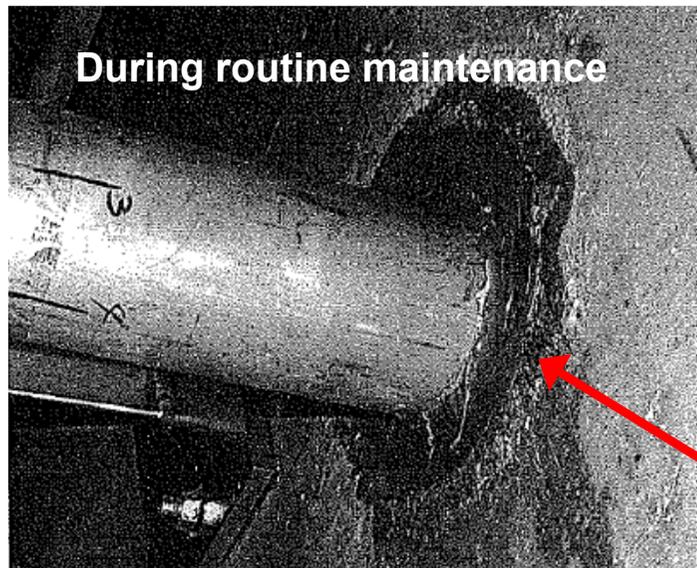
Typical image of penetrated parts

(penetrated part (1) photo: October 2000)

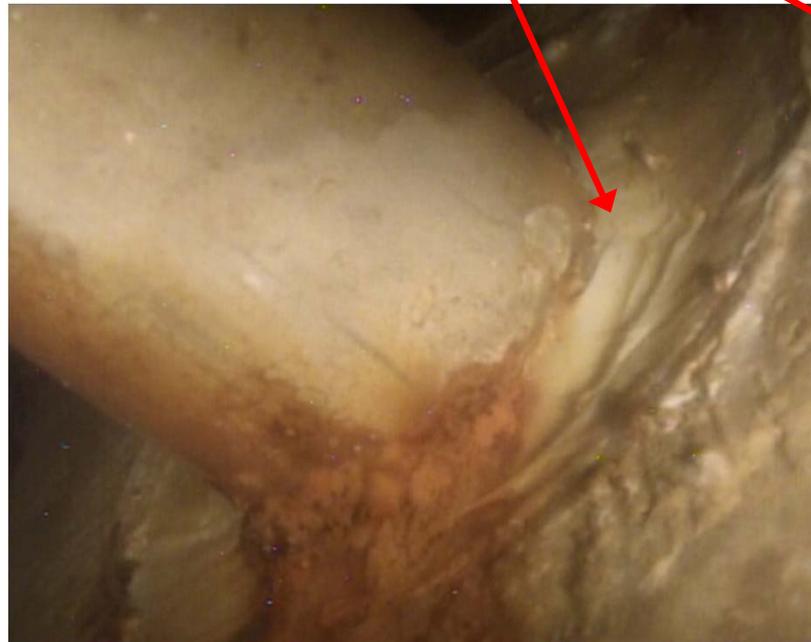
- Surface of penetrated parts target: penetrated part (1) and (2)
 - On underwater imaging, serious damages on seal material of penetrated parts were not found.
 - For penetrated part (3) to (5), obstacle blocks underwater view.

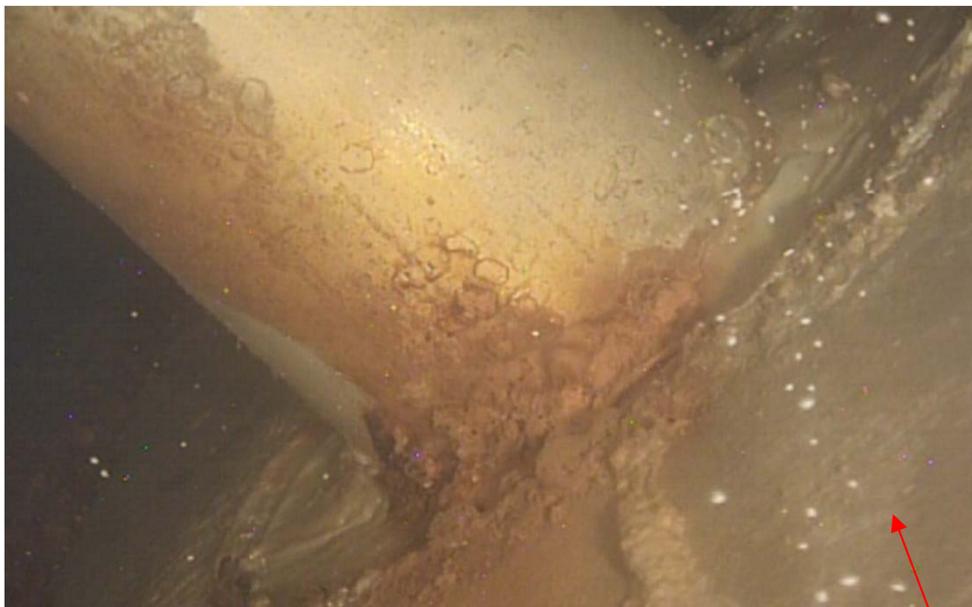
penetrated part(1)

- dispersing tracer* and tracked it, leak point around penetrated part **was not found.**
(*tracer: clay particles)

tracer

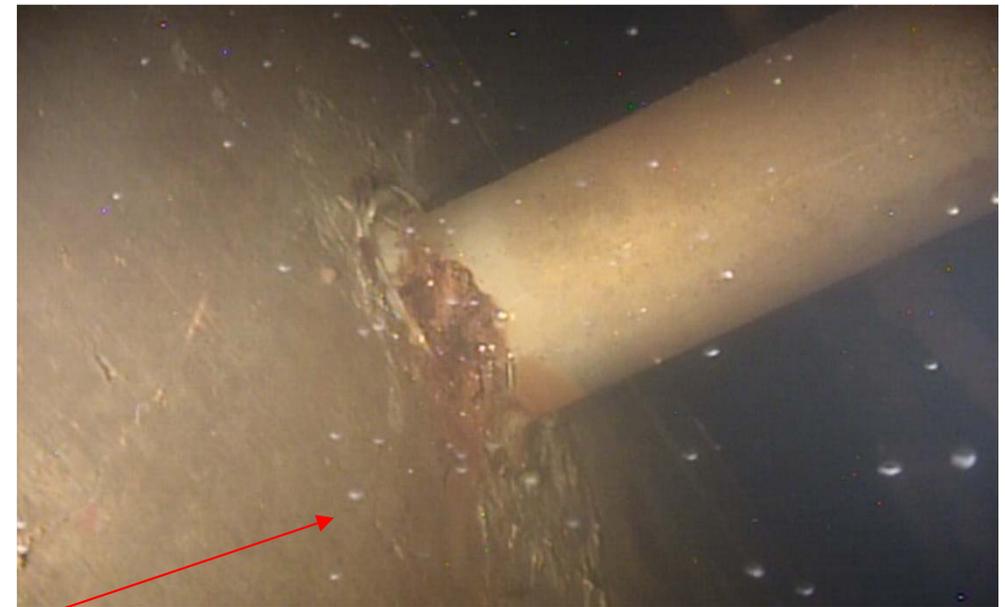
penetrated part (2)

tracer dispersed around penetrated part

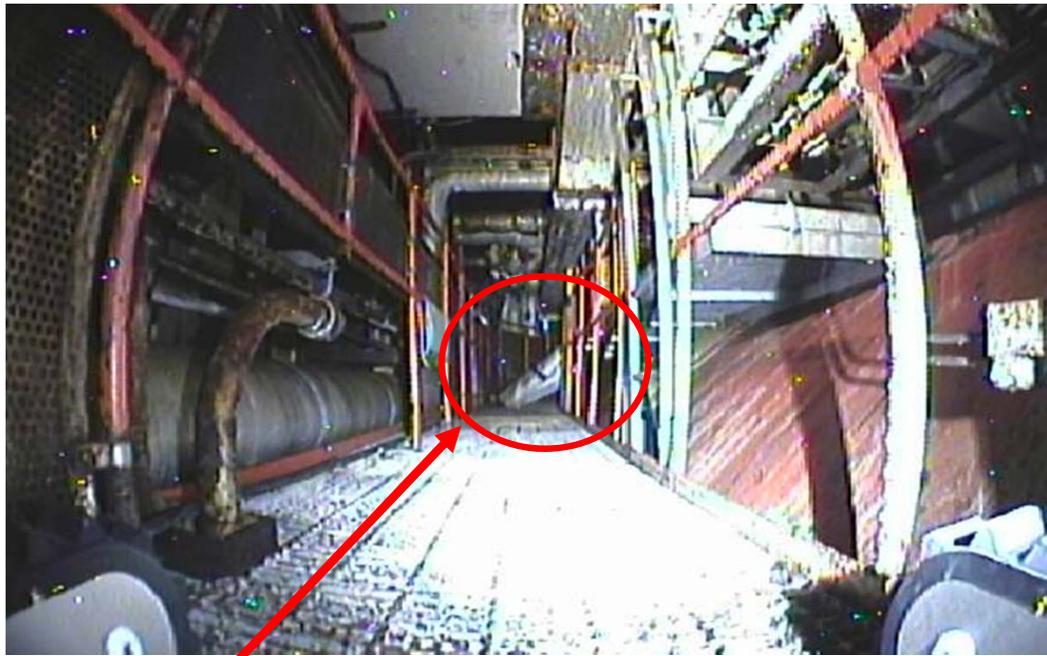
- On upper part of S/CS/C, no leakages.
- Major dropping on catwalk is a thermal plate.

thermal plate (dropped) Typical image

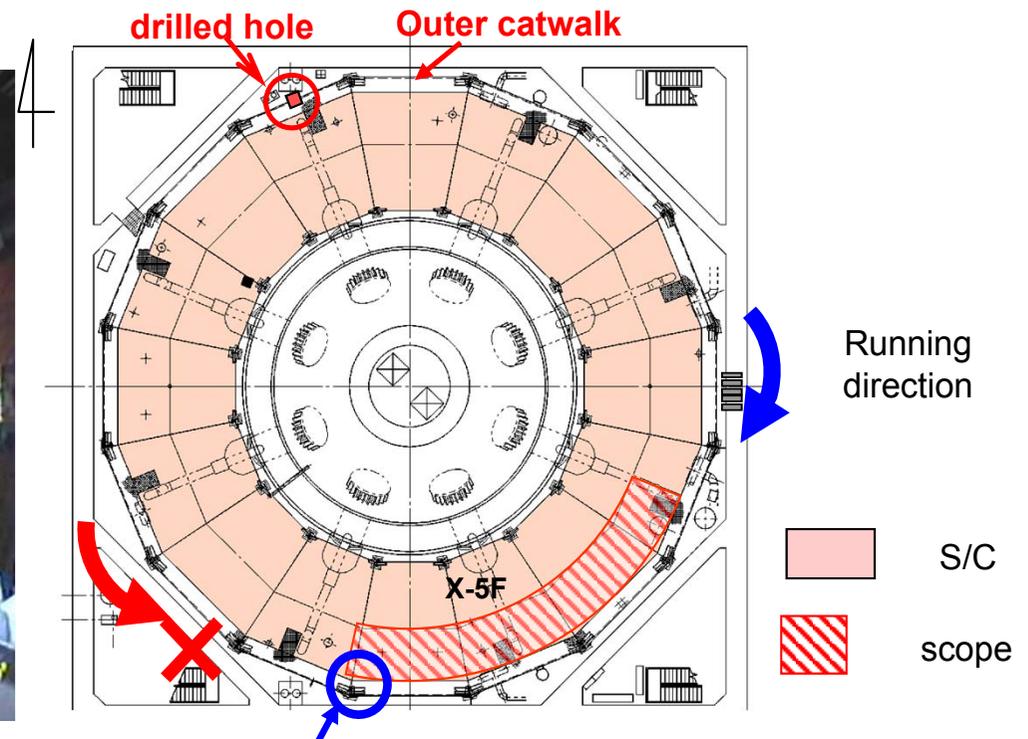
thermal plate (dropped)
