**Survey of wall of torus room
in Unit 2 in Fukushima Daiichi NPS
(Report for demonstration survey
in R & D project)**

July 28, 2014

Tokyo Electric Power Company

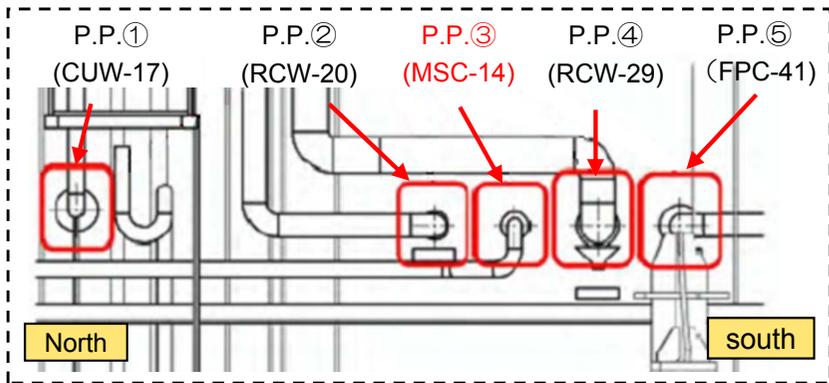
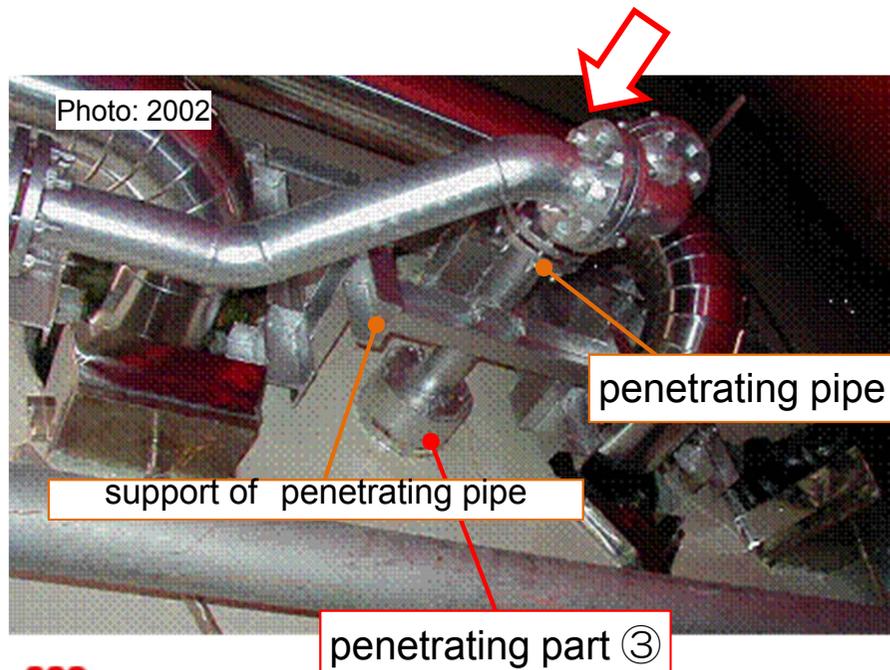
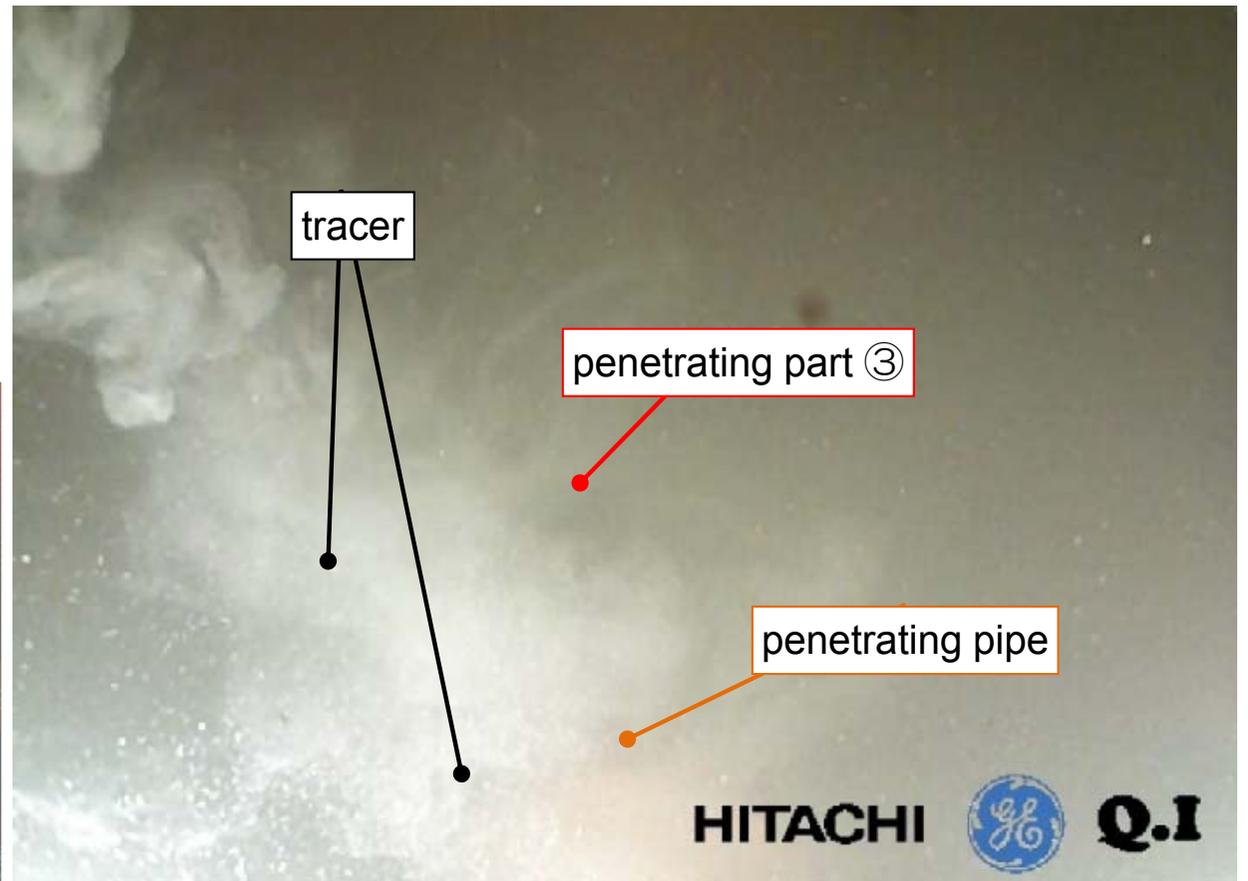
Results of survey using camera on swimming robot

- no remarkable damage has been found around penetrating part ① to ⑤
- no flow has been found around penetrating part ① to ⑤ in sonar survey

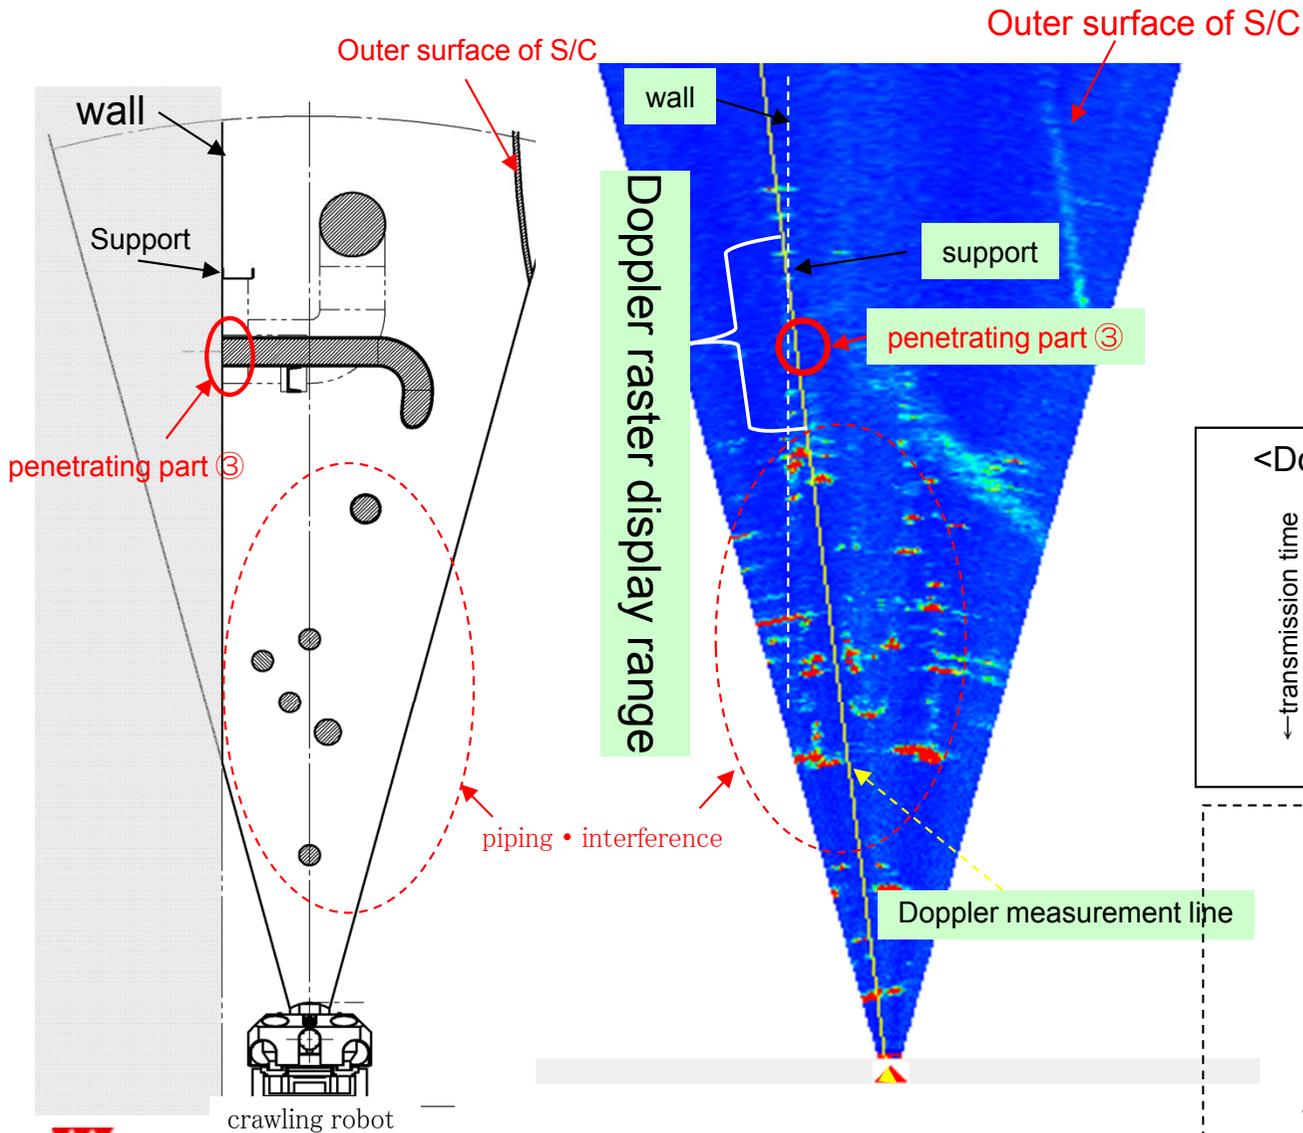
After throwing tracer

■ For penetrating part ③, inflow of tracer has not been found in Doppler measurement using sonar
