Results of Research Concerning Exterior Section under S/C (Suppression Chamber) at Unit 2

(Report on Verification Test Regarding a Device for Surveying Exteriors under S/C (Pressure Suppression Chamber) as a Part of “Developing Technologies for Surveying and Maintenance Involved in the Filling of the Primary Containment Vessel (Water Cutoff)”)

September 4, 2014

Tokyo Electric Power Company

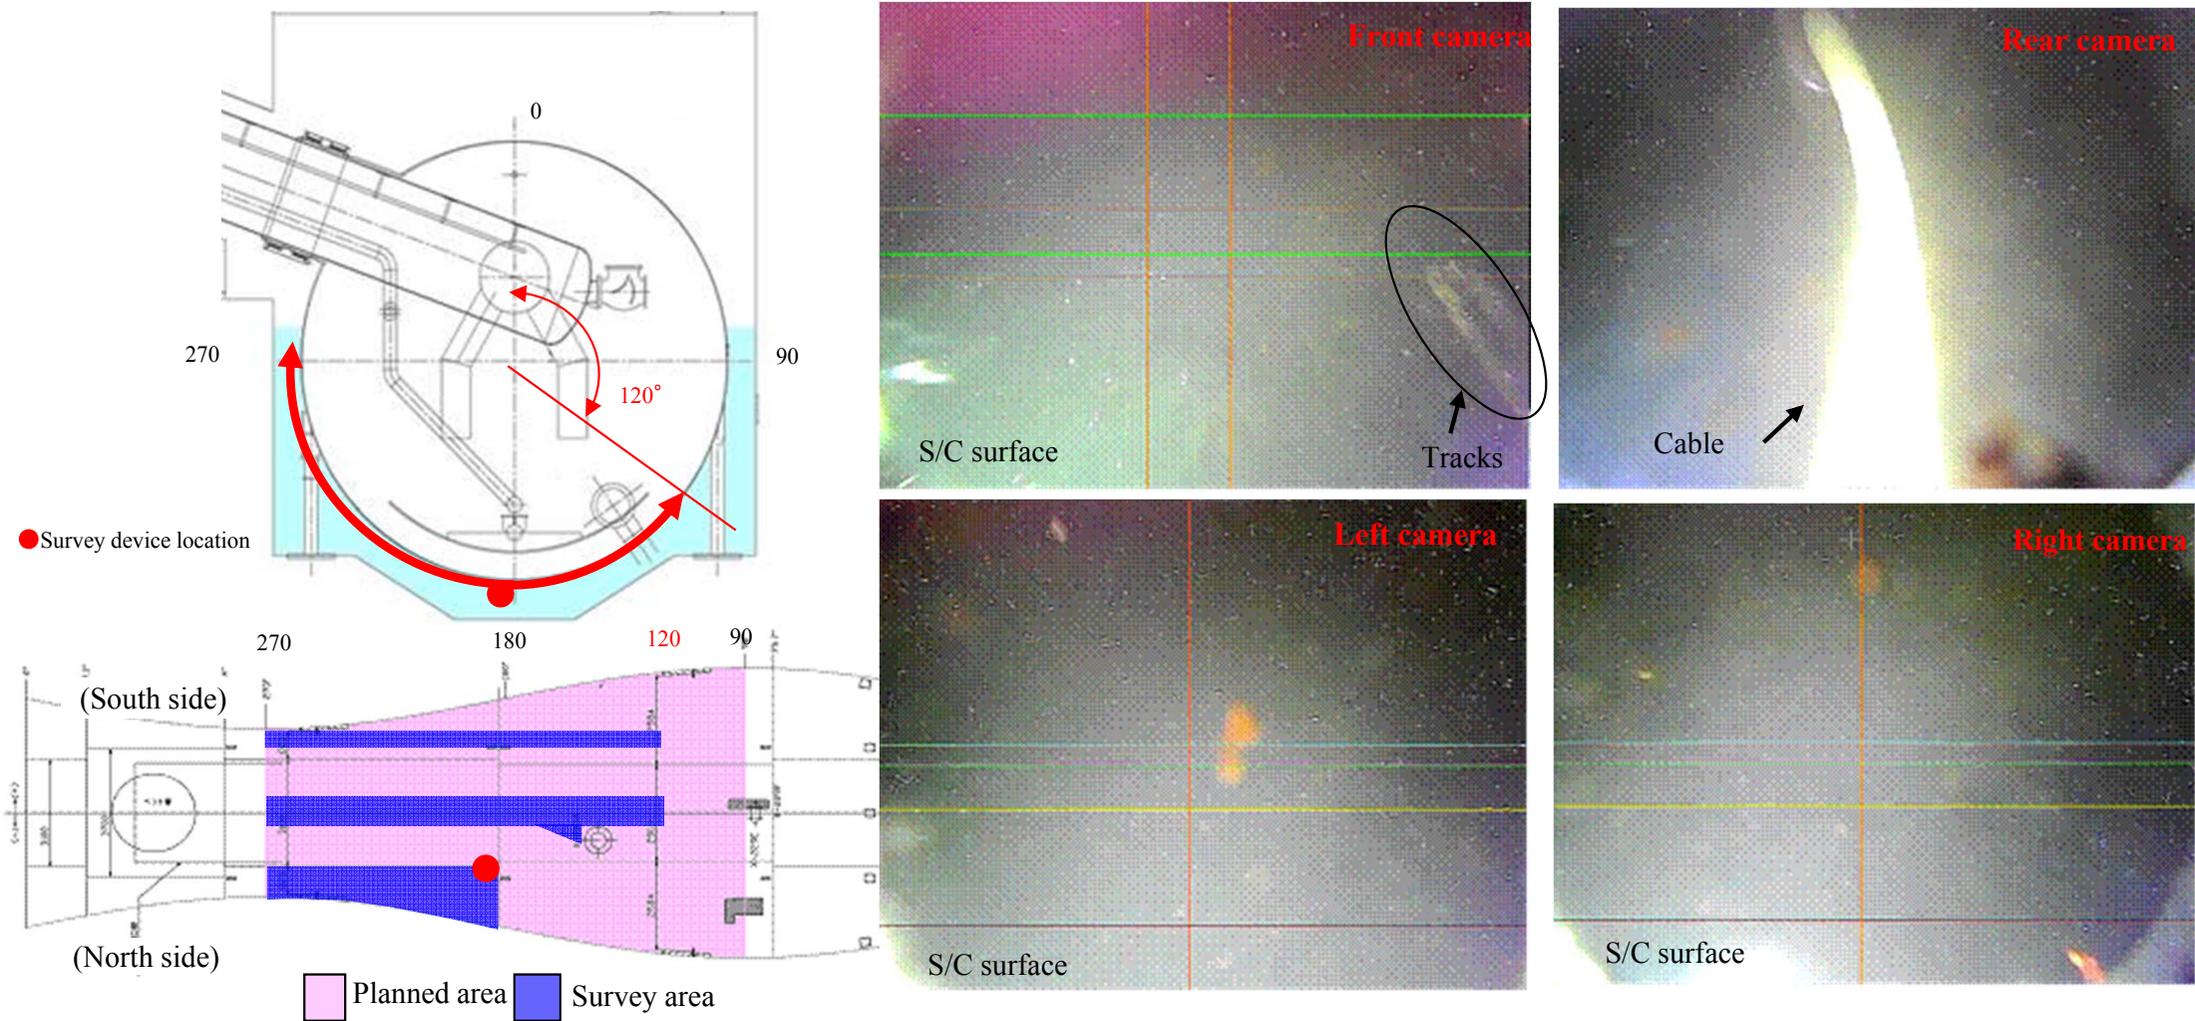
Outer surface of S/C bottom (near 180°)

- It was confirmed possible to use the support device to attach or remove the survey device from the outer surface of the S/C.
- No openings were found within the survey area.

[Supplementary] Underwater field of view (front camera) is 100~200 mm (initial plan was roughly 350 mm)

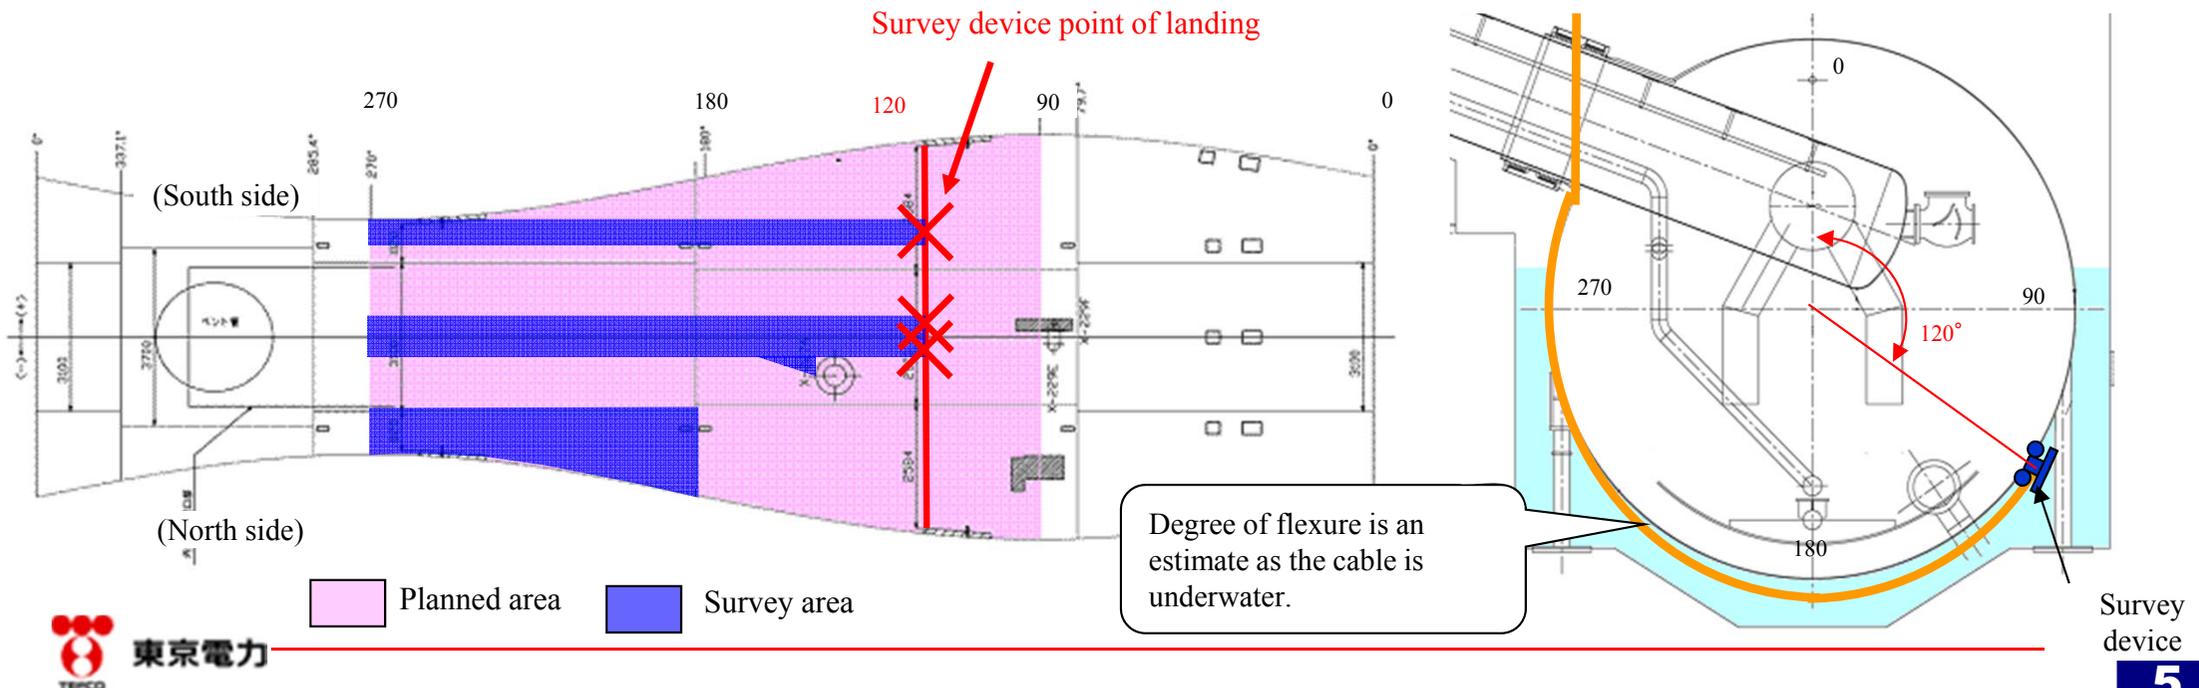
- As the survey device fell down repeatedly (3 times) near “approx. 120° ” on the S/C, the range of approx. 90~120° on the outside wall of the S/C could not be surveyed. (The cause is currently being investigated)
- As suspended matter made the field of view underwater worse than expected, the survey required more time for completion.

Pause the survey, consider countermeasures, and decide whether to survey unsurveyed areas.

- The **causes of the survey device falling** from a location near approx. 120° on the outer surface of the S/C **needs to be investigated and an improved survey device created.** (Preparations are currently underway to investigate causes in the field)
- As it is possible that the radiation dose level that the S/C bottom is high, **a measure to reduce survey device dose level is needed.**
- **Due to poor field of view underwater and subsequent lengthened survey times, a substitute method must be examined.**
 - Projected survey period (shortest): 8 days (1 bay) → Projected survey period based on verification test results (shortest): 16 days (1 bay)
 - Planning assumes underwater field of view of roughly 350 mm. About 100~200mm for verification tests.

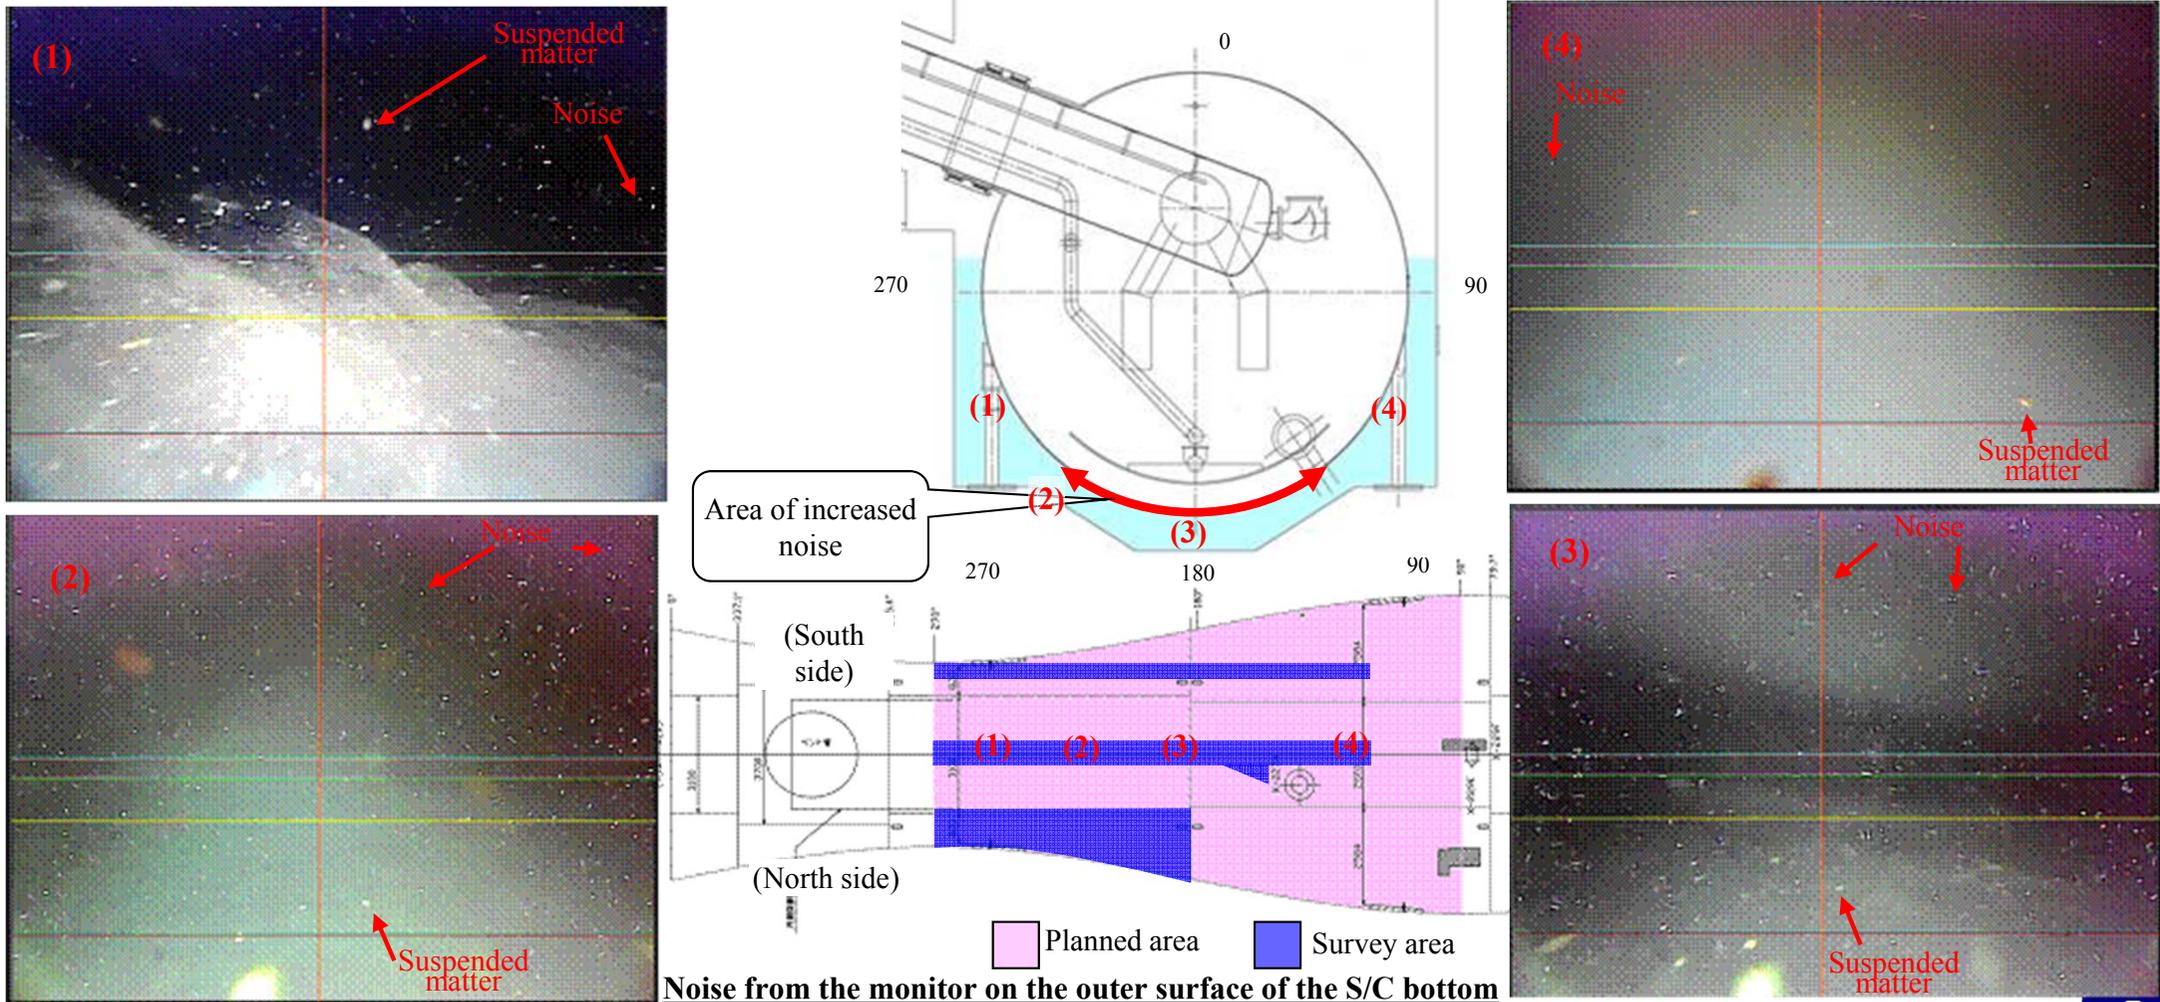
- It was discovered that **noise thought to be caused by the dose level shown on the monitor screen increased** as the survey device moved towards the S/C bottom.

[Increased noise in the area of the S/C bottom could mean the dose level is high]

- Noise in the monitor image will be checked and radiation dose level at the S/C bottom will be assessed.
