Reference
January 19, 2015
Tokyo Electric Power Company

**Regarding the fatal accident at Fukushima
Daiichi NPS involving a cooperative company
employee working on a rainwater receptacle
tank**

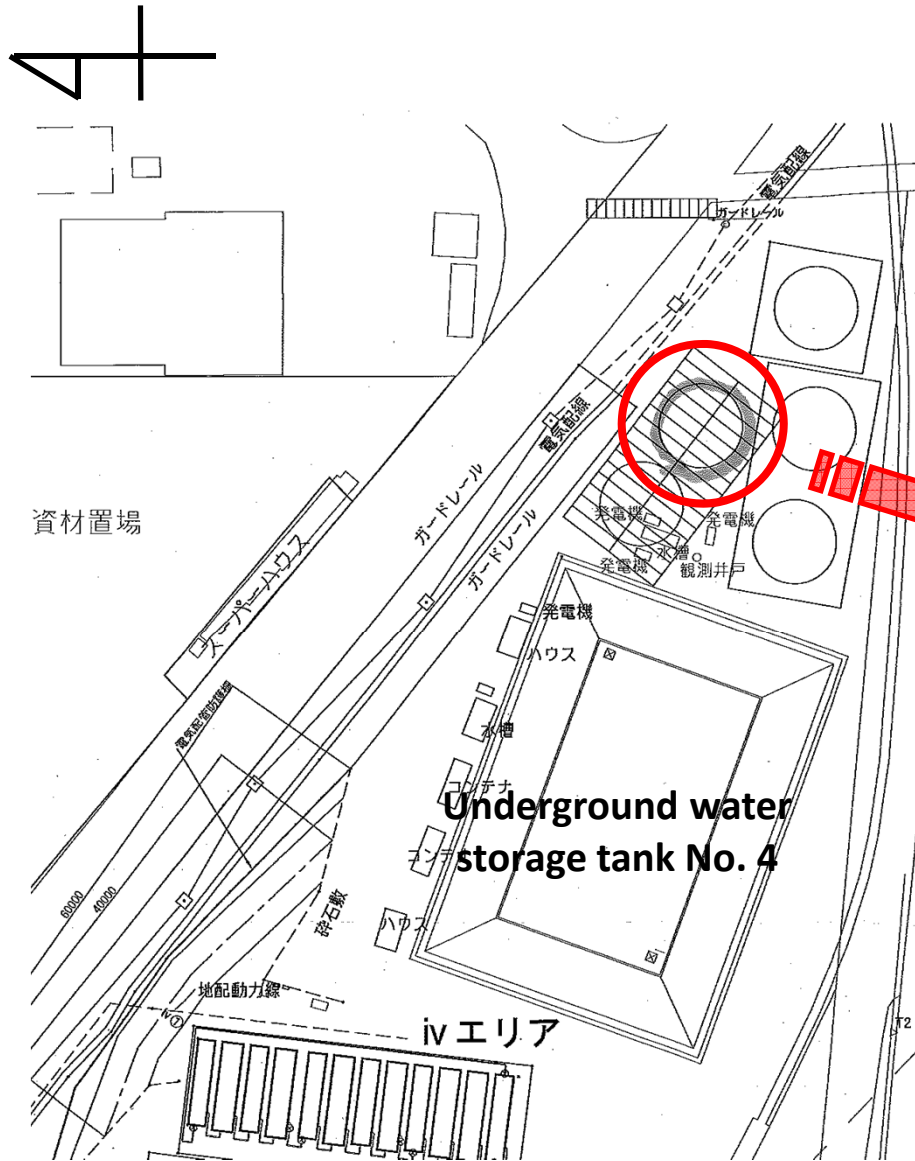
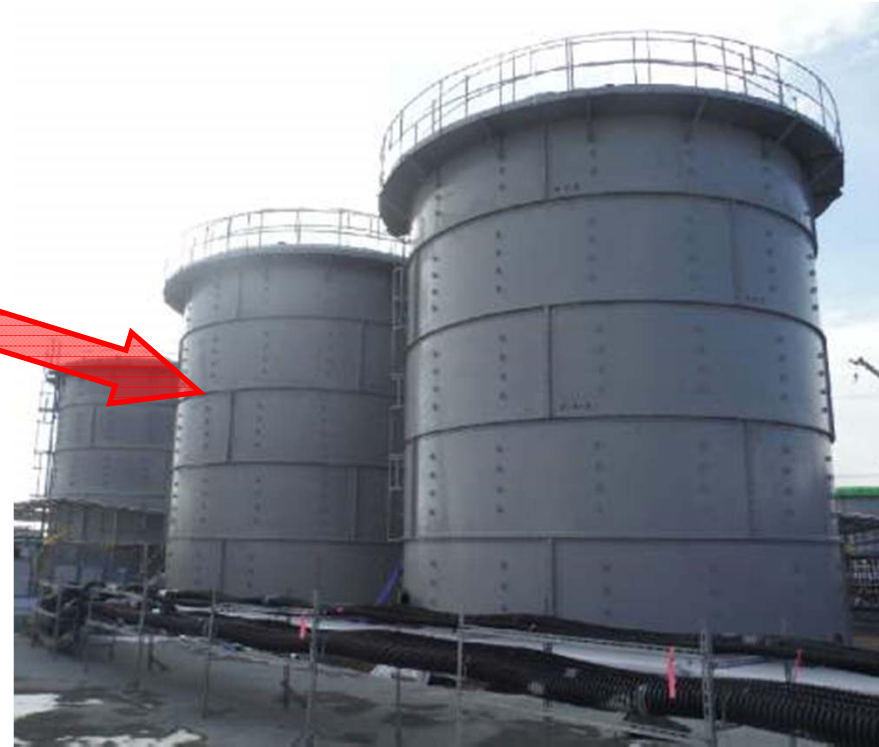
Rainwater receptacle tank No.2

Site: Rainwater receiving tank No. 2 (on the east side of No. 4 underground storage tank area.)

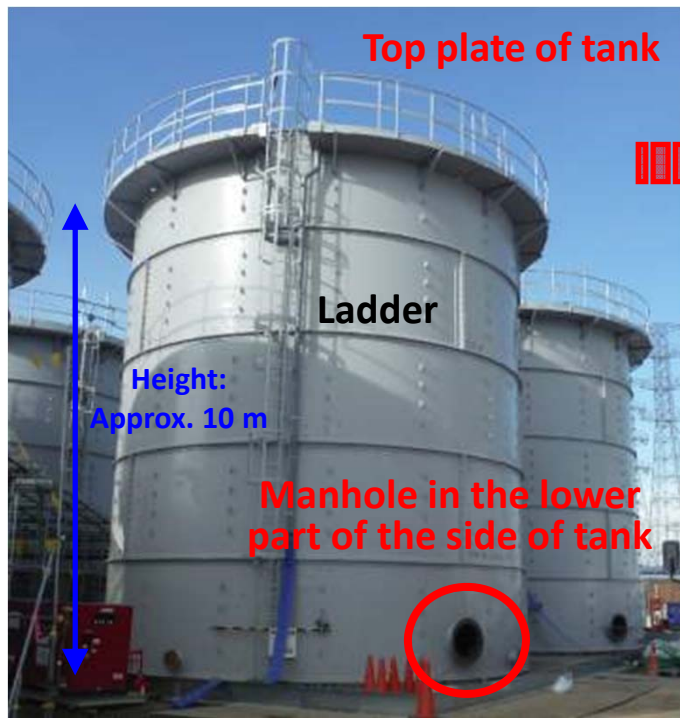
Rainwater receptacle tank No. 2

Accident occurrence: To conduct a water leakage check inside the rainwater receptacle tank No. 2 currently under construction in the J tank area, one Tepco employee and two workers from a cooperative company subcontracted by one of the construction partners entered the tank from a manhole located at the lower part on the side of the tank. The interior was too dark for the inspection, so one of the two workers climbed up to the top of the tank to let sunlight into the tank by moving the cover on the top plate. During this process, he fell with cover (weight approx. 51 kg) from the plate to the bottom of the tank (height: approx. 10 m)
