1. Progress of Unit 1 PCV internal investigation

(Preliminary report of March 18 investigation) 1/2

Tokyo Electric Power Company Holdings, Inc.

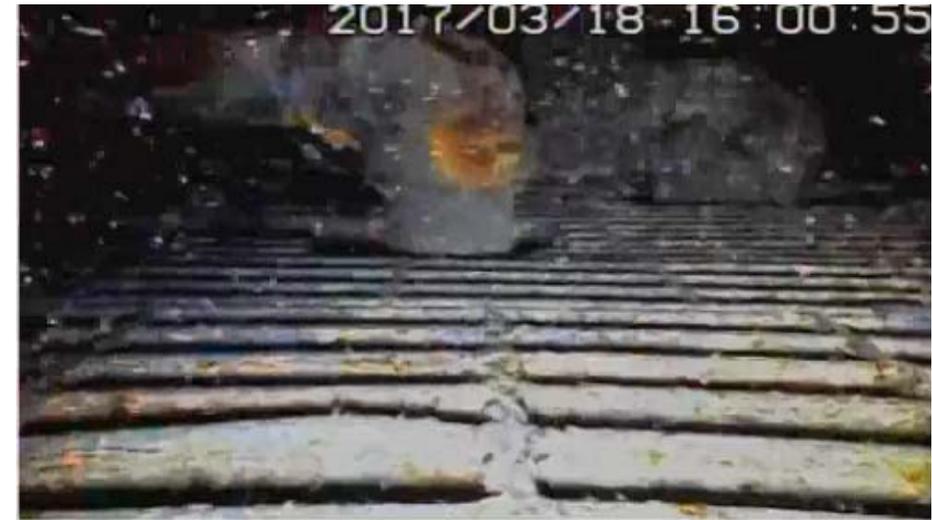
On the metal grating
(Front left-side camera of the investigation device)

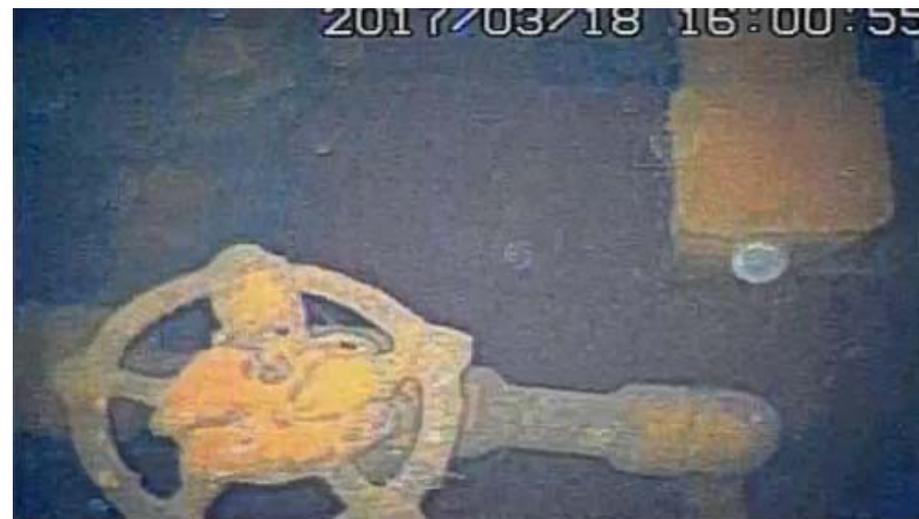
Underwater image at measuring point D0

- (Provisional values)
- On metal gating: 7.8 Sv/h
 - The lowest point: 1.5 Sv/h (About 1m above the PCV basement floor*)

The conditions of PCV basement will be evaluated after organizing digital images and radiation data.
