Partial damage to temperature gauge cables for the
Reactor Pressure Vessel (RPV) found during the
Fukushima Daiichi NPS Unit 3 Primary Containment Vessel
(PCV) internal investigation

November 30, 2017

Tokyo Electric Power Company Holdings, Inc.

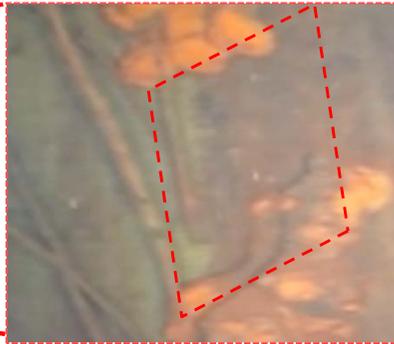
Damage was found along the route inside the pedestal

- temperature gauge cables found damaged are made of a metallic sheath and wires that have a melting point of more than 1,000°C.
- It is assumed that the cables experienced thermal cutting by **high-temperature molten objects** that fell onto the cables from the RPV bottom.
- **The 12 temperature gauges along the route leading inside the pedestal are considered to be “broken”** because thermal cutting of the cables has rendered them unable to measure the temperatures at the bottom of the RPV.

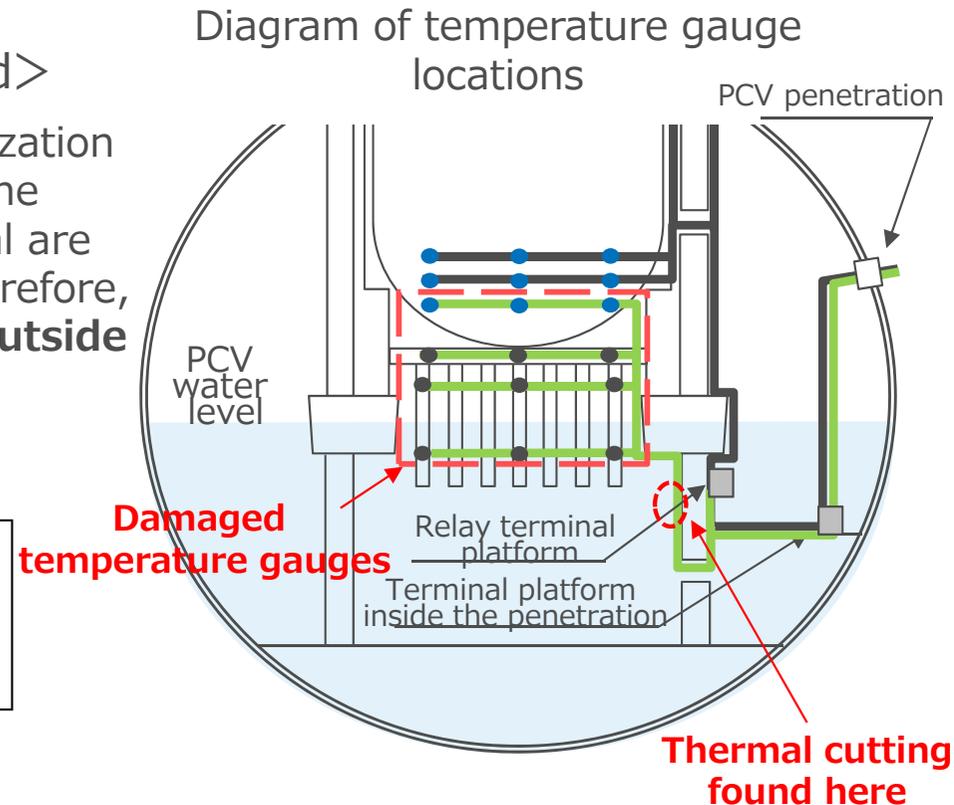
- It is assumed that the RPV was damaged after the depressurization of Unit 3, and thought unlikely that melted fuel spattered to the height that the temperature gauge cables outside the pedestal are located and reached temperatures of more than 1,000°C. Therefore, **it is assumed that temperature gauges along the route outside the pedestal were not damaged by thermal cutting.**

Due to the location of installation it is thought that the state of cooling is confirmed, but a further investigation will be performed.

- We will further confirm the state of cooling by measuring the resistance of temperature gauge circuits and looking at past temperature data for RPV and PCV temperature gauges.
- We will also deliberate how to check the state of cooling going forward based on the results of the PCV internal investigation etc.

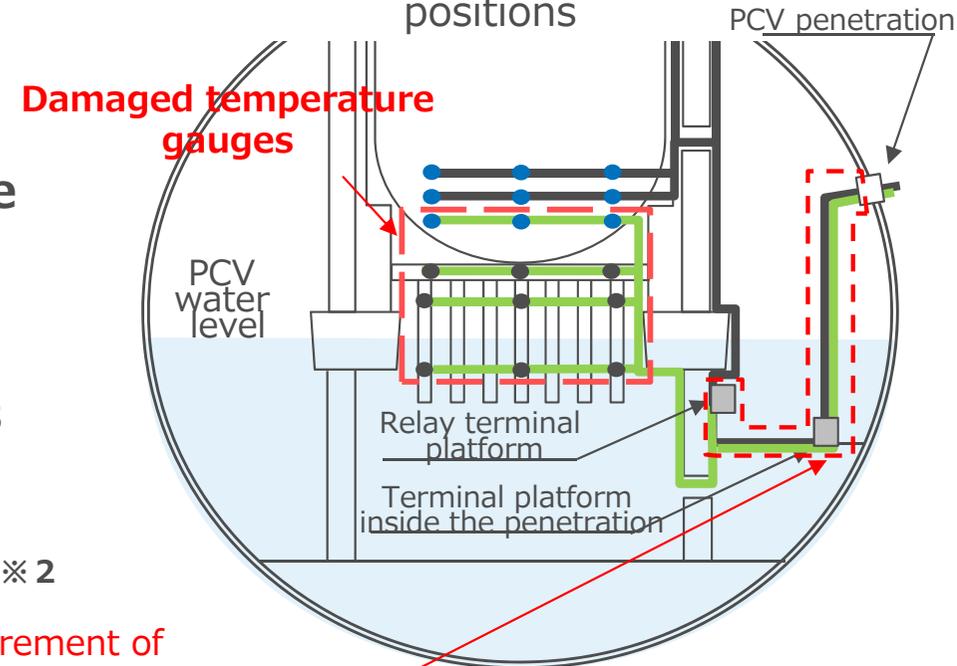
Outline of temperature gauge positions

- Thermocouple temperature gauges can measure temperatures only when the copper and constantan wires form a closed circuit. **The temperatures in the RPV (measuring points) cannot be measured** because the cables were severed by thermal cutting.
- Insulation reductions inside the PCV caused by the accident have been confirmed. Temperature readings can be taken at locations of insulation reductions because the insulation reductions form thermocouple circuits. **This means that temperatures in the PCV^{※2} are being measured.**

※2 Scope of measurement of temperature gauges with cables severed by thermal cutting
