Fukushima Daiichi Nuclear Power Station Unit 2 Primary Containment Vessel Internal Investigation Results

February 1, 2018

Tokyo Electric Power Company Holdings, Inc.

1. Primary Containment Vessel Internal Investigation Overview

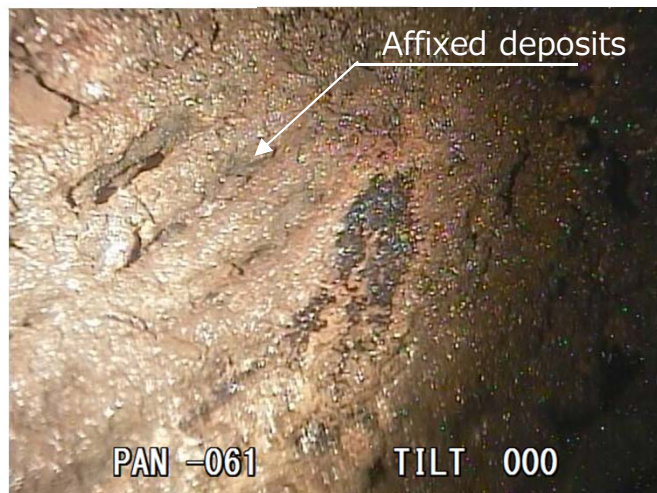
Photo location A Fallen grating ②

- The entire bottom of the pedestal was found to be covered with sandy and clay-like deposits.
- Some fuel assembly components (top tie-plate) have fallen to the bottom of the pedestal and deposits thought to be fuel debris were found in the vicinity of these fallen components.

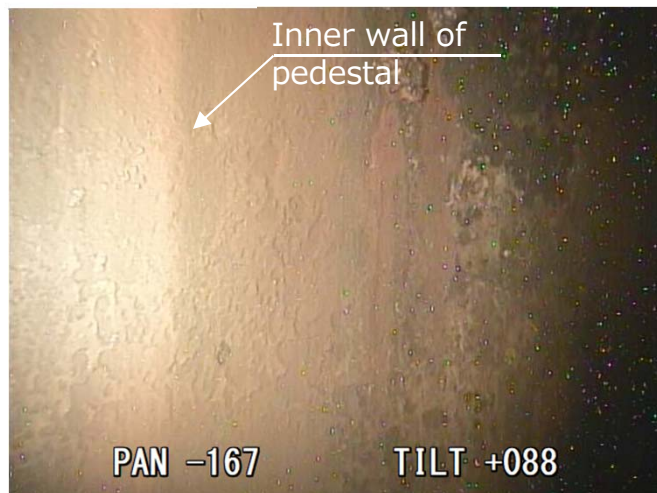
Photo location D Surface of inner wall of pedestal

No significant damage was seen on the inner wall of pedestal

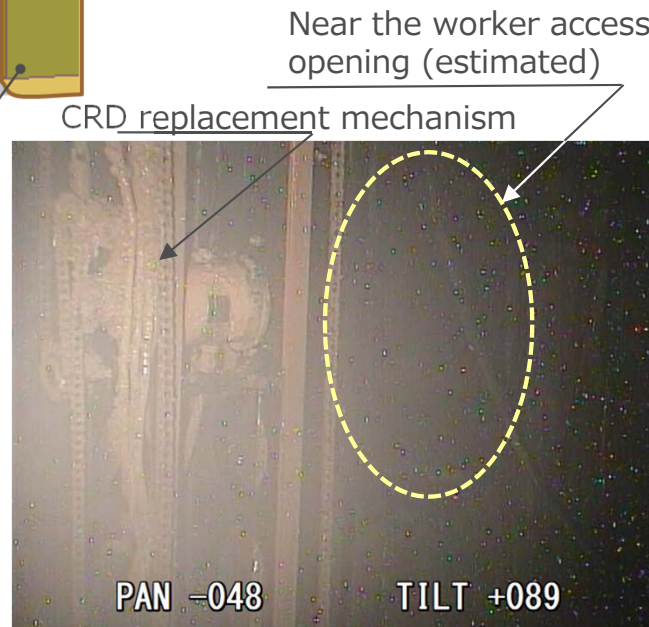
Photo location E CRD replacement mechanism

- No significant damage was seen to existing structures inside the pedestal (CRD replacement mechanism)
- The CRD housing supports were found to be in the same condition as was seen during the January~February 2017 investigations.

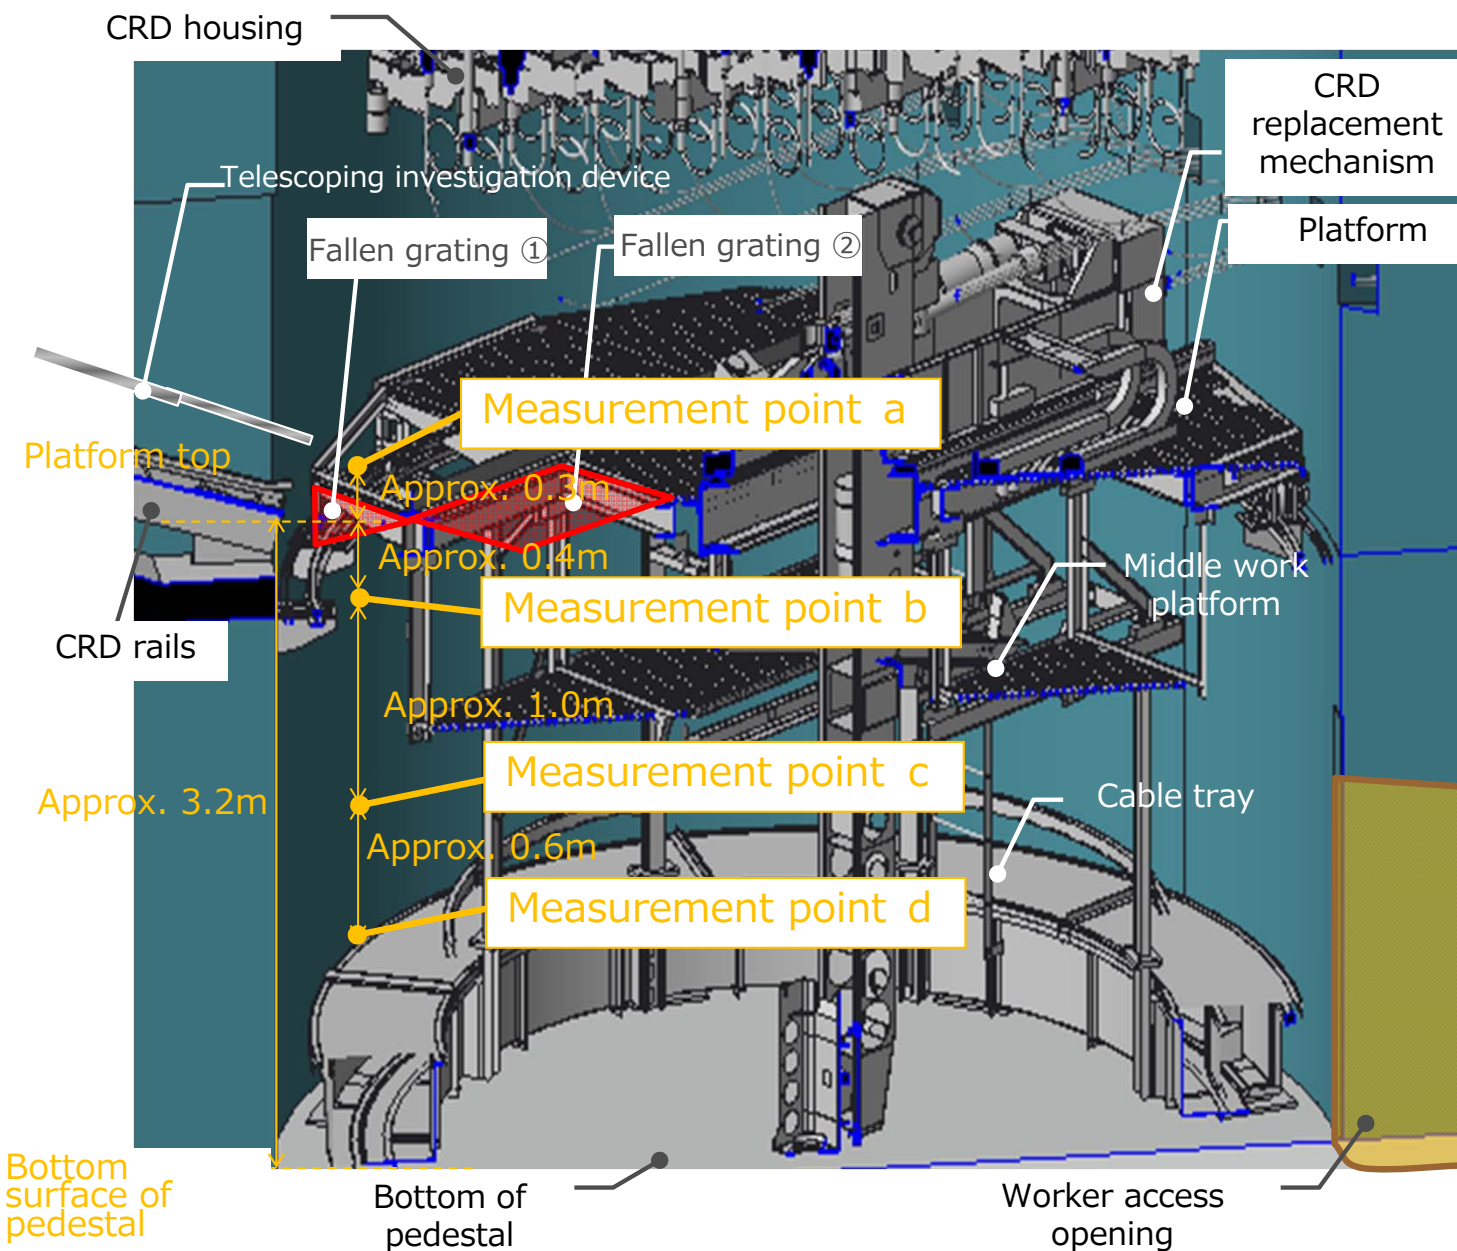
Measurement point	Dose rate ^{※1,2} [Gy/h]	Temp. ^{※2} [°C]
a	7	21.0
b	8	21.0
c	8	21.0
d	8	21.0

【Reference: Outside the pedestal^{※3}】
Dose rate: Max. 42[Gy/h]
Temp.: Max. 21.1[°C]
