3-D Rendering of Images obtained during the Fukushima Daiichi Nuclear Power Station Unit 3 Primary Containment Vessel (PCV) Internal Investigation

April 26, 2018

Tokyo Electric Power Company Holdings, Inc.

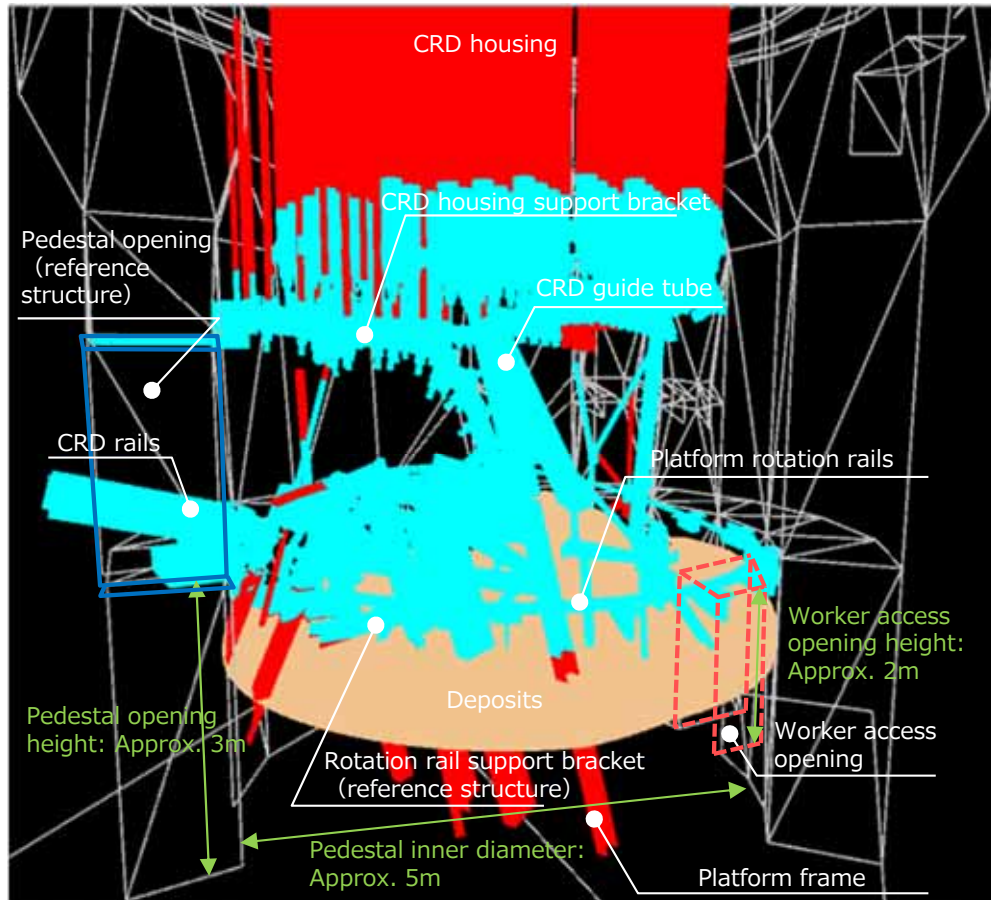
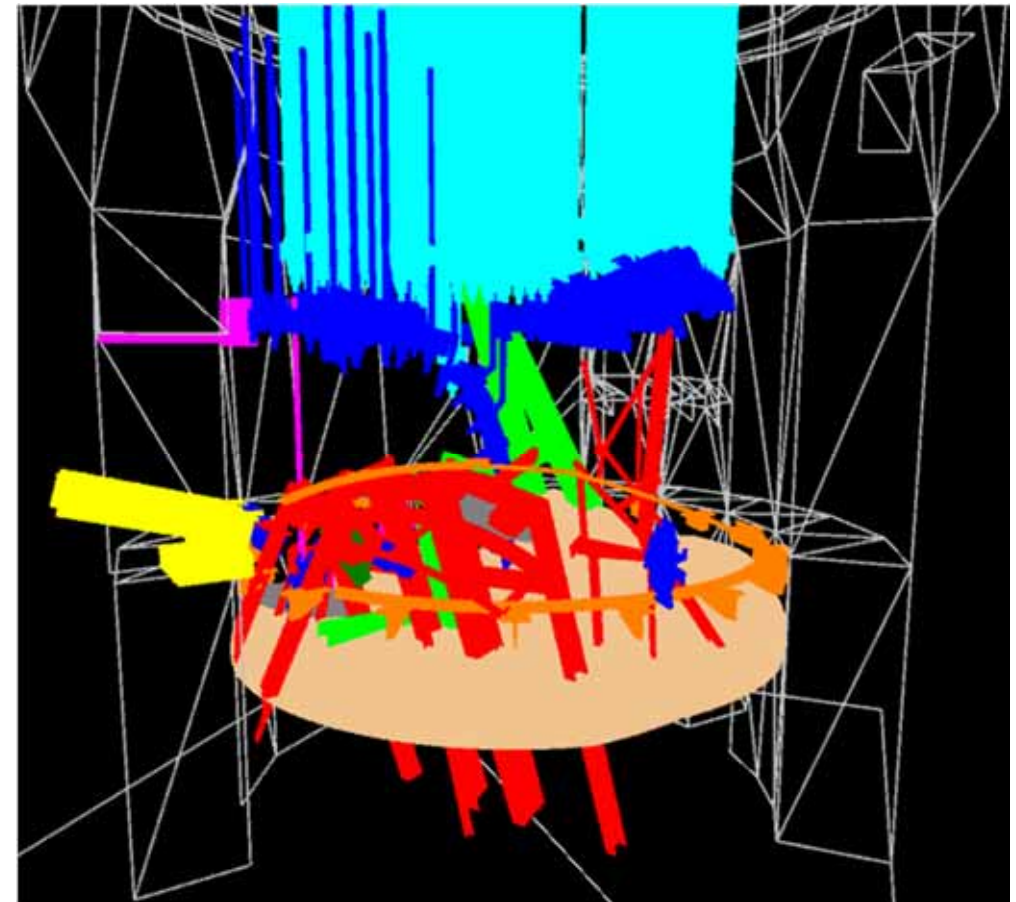
2. Scope of structures identified in the videos

- The rendering contains structures that were identified in the videos as well as structures that were rendered based upon estimates made using design information because they could not be identified in the videos.
- Since no significant damage could be seen to the pedestal opening or a portion of the rotation rail support brackets, these structures were used as reference points for the 3-D rendering based upon the assumption that they are in the same position as they were prior to the accident.
- The rendering was created in order to get an overall feel for conditions inside the pedestal and therefore the positions of structures are only approximations.

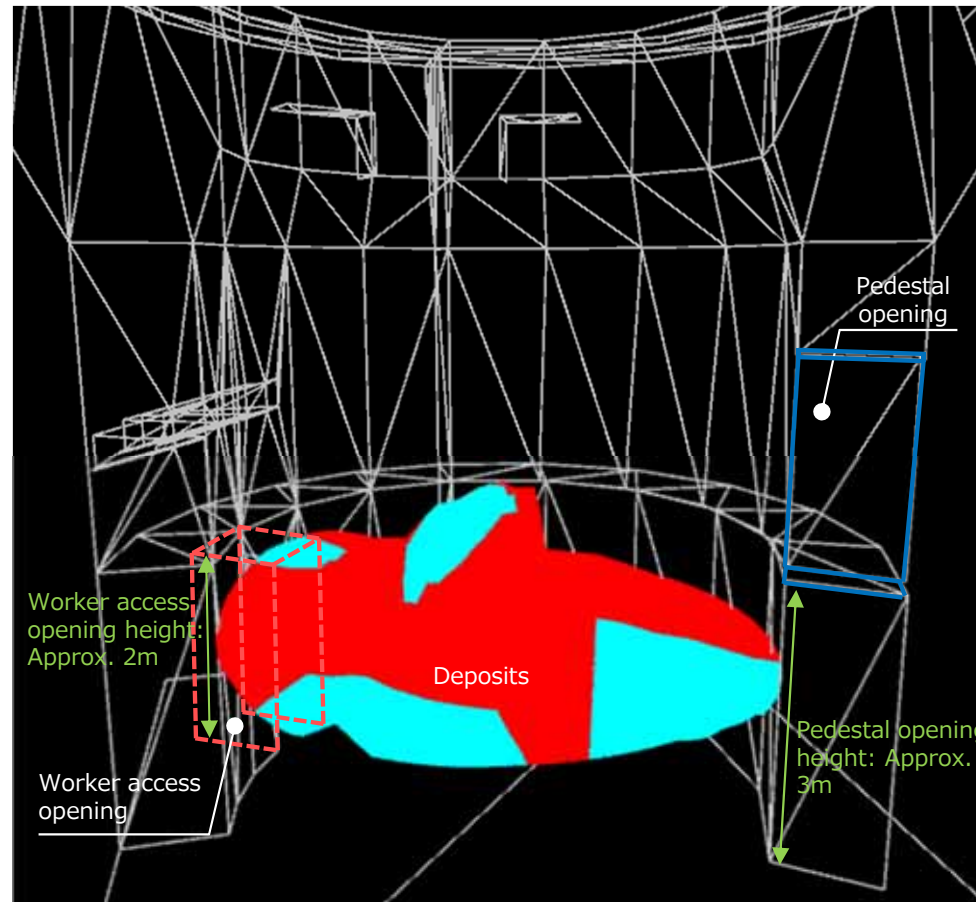
3. Scope of deposits identified in the videos

- The height of deposits identified in the videos was estimated based upon the location of structures in the vicinity (pedestal opening and a portion of the rotation rail support brackets) to recreate the approximate height of the deposits.
- Since a large portion of the deposits could not be seen on the video they were re-created based upon the estimated height of deposits that could be seen in the video.
- Structures are not shown in the diagram on this page to make it easier to see the deposits

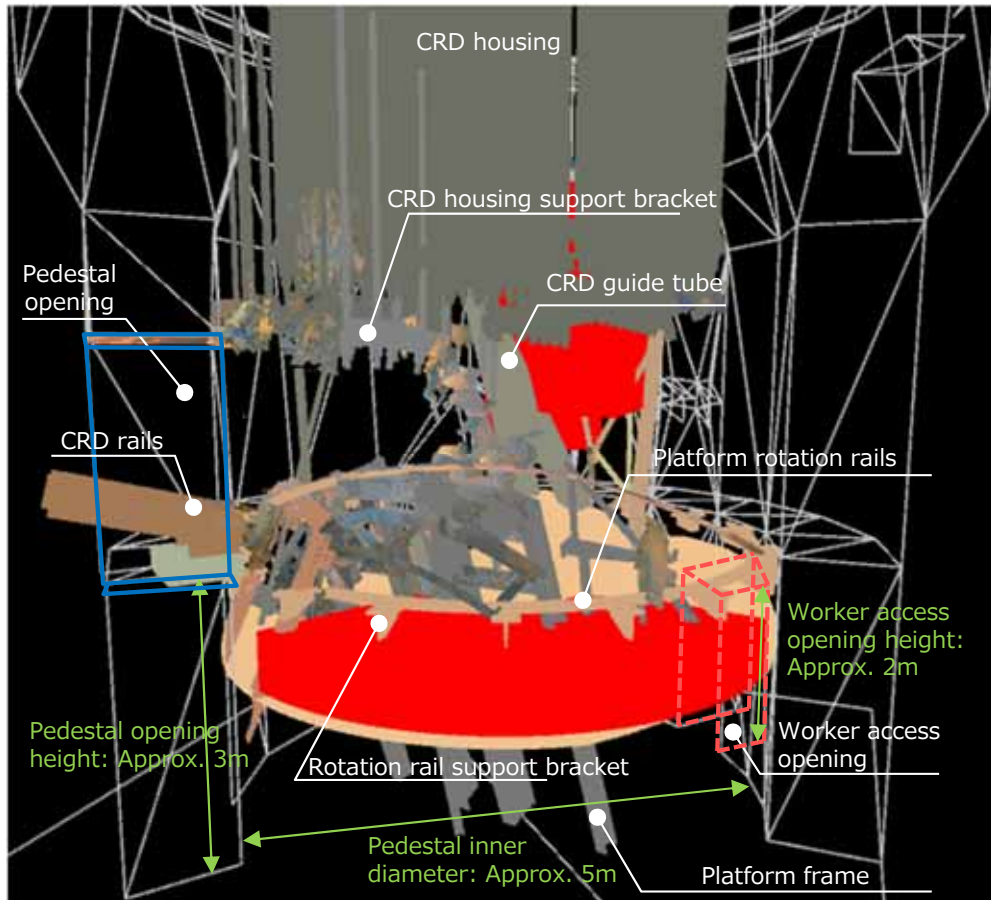
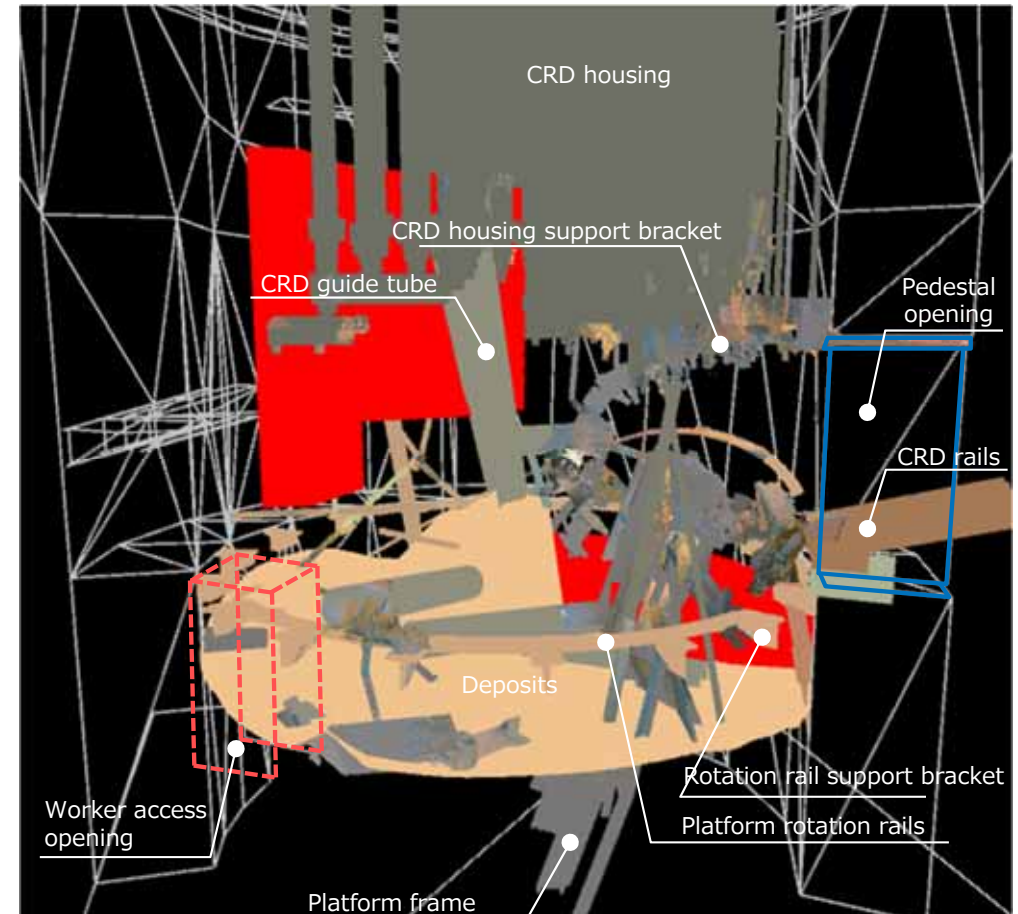
4. Estimating spaces not visible on the videos

- Spaces that could not be captured on video due to the churning up of deposits during the July 2017 investigation were estimated.
- Structures may exist in the spaces that could not be captured on video

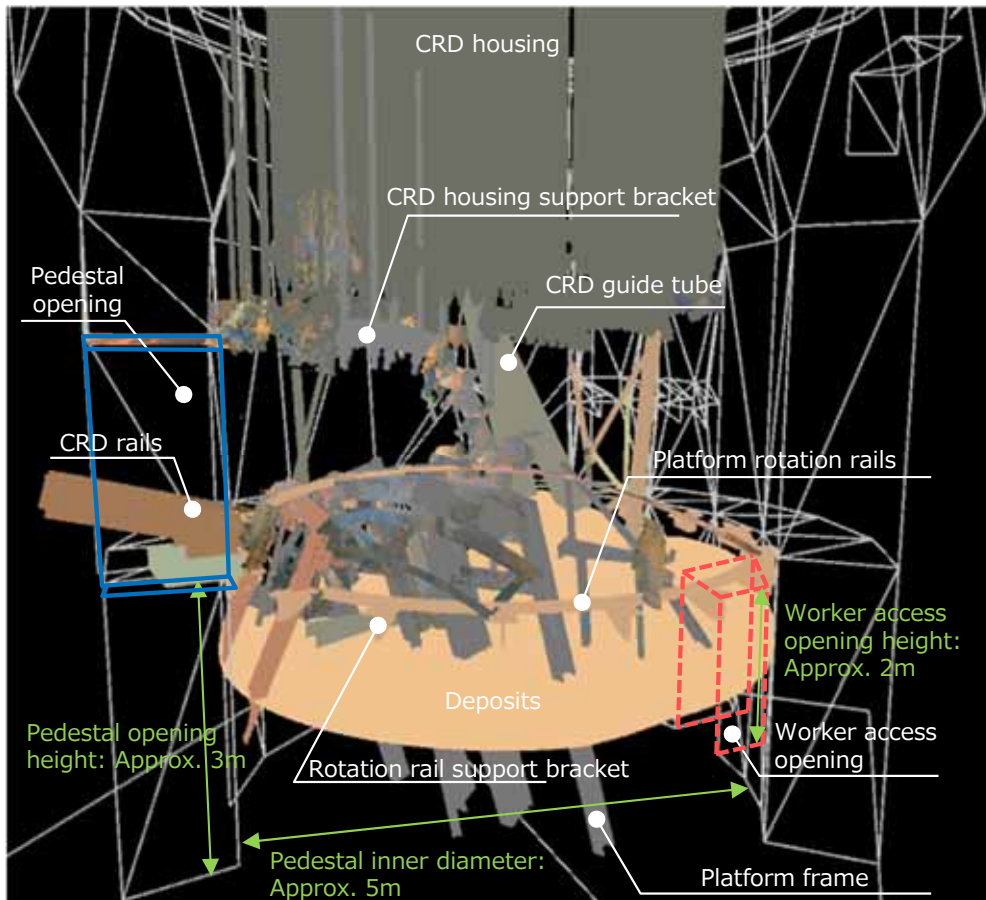
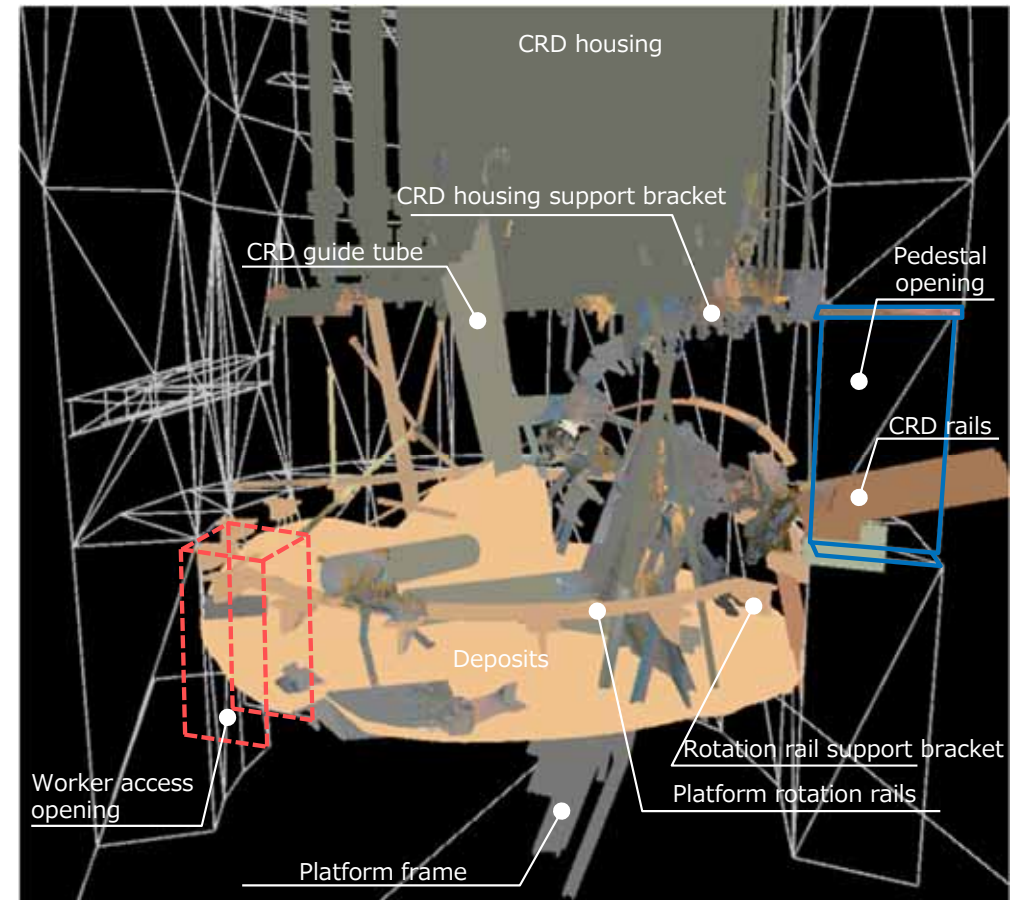
5. Assumptions from 3-D rendering

- The platform has been dislodged from the rails and a portion of it is buried in deposits
- The height of deposits is highest in the center and gets lower as you move away from the center.
- It is possible that the reason why deposits are higher in the center is because structures, such as the CRD replacer, exist directly underneath

- Creating a 3-D rendering of the inside of the pedestal enabled us to visibly ascertain the relative location of structures as you move inside the pedestal from the CRD rails, and we were able to learn that the CRD housing support brackets have fallen off and that the platform is dislodged from the rails.
- Deposits are highest at the center but considering the fact that the platform is dislodged and that the CRD replacer could not be seen in the video, it is possible that the reason why deposits are higher is because molten material that may contain fuel debris fell on top of the CRD replacer.

- This rendering enabled us to get an overall view of the structures that have fallen into the pedestal. Based on these results and data that has been obtained to date, we will plan more investigations as we continue to deliberate the removal of fuel debris, such as the designing of fuel debris removal equipment and removal procedures.
