Reference Picture 1 "Initial response at the time of and after the Tohoku-Chihou-Taiheiyo-Oki Earthquake at Fukushima Daiichi Nuclear Power Station" Tokyo Electric Power Company June 20, 2011

Tokyo Electric Power Company June 20, 2011

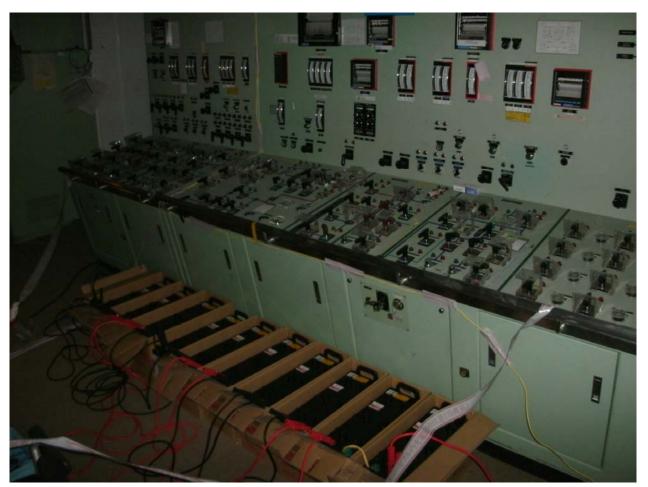
Used as power source for instrument (page 3)

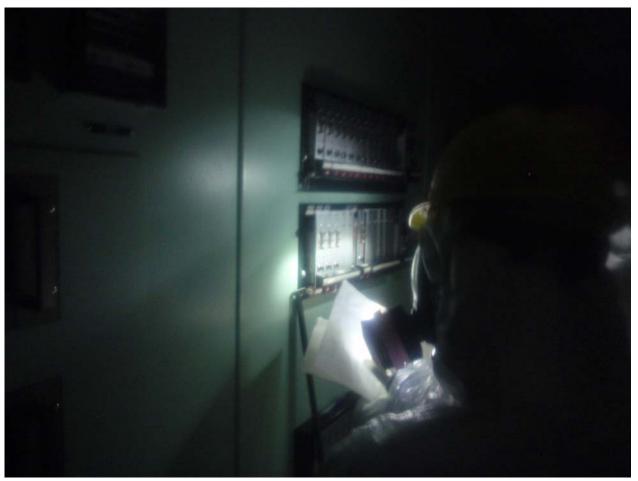
Reading instrument by relying on light (page 3)

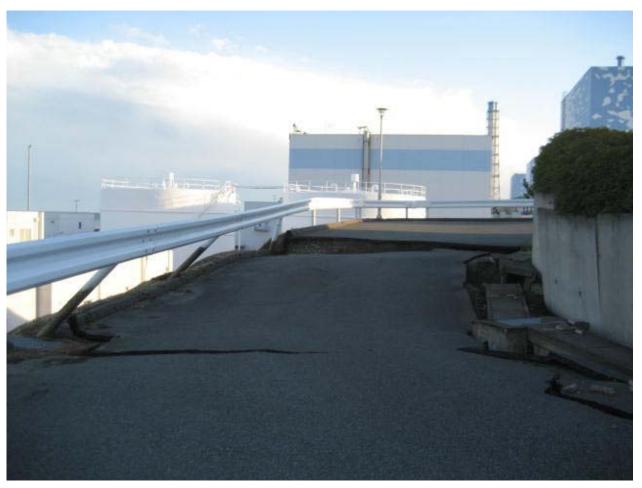
Cave-in road (page 4, 11)

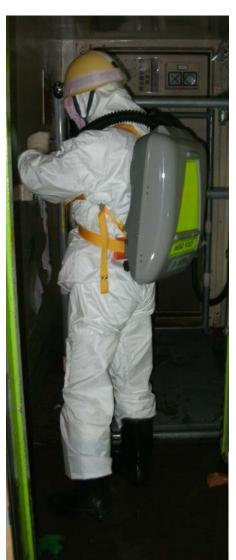
Self-air-set (page 5)

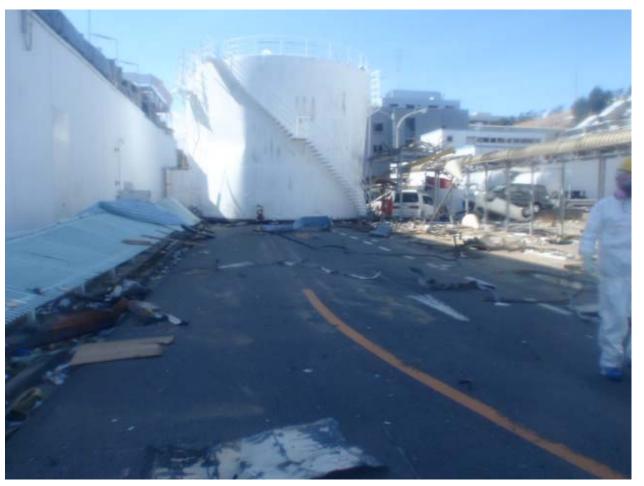
Flowed tanks by tsunami (page 11)

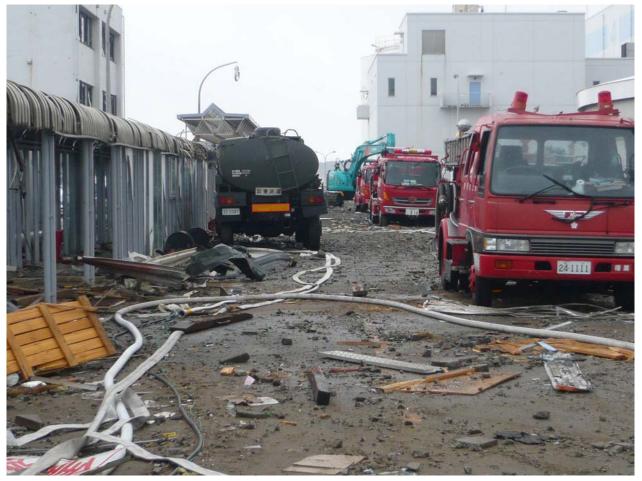
Water injection by fire trucks (page 12)

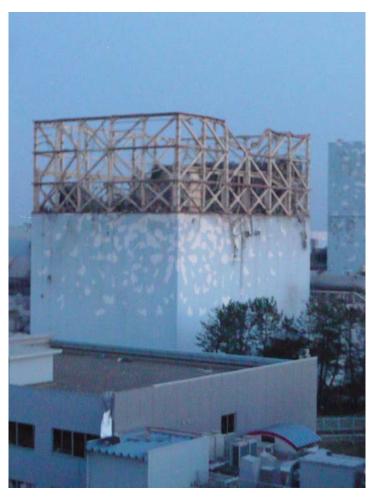
Explosion at the reactor building of Unit 1. (page 13)

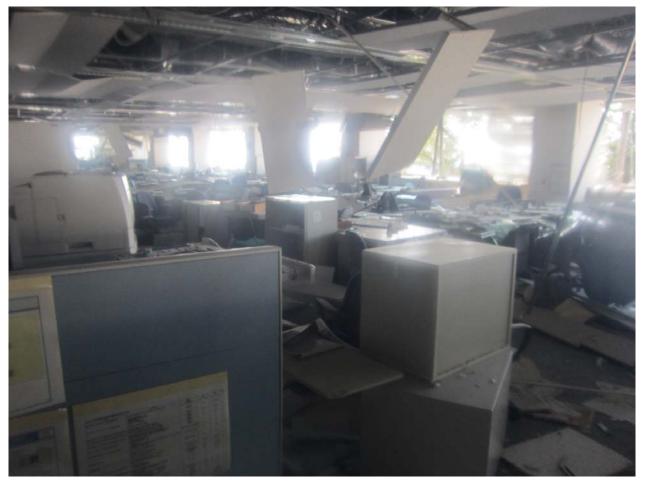
Devastated status at the Administration Office Building (page 14)

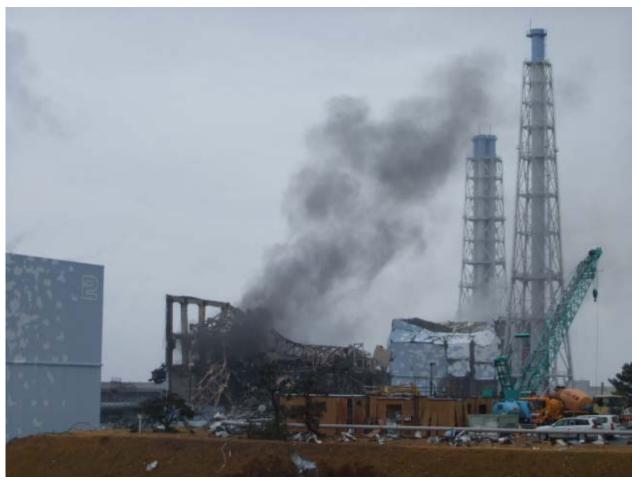
Apparent condition of Unit 3 after explosion (page 35)
