October 28, 2011  
Tokyo Electric Power Company

### Crack on the casing for axle junction of Ceiling Crane of Spent Fuel Pool Building at Fukushima Daiichi Nuclear Power Station

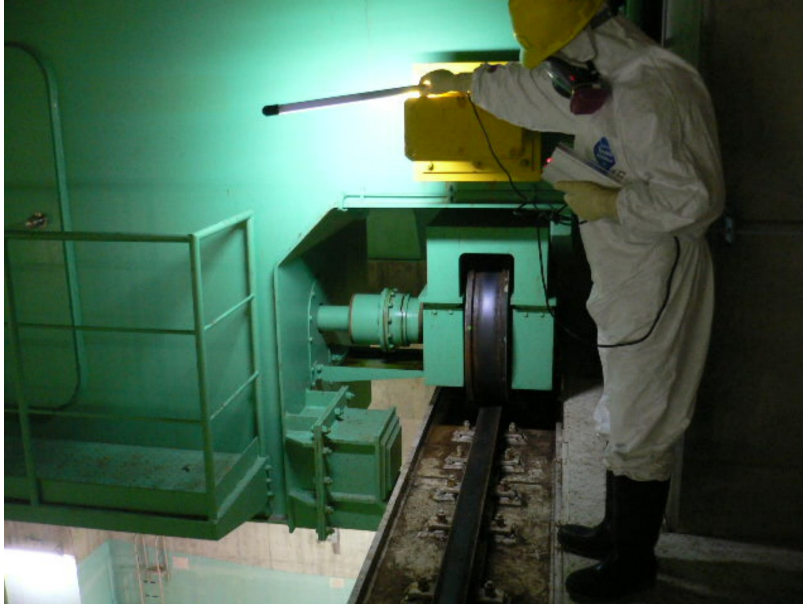
Crack was found on the casing for axle junction
