Behavior of Plants after the Accident

November 30, 2011

Tokyo Electric Power Company

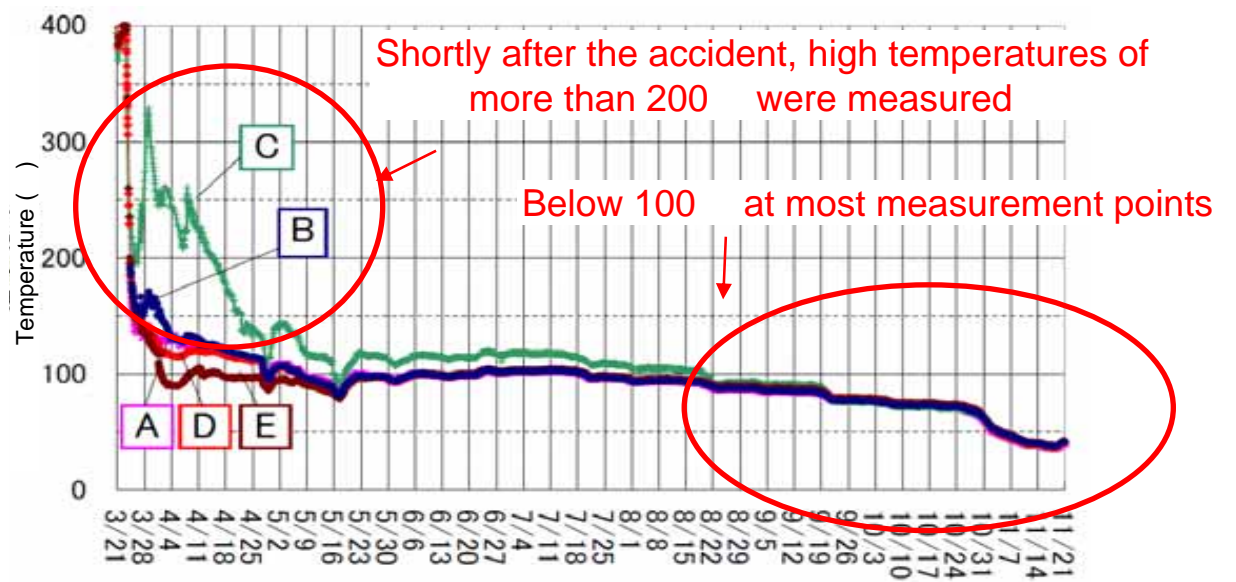
Figure-2 Behavior of temperatures after the accident

- Knowledge acquired from behavior from March to May
 - When temperature of each point began to be able to be measured, temperatures of RPV exceeded 400 °C at several points.

- At some facilities such as CRD housing at the bottom of RPV, temperatures were able to be measured.
 - Steel temperature of RPV remained at nearly 100 °C ~ 120 °C and temperature at several measurement points reflected changes of water injection volume

- Temperatures were remained relatively high at several points of upper part of RPV.
- Knowledge acquired from behavior from May to September
 - Difference in temperatures at upper part of RPV and at the bottom of the RPV decreased.

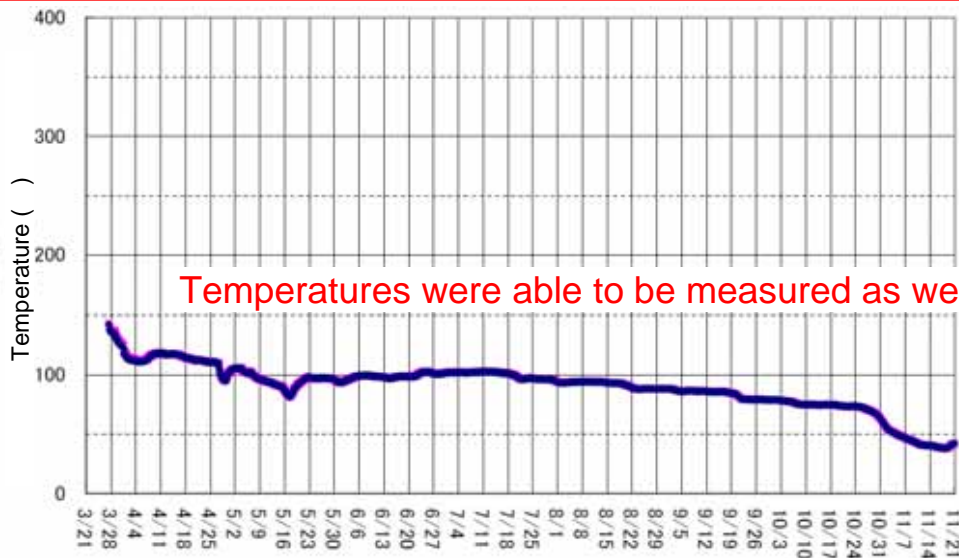
Figure-3 Behavior of temperature at CRD housing

- As of August, temperature at the bottom of RPV became lower than saturation temperature, and trend of lowering of temperature continued.
- Knowledge acquired from behavior after October

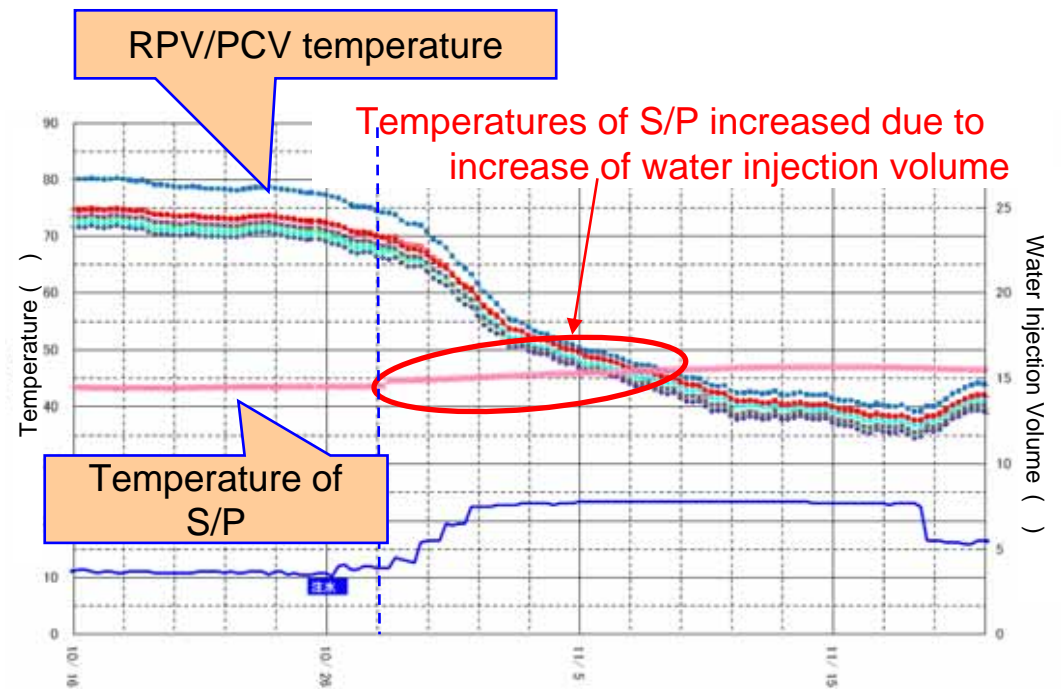
Figure-4 Behavior of temperatures after increase of water injection volume on 10/28

10/28	3.8	4.5m ³ /h
10/29	4.5	5.5m ³ /h
10/30	5.5	6.5m ³ /h
10/31	6.5	7.5m ³ /h
11/18	7.5	5.5m ³ /h

- From late October, as water injection volume increased, temperature of each part of RPV/PCV decreased rapidly. On the other hand, after increase of water injection volume, temperature of S/C pool increased and exceeded that of each part of RPV/PCV.

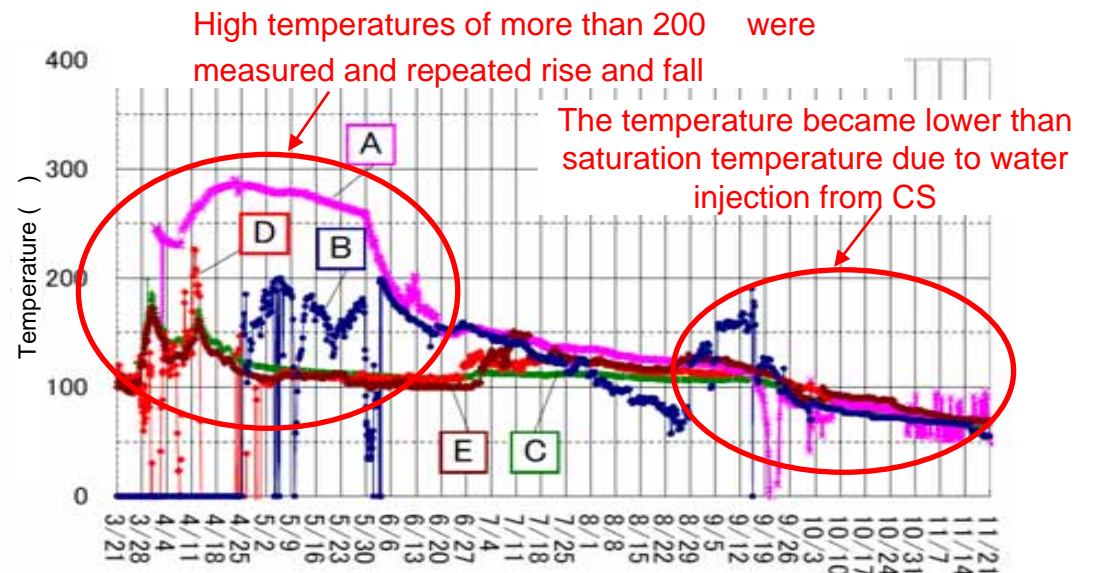
Figure-6 Behavior of temperatures after the accident

- Knowledge acquired from behavior from March to May
 - Temperature at the bottom of RPV remained at nearly 100 ~ 120 °C.
 - Temperature at several measurement points reflected changes of water injection volume

- Temperatures were remained relatively high at upper part of RPV.
- Knowledge acquired from behavior from May to September
 - Temperature at bottom of RPV indicated around the saturation temperature after water injection from reactor feed water system.

- Temperatures were remained relatively high at upper and middle part of RPV.
- Knowledge acquired from behavior after October
 - Measured temperature at upper part of RPV decreased due to water injection from core spray system that passed core part directly. After we increased the water injection volume, the temperature became lower than saturation temperature.

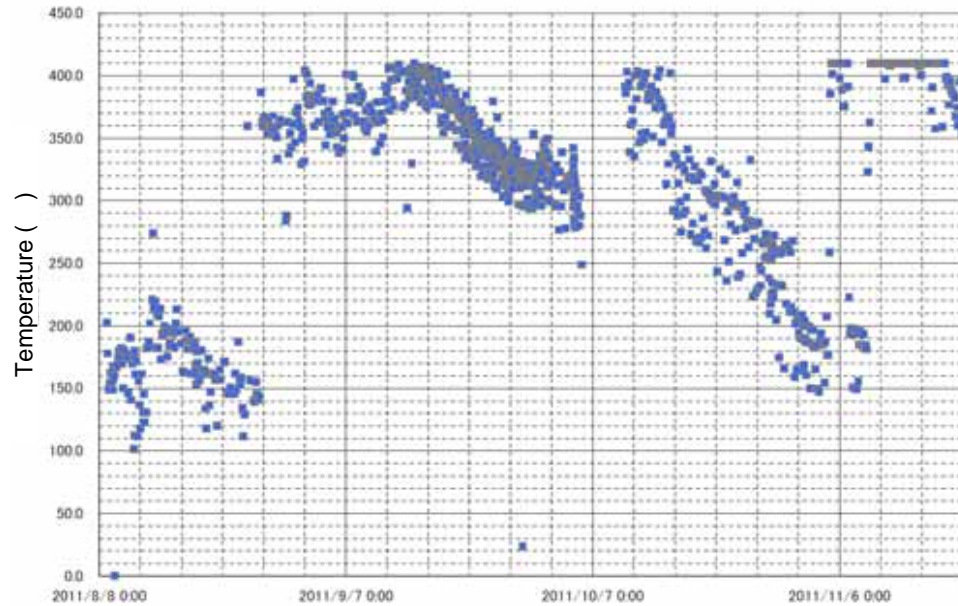
Figure-7 Behavior of temperature at CRD housing

() The temperature out of measure range were not plotted in this graph.

- Ambient temperature of PCV was lower than saturation temperature. Yet, temperatures were remained high (higher than saturation temperature) at several points (CRD housing and SRV).

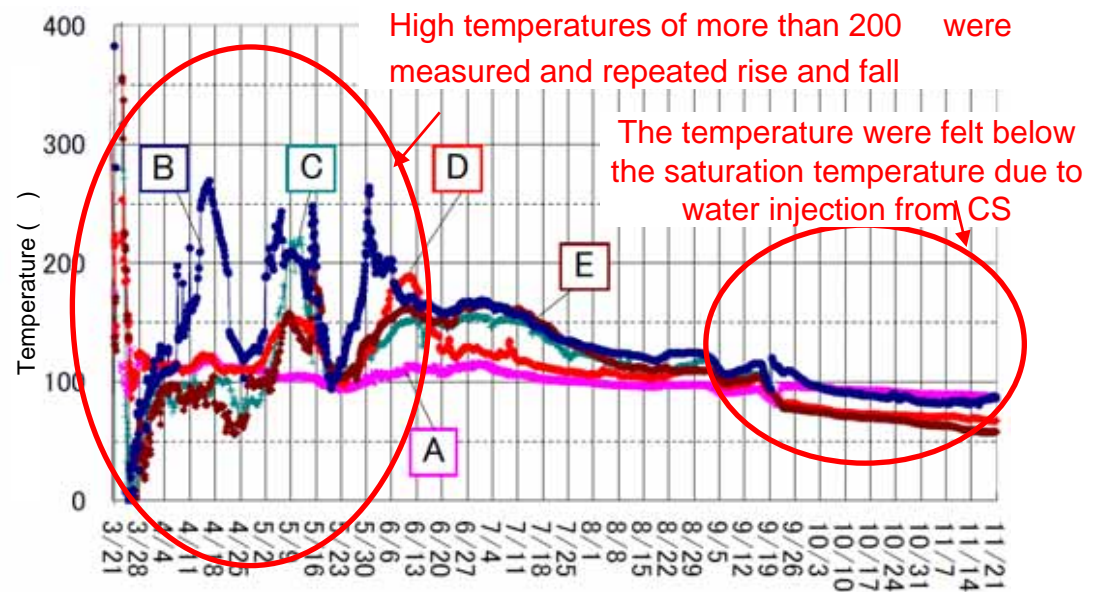
Figure-10 Behavior of temperatures after the accident

- Knowledge acquired from behavior from March to May
 - Steel temperature of RPV remained at nearly 100 ~ 120 .
 - Temperature at several measurement points reflected changes of water injection volume.

- Temperature at several measurement points increased from May.
- Knowledge acquired from behavior from May to September
 - Overheat of whole RPV was continued even though reactor feed water system had operated.

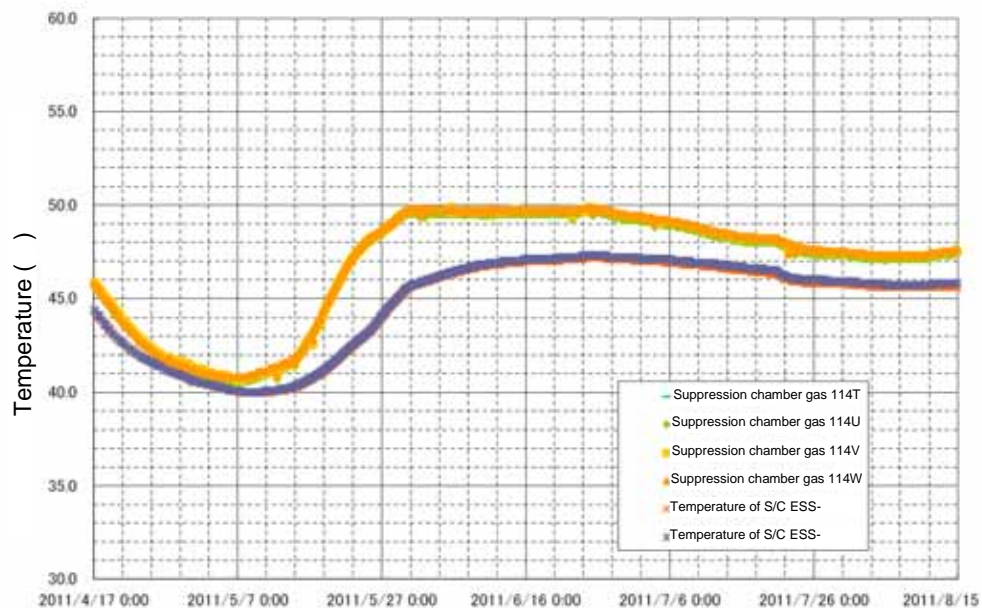
Figure-11 Behavior of temperature of SP gas and SC water

5/12	9	12m ³ /h
5/13	12	15m ³ /h
5/17	15	18m ³ /h
5/20	18	21m ³ /h
5/23	21	18m ³ /h

- Temperature of S/P water and S/C gas were increased due to increase of water injection volume.
- Knowledge acquired from behavior after October
 - Measured temperature at upper part of RPV decreased due to water injection from core spray system that passed core part directly.

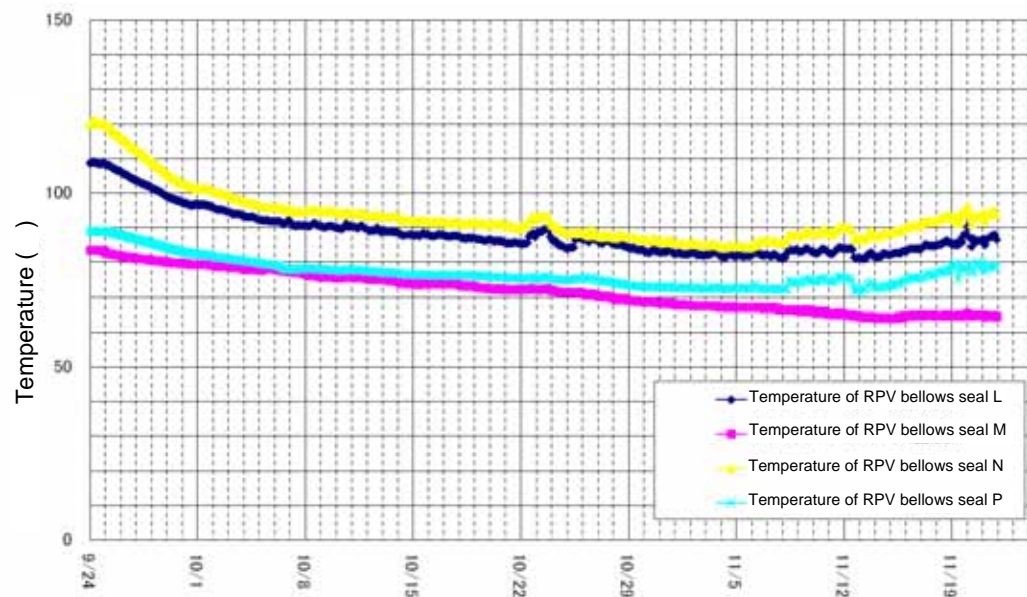
Figure-12 Behavior of temperature of RPV bellows seal

- The temperature became lower than 100 in late September by increasing the water injection.
 - Ambient temperature of PCV had been lower than saturation temperature. Yet, the thermometer infrequently indicated high (higher than saturation temperature) at several points (bellows seal of RPV and SRV) after the temperature of RPV became lower than 100 .
