# A One-year Review of Fukushima Daiichi Nuclear Power Station “Steps to Achieve Stabilization”

March 2012

# I. Accident Causes & Measures Taken

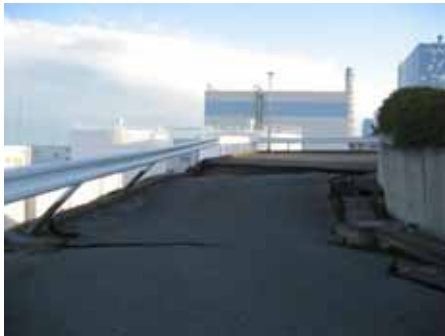
Fukushima Daiichi

Ground subsidence partially occurred

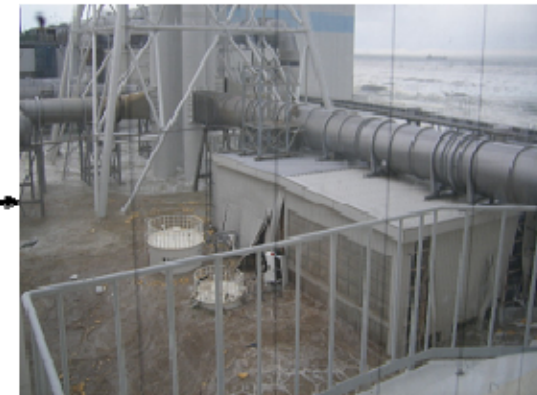
Date : 2011/3/11 15:44

Heavy Oil Tank (about 5.5 m high) was submerged by the tsunami, which was located at the level of OP +10 m.

**Outdoor flooding conditions at Fukushima Daiichi Nuclear Power Station**

(Near the Unit 4 South-side Central Environmental Facility Process Main Building site height O.P.+10m, heavy oil tank height approximately 5.5m)

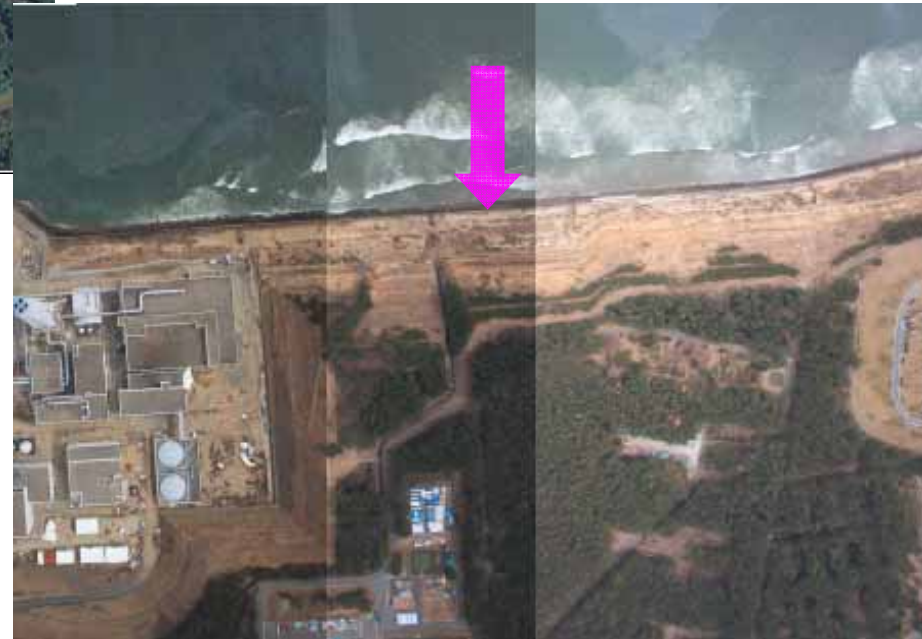
After March 11th

Washed Away Trees

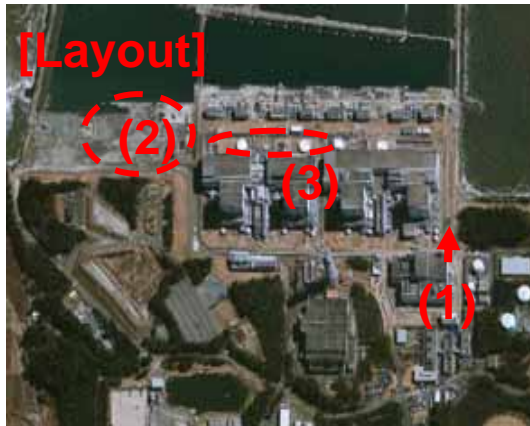
(1) Tsunami overflow

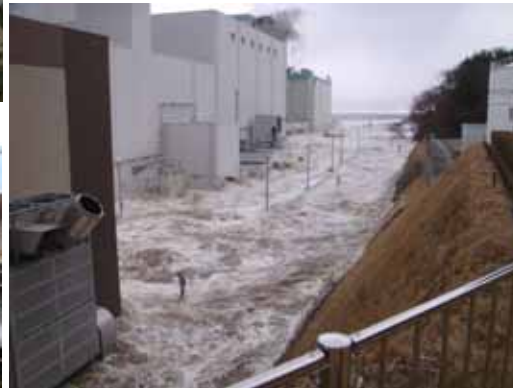
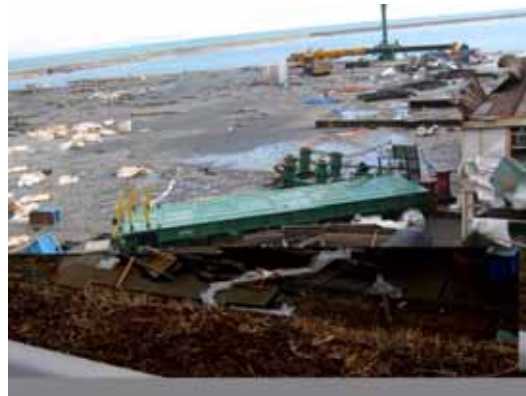
(2) Damage to the low area (Pickup area)

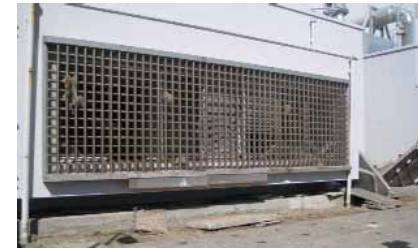
Inundation through the louver of Unit 1 Reactor Annex Building

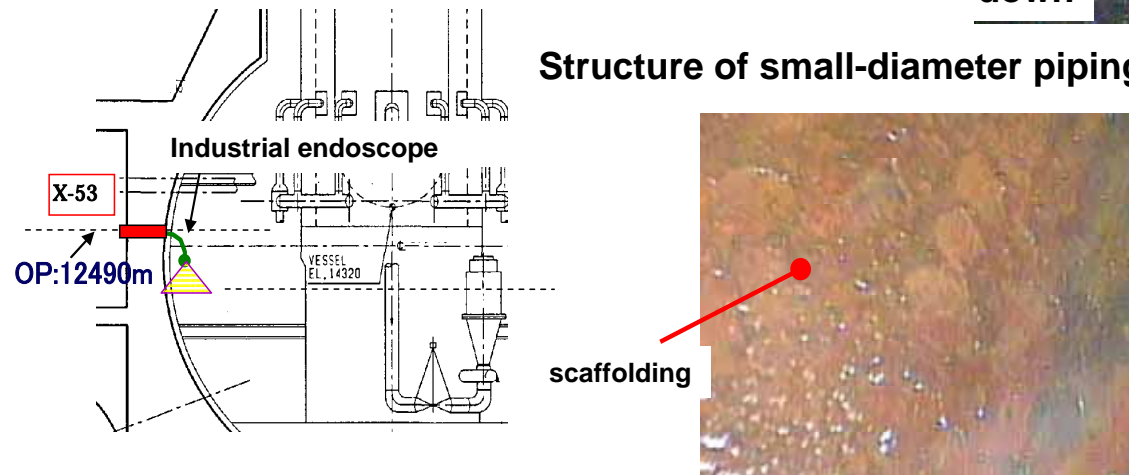
PCV inside wall

No damage was confirmed to the small-diameter piping inside the PCV according to the video observation in Unit 2 of Fukushima Daiichi

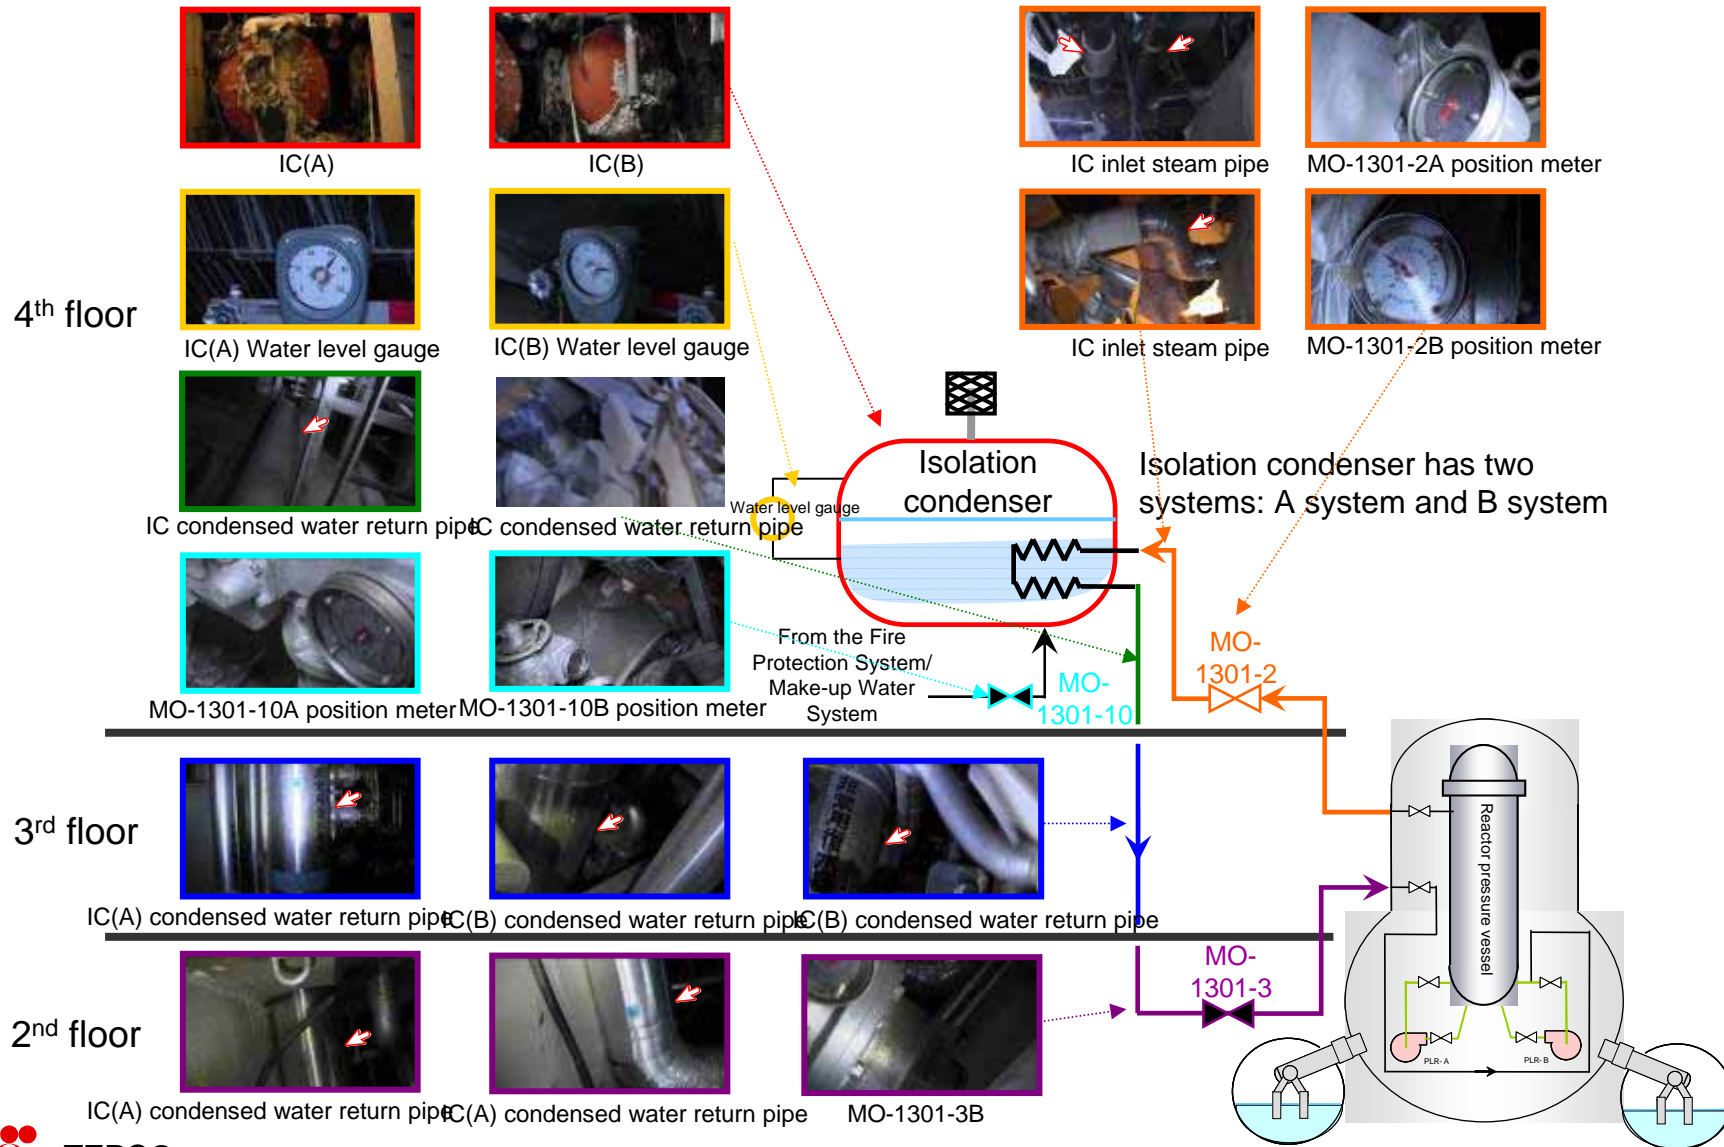
No damage was confirmed to the body and piping of Unit 1 IC as a result of visual observation where possible.

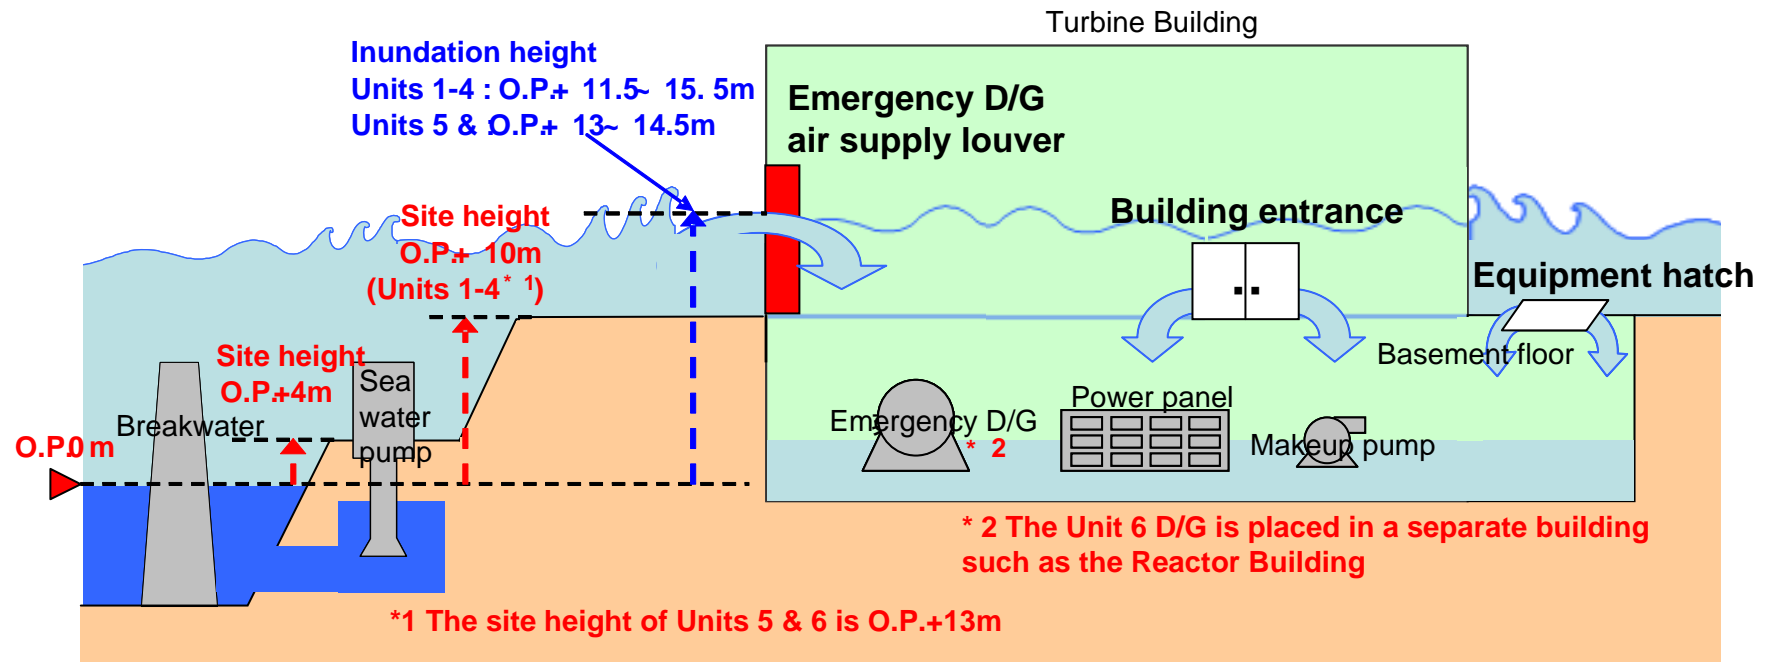
Emergency diesel generators and electrical equipment rooms were flooded through (1) entrance of the building, (2) equipment hatch, (3) inlet air louver of emergency D/G, (4) trench and duct (cable penetrations etc.), and lost its functions. Emergency sea water pumps outdoor were submerged and lost its function.

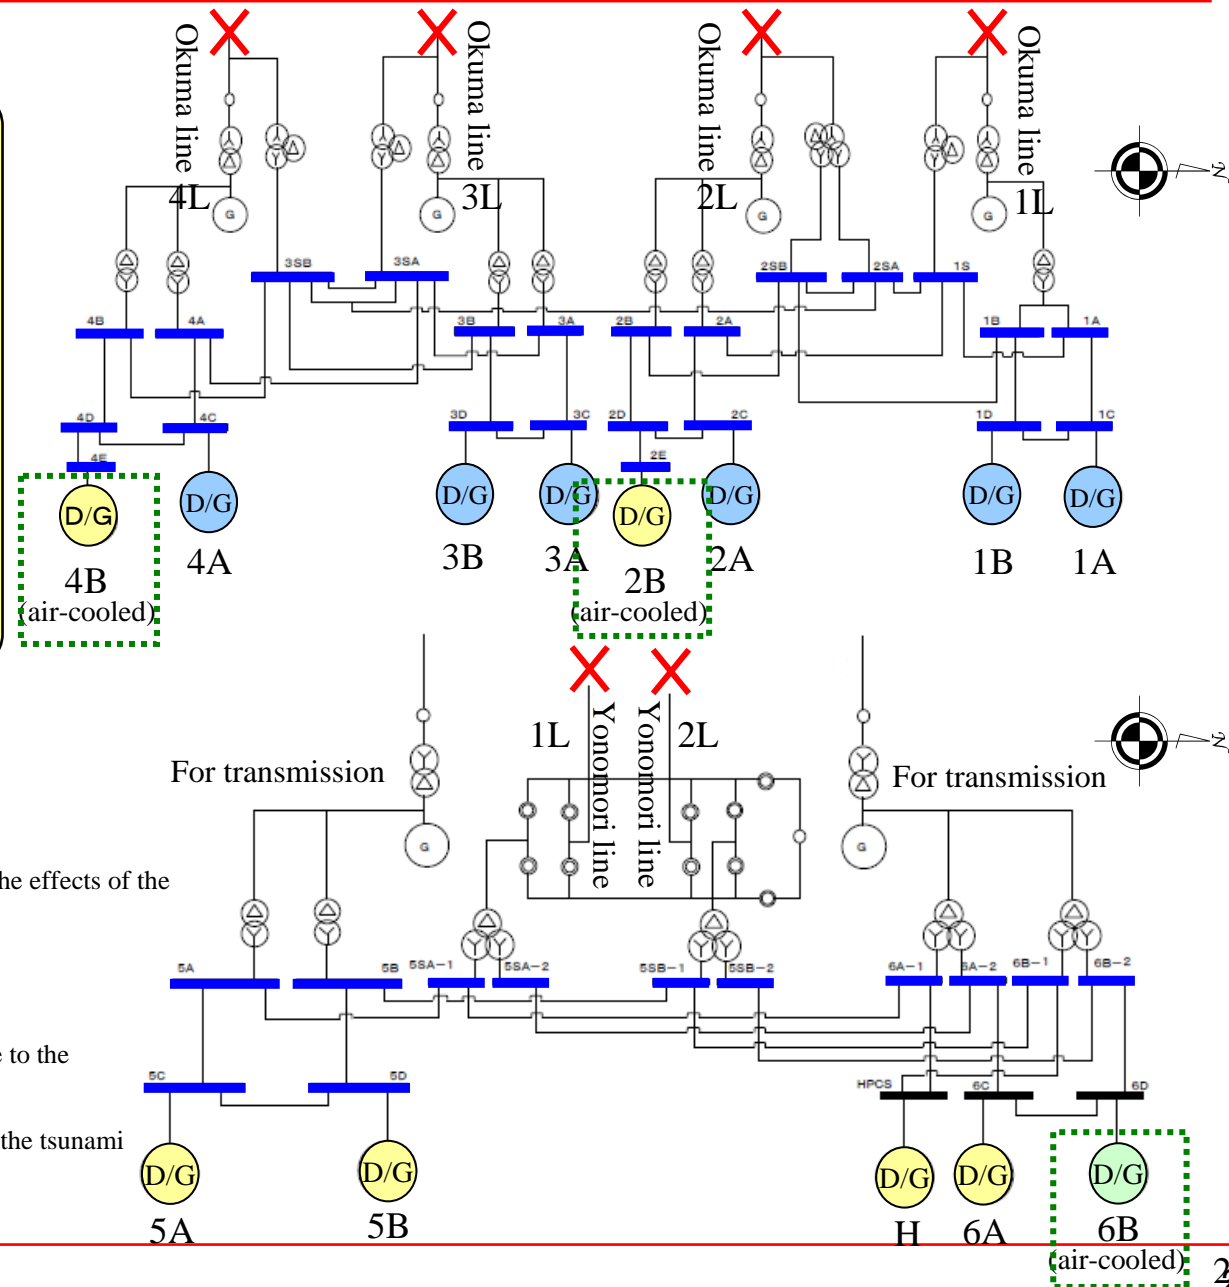
- All emergency D/Gs in Units 1 to 5 were stopped and resulted in AC power loss.
- One air-cooling emergency D/G in Unit 6 could continue its operations and the power supply was maintained.

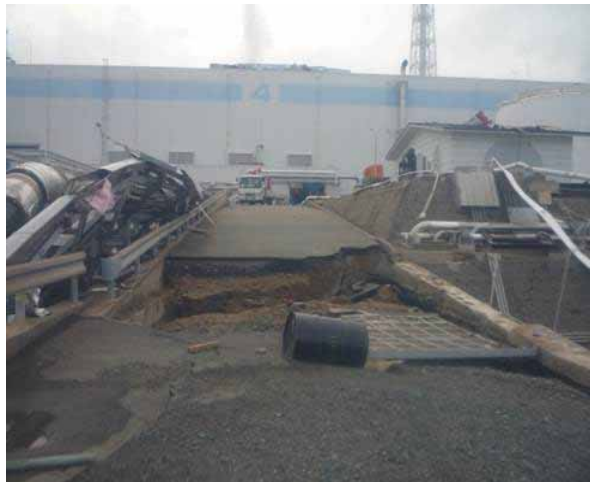
Subsidence of roads etc.  
Dangerous to walk in, especially at night

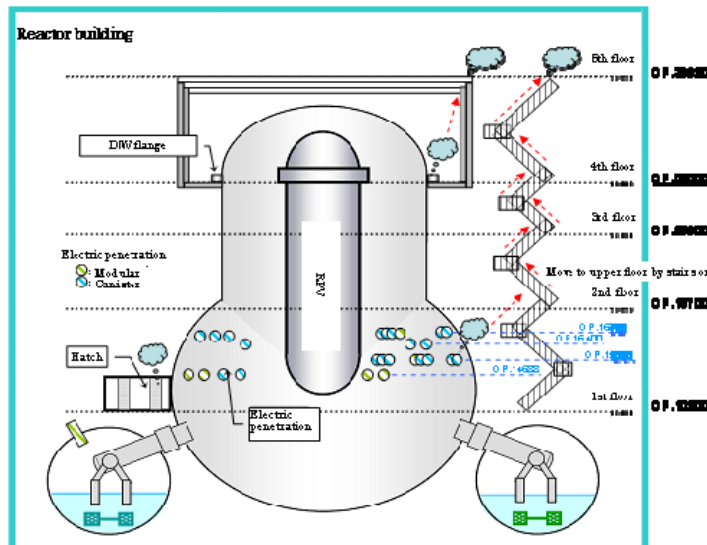
- Unit 1 & 3: Hydrogen generated from the damaged reactor fuels without cooling function accumulated in the PCV, leaked into the Reactor Building and then exploded.  
(It is estimated that inert gas (nitrogen) was properly inserted and thus the explosion inside the PCV was able to be avoided.)
- Unit 4: Hydrogen leaked and accumulated from the neighboring Unit 3 through the Standby Gas Treatment System (SGTS) piping while it was venting and then it exploded.
- Unit 2: It is estimated that the air ventilation inside the building was stimulated when the blow-out panel on the top floor burst open due to the explosion of Unit 1 and thus an explosion was avoided.

There are possibilities that the inferred leakage flow paths differ between Unit 1 and 3 according to system configuration
