Inspection of the equipment hatch of PCV in Unit 3 of Fukushima Daiichi Nuclear Power Station

April 19, 2012
Tokyo Electric Power Company

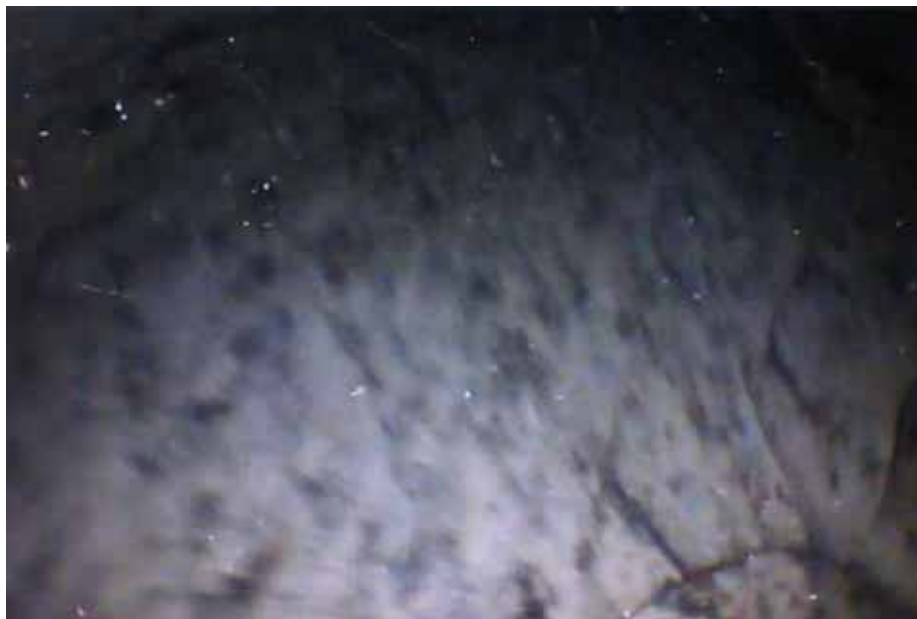
Dry surface

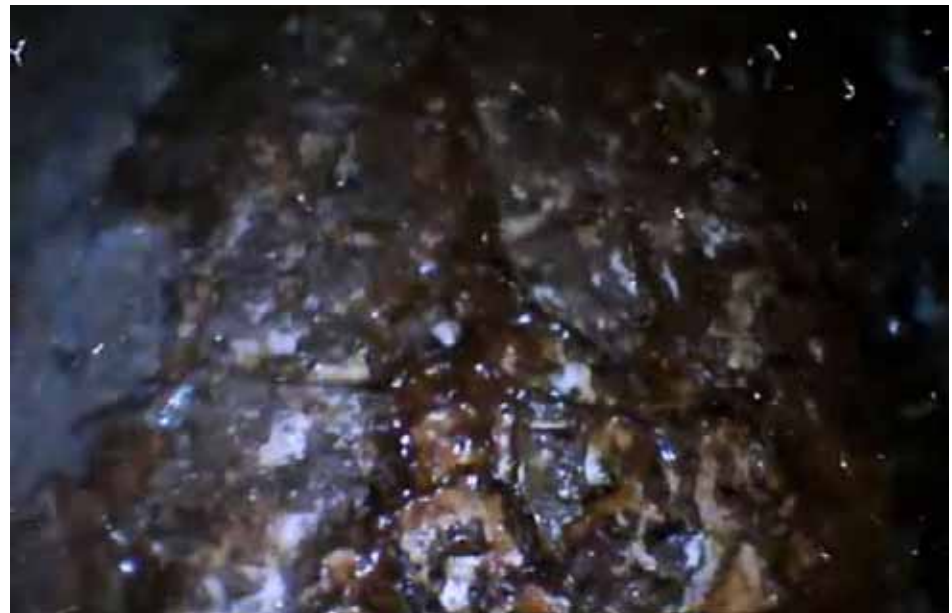
- We checked the situation around the equipment hatch flange of PCV, and we confirmed floor surface where the water leakage could have occurred.
- Hereafter, we will study the result of the inspection in detail.

Floor surface where the water leakage could have occurred
