# Soundness Verification Results of Unit 4 Reactor Building at Fukushima Daiichi Nuclear Power Station

May 25, 2012

Tokyo Electric Power Company

# Inspection Overview

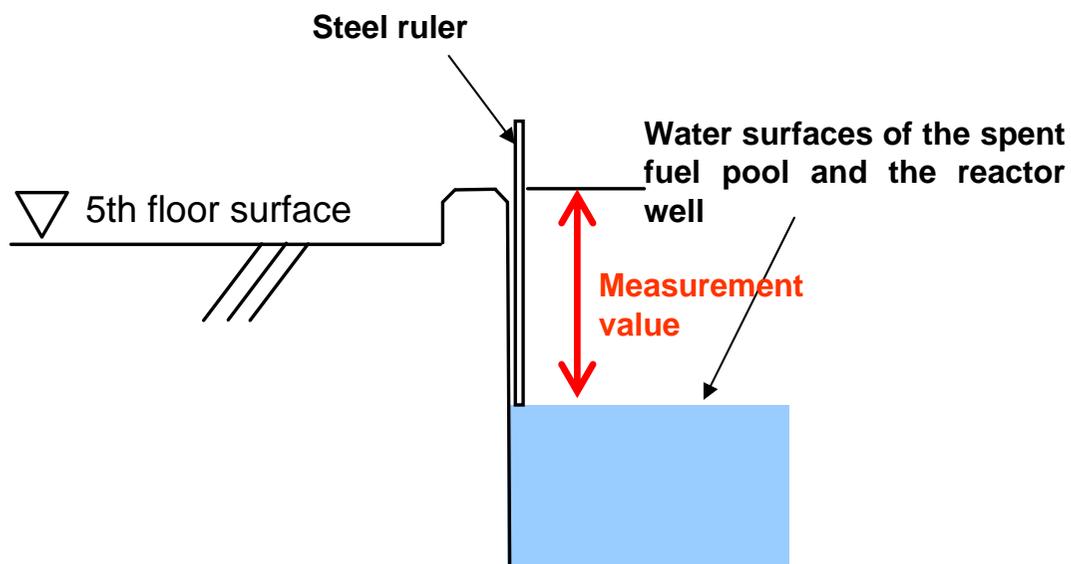
As the measurement values on the four corners are about the same, it can be concluded that the 5th floor surface and the water levels of the spent fuel pool and the reactor well are parallel. (It has already been confirmed that the building is not tilted based on the measurement results acquired on February 7, 2012 and April 12, 2012.)

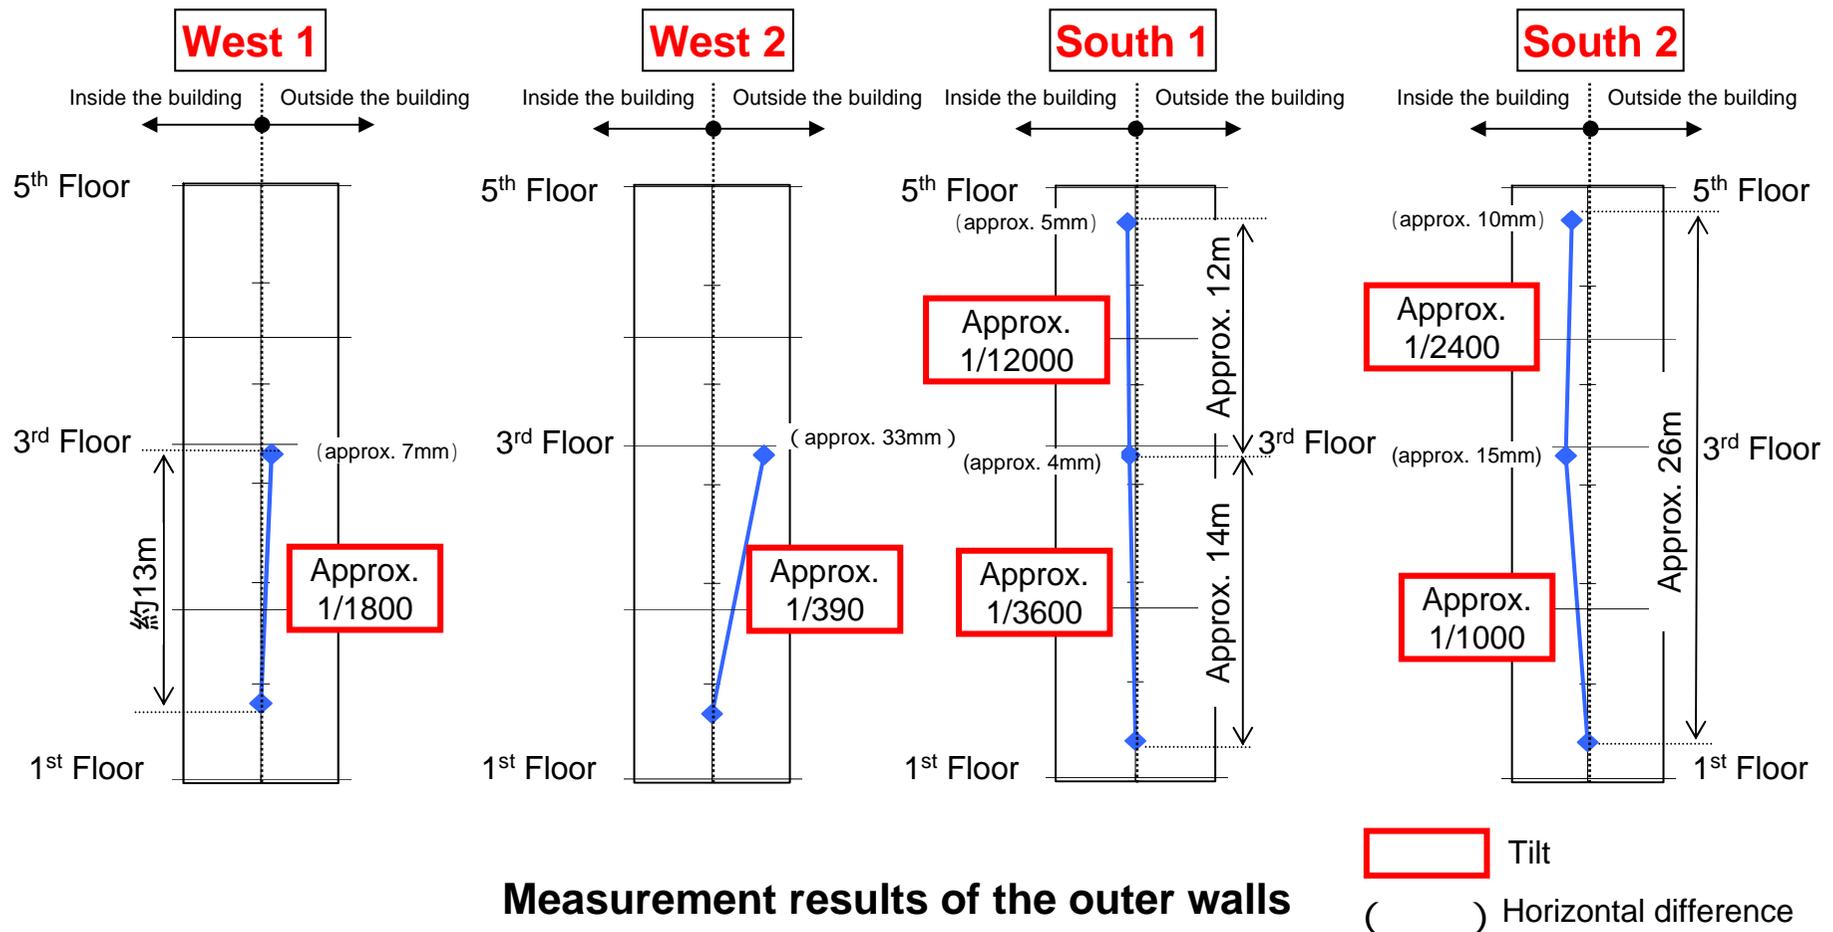
The results of the exterior wall perpendicularity were all below the limits given in the Building Standard Act\*. It can be concluded that the building itself is not tilted and the structure safety is secured.

\*According to the Building Standard Act, 1/200 is the set limit for the tilt of the building in the allowable stress calculation.

-JASS5N (the Building Standard Act) sets the acceptable value of the construction error for reinforced concrete structure as  $\pm 20\text{mm}$ .

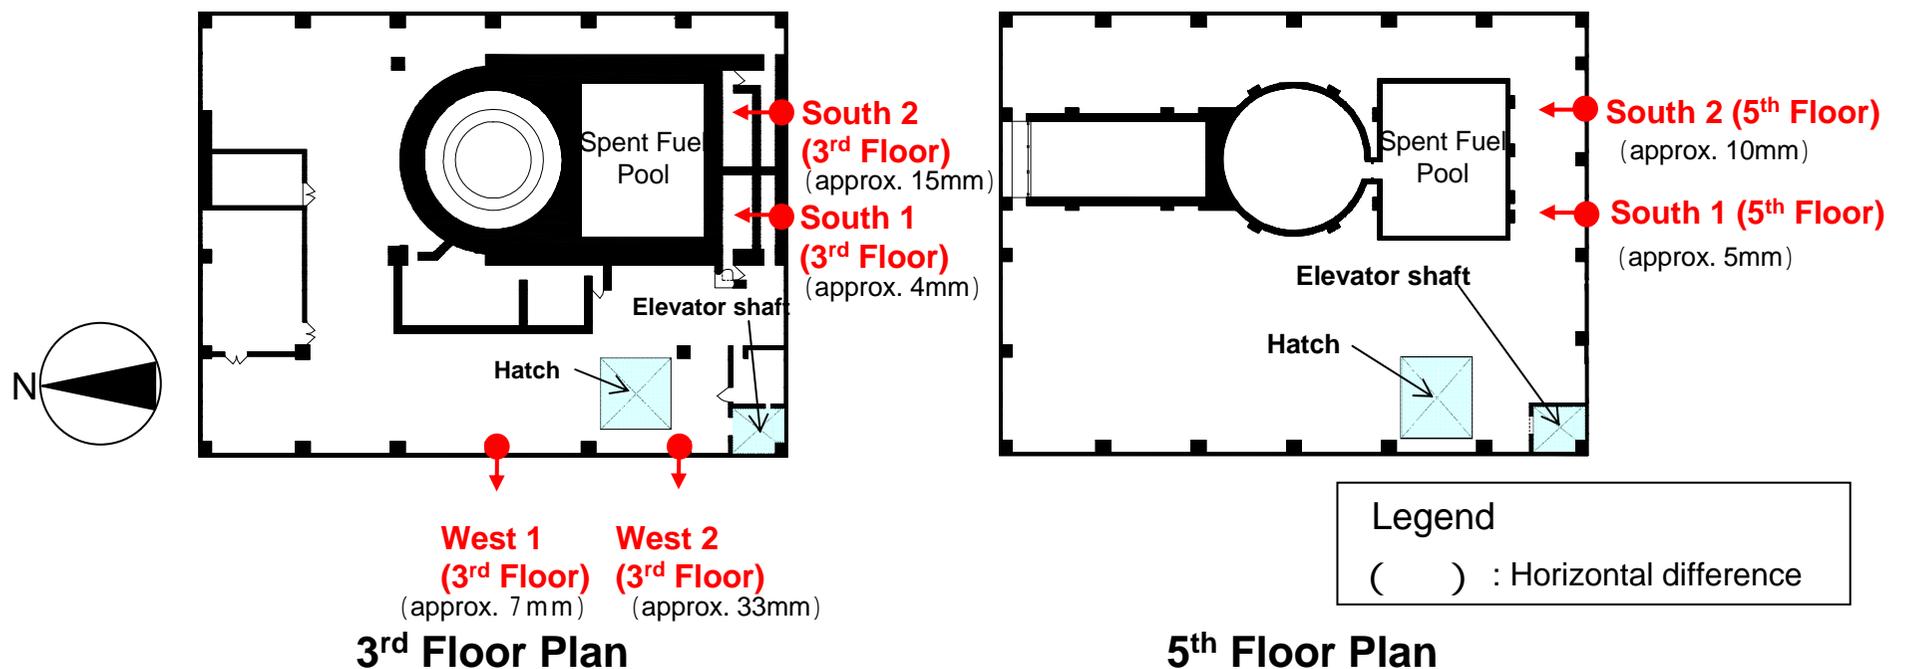
The point West 2 is presumed to have partially expanded due to the weak force constraints because of the existence of the vaulted floors for hatches and elevator shafts near the point.

Should the existence of the wall neglected, the weight that comes from the earthquake load is little as 10%, compared to the overall weight of the building. The effects that the whole building and the spent fuel pool get from this deformation are little, since they are both separated from the walls. We will further continue analyzing in order to evaluate quantitatively the effects of the partial deformation.

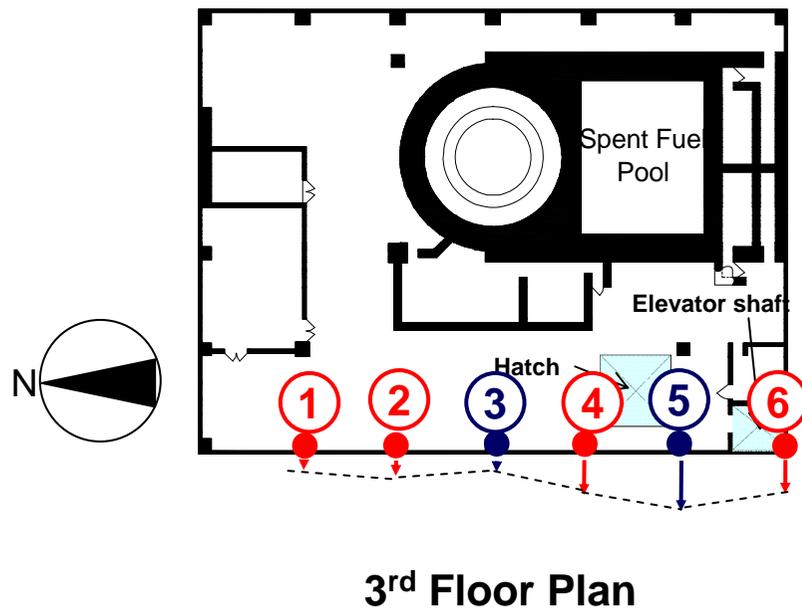
We measured a few points near the measurement point on the west wall where partial deformation was confirmed, to confirm the deformation tendency, on May 25.

The expansion of the west exterior wall was confirmed as a partial deformation.

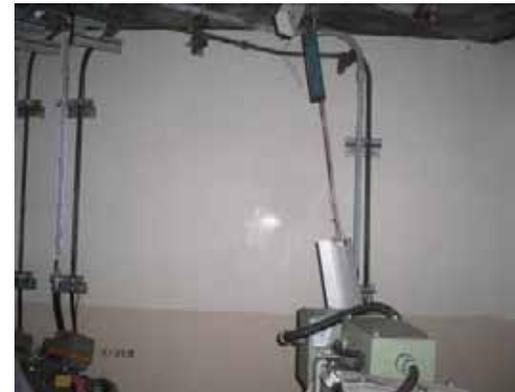
①  
1st  
Floor

As a result of visual inspection, cracks of which the width exceed 1mm or which have the possibility of rebar corrosion were not confirmed.

The wall that supports  
the spent fuel pool

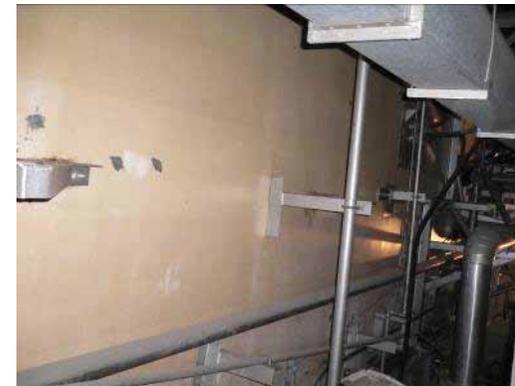
②  
2nd  
Floor

The wall that supports  
the spent fuel pool

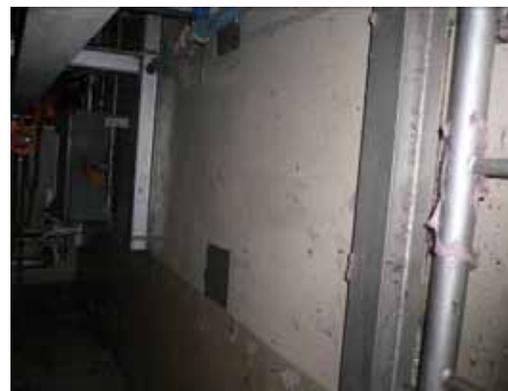
3<sup>rd</sup> Floor

The spent fuel pool wall

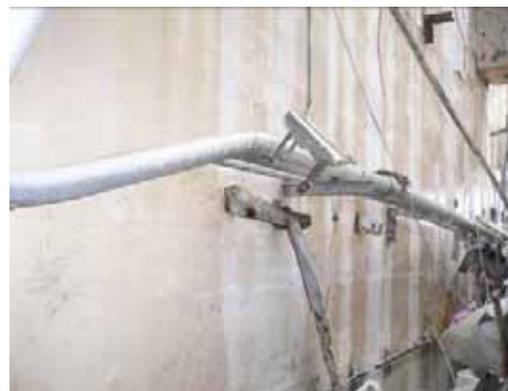
4<sup>th</sup> Floor

The spent fuel pool wall

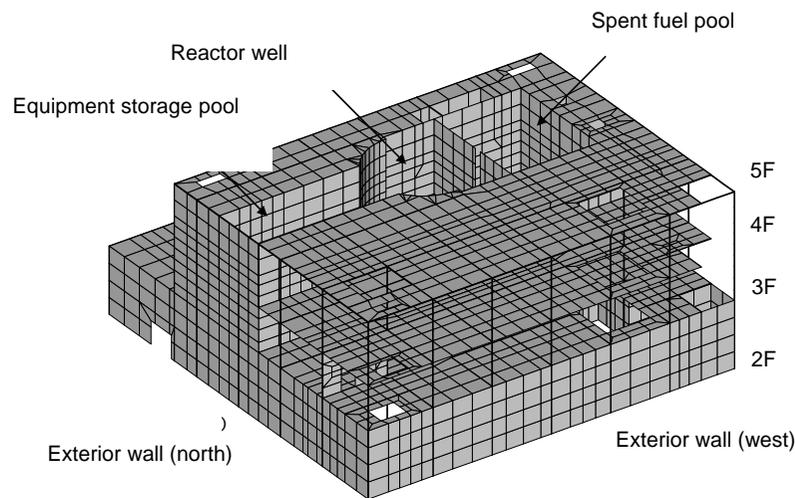
- We have confirmed that the spent fuel pool is safe even if it faces an earthquake of the same level of Tohoku-Chihou-Taiheiyou-Oki Earthquake by an analysis which took into account of the damages by the explosion, etc.
- Furthermore, we reinforced the bottom of the spent fuel pool and improved more than 20% of its seismic margin.

**Analysis Model that took into account of damages of the walls (FEM)**

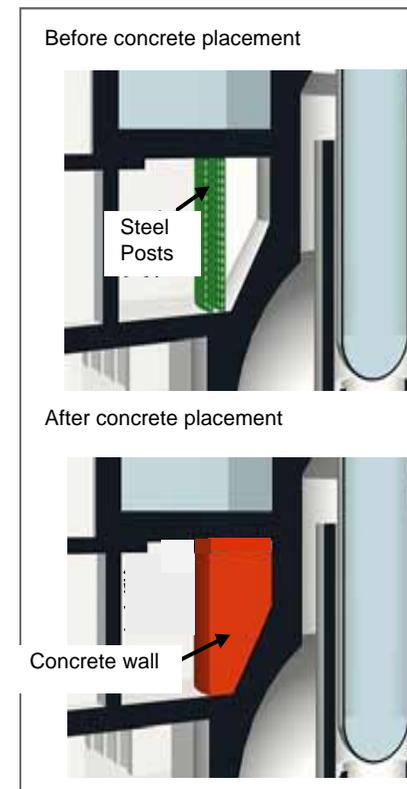
**Reinforcement of the bottom of the spent fuel pool**
