July 12, 2012

Tokyo Electric Power Company

# **Fukushima Daiichi Nuclear Power Station Unit 3 Reactor Building Basement Torus Room Investigation**

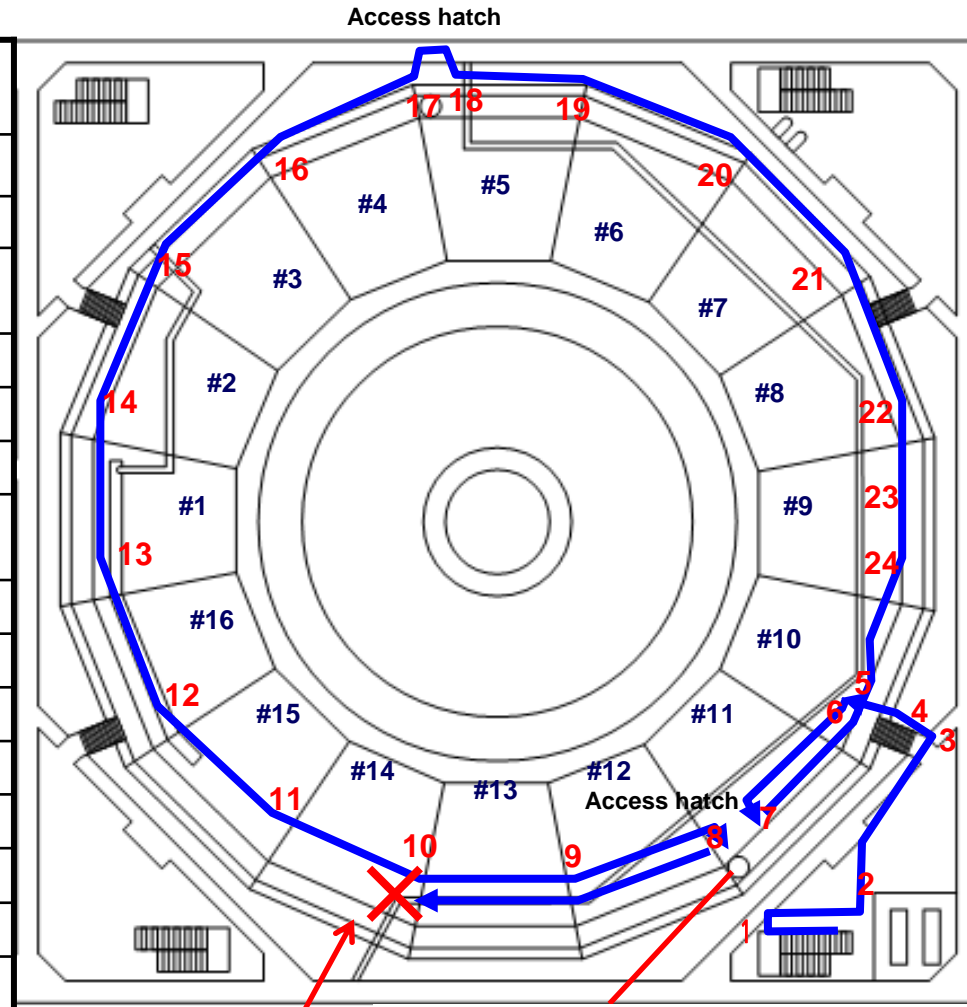
Point	Dose rate [mSv/h]	Remark	Point	Dose rate [mSv/h]	Remark
1	4		16	186	
2	18		17	234	
3	46		18	360	Side of the access hatch
4	100		19	169	
5	190		20	158	
6	173		21	164	
7	154	Side of the access hatch	22	186	
8	125		23	240	
9	176		24	193	
10	230				
11	192				
12	158				
13	176				
14	180				
15	179

Location where the cable communication of survey runner was interrupted

The robot was unable to go through the side of the access hatch as it was too narrow

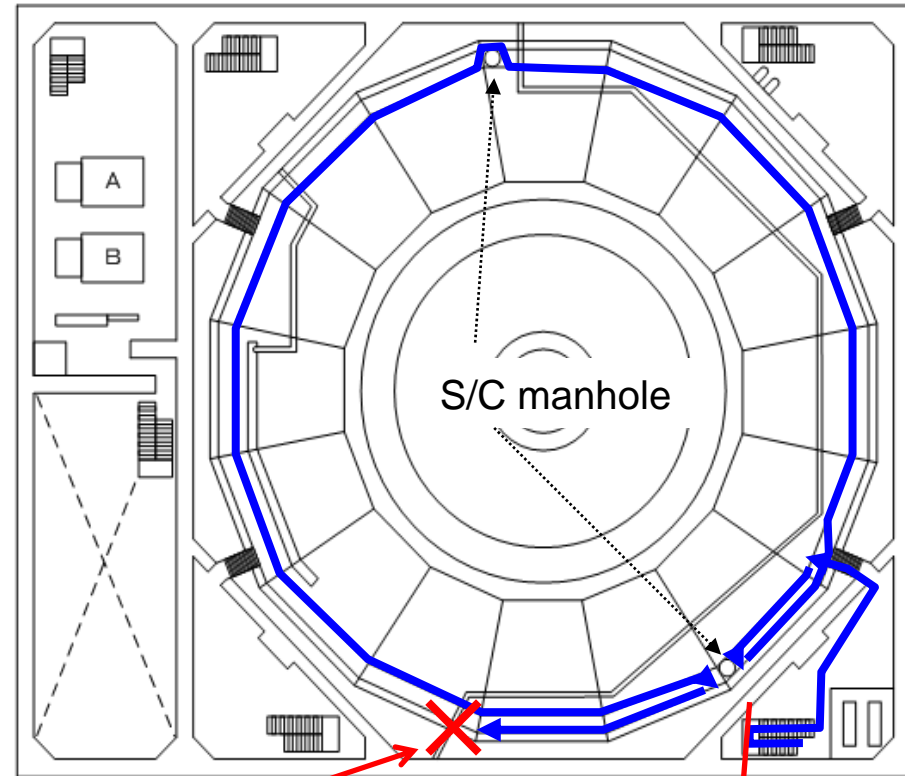
R/B Basement

Location where the cable communication of survey runner was interrupted

The robot was unable to go through the side of the access hatch as it was too narrow
