# The Soundness of Unit 4 Reactor Building and Spent Fuel Pool at Fukushima Daiichi Nuclear Power Station

August 30, 2012

Tokyo Electric Power Company

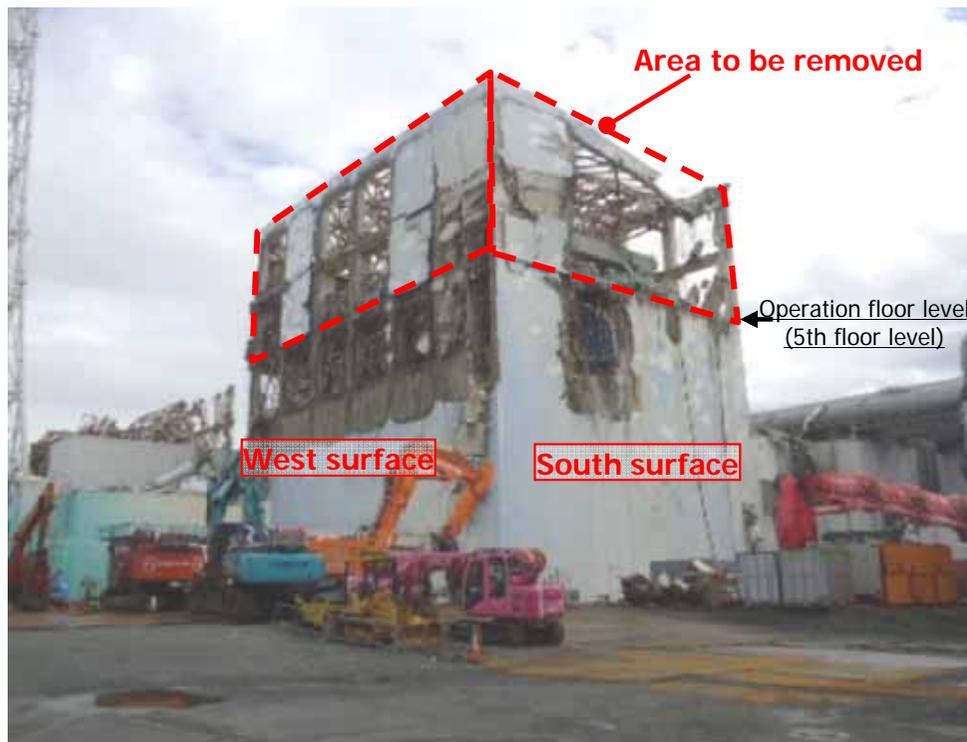
Operation floor (5th floor level) with debris remaining on it (South and west surfaces)

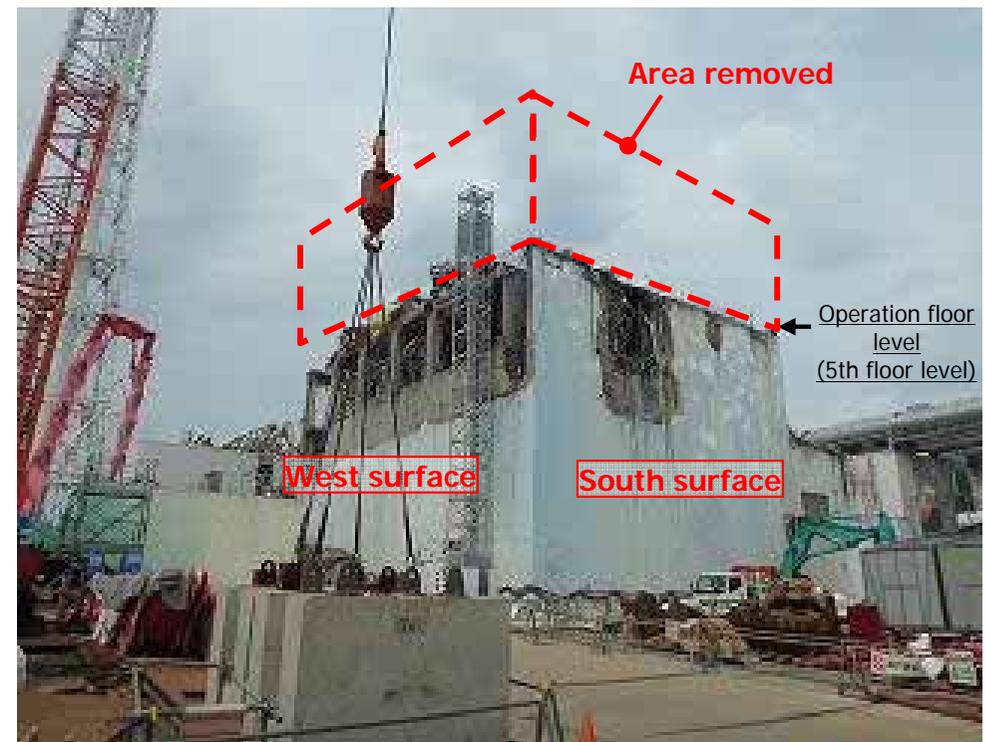
Operation floor (5th floor level) with debris removed (South and west surfaces)

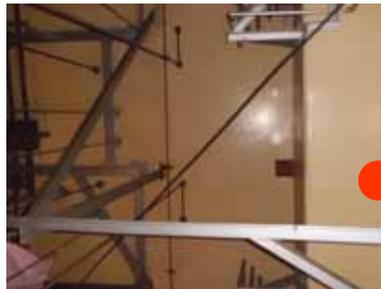
View from the lower floor  
(Before placement of concrete wall)\*<sup>1</sup>

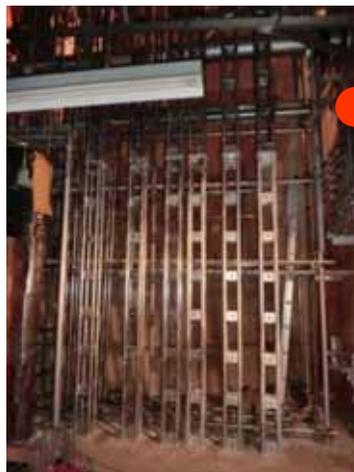
Steel posts  
(Before placement of concrete wall)\*<sup>2</sup>

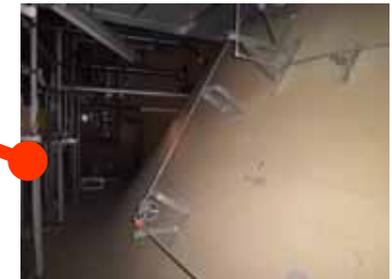
Wall supporting the 2nd floor  
pool structure (Before  
placement of concrete wall)\*<sup>3</sup>

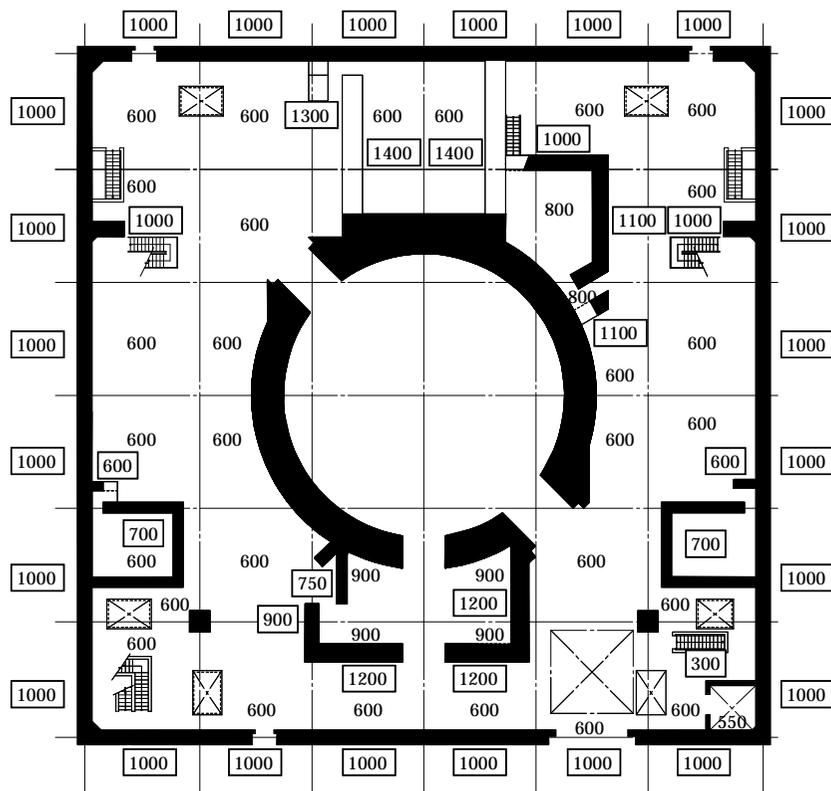
1st floor - Plan view

- The floor slabs and the walls were intact as a result of visual inspection\*1.

\*1 At the regular inspection carried out in May 2012, partial bulge was found on the west and south wall surfaces on the 2nd floor, however, the concrete strength has not decreased and no large crack was found. ("Report on the Seismic Safety of Unit 4 Reactor Building at Fukushima Daiichi Nuclear Power Station in Consideration of the Partial Bulge on the Exterior Walls" (June 25, 2012))

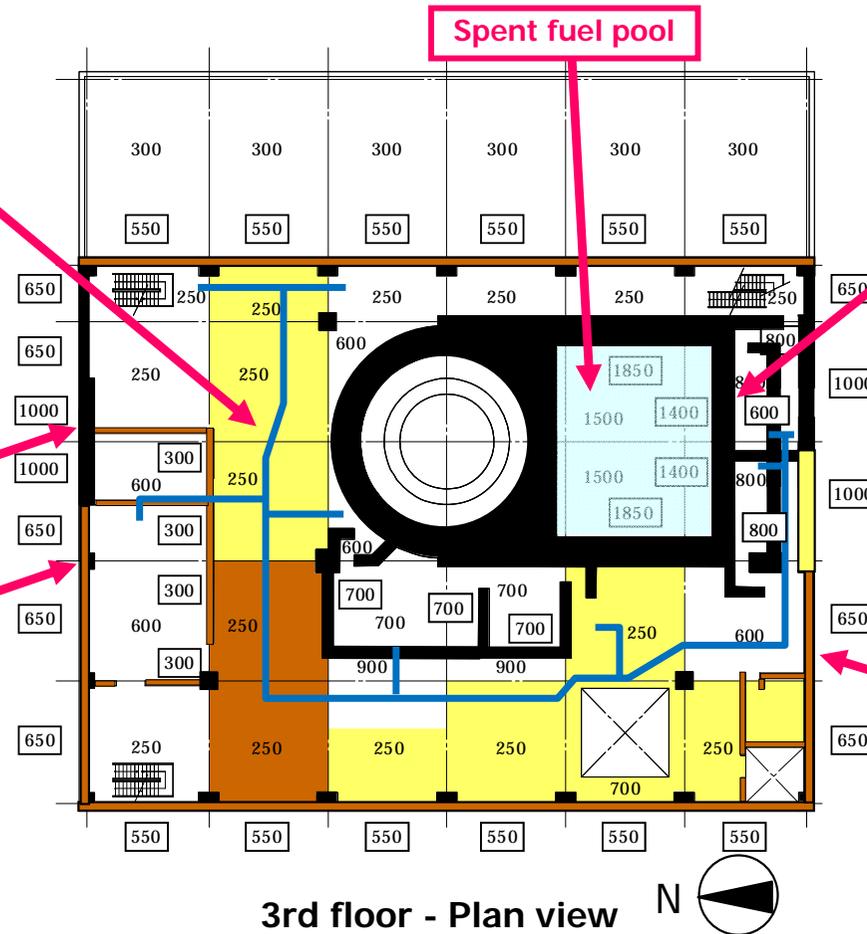
Floor damage was found in the area near the duct route  
 Floor thicker than 25cm: No damage found  
 Floor thinner than 25cm: More damaged

Walls thicker than 65cm: Less damaged

Walls thinner than 65cm: More damaged

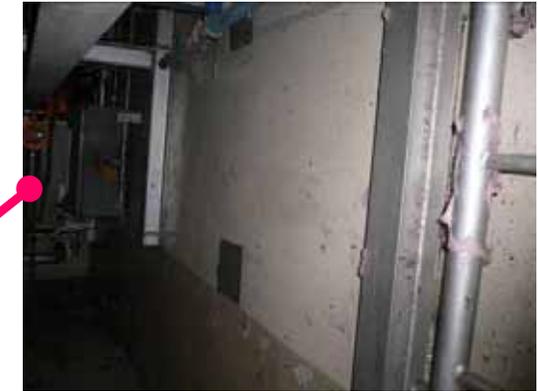
Spent fuel pool wall  
(No damage found)

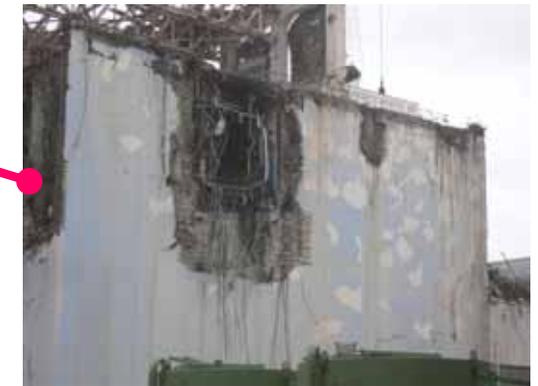
Exterior wall  
(Completely destroyed)

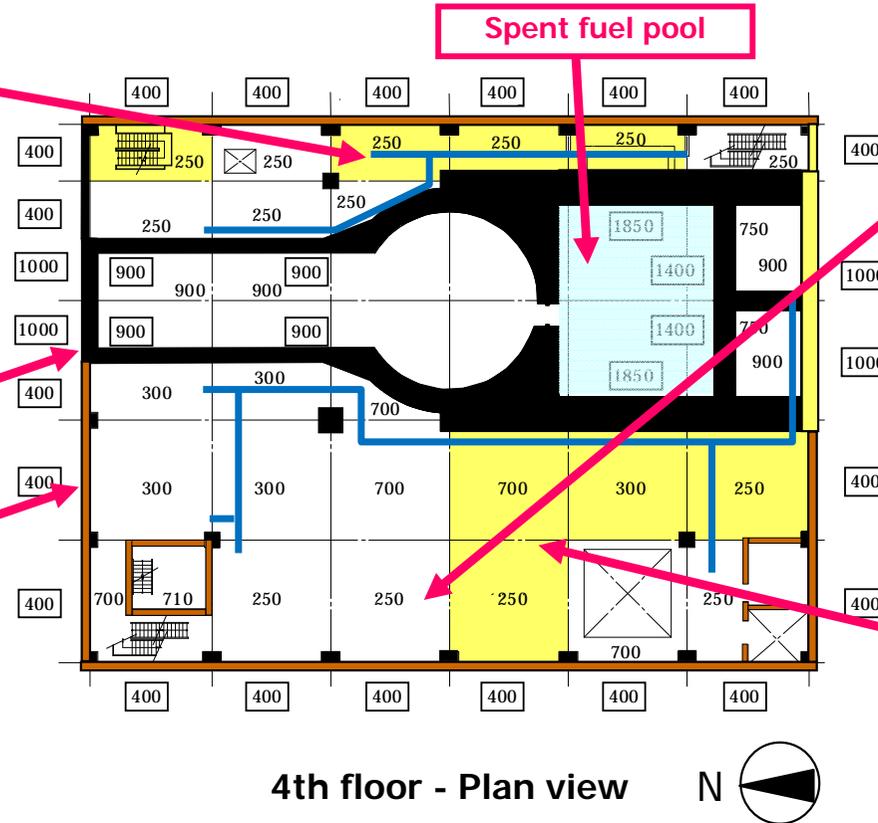
Floor damage was found in the area near the duct route  
 Floor thicker than 25cm: Less damaged  
 Floor thinner than 25cm: More damaged

Walls thicker than 40cm: Less damaged

Walls thinner than 40cm: More damaged

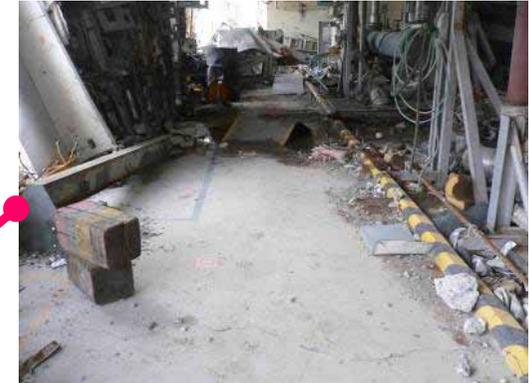
Floor  
(No damage found)

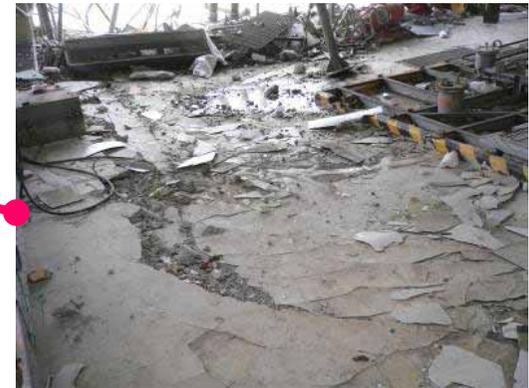
Floor  
(Partially damaged)

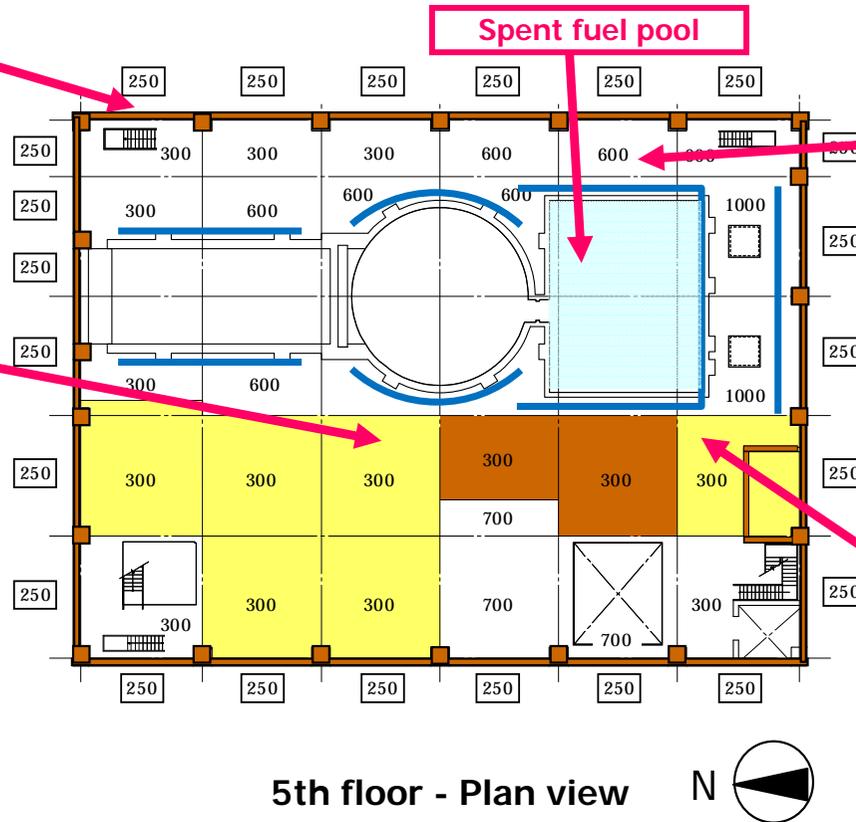
The walls on the 5th floor and above were removed since they would interfere with the cover to be installed for fuel removal.

Floor thicker than 30 cm: No damage  
 Floor thinner than 30cm: More damaged

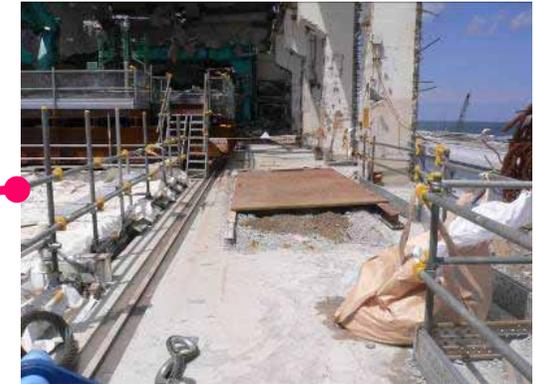
Floor  
(No damage found)

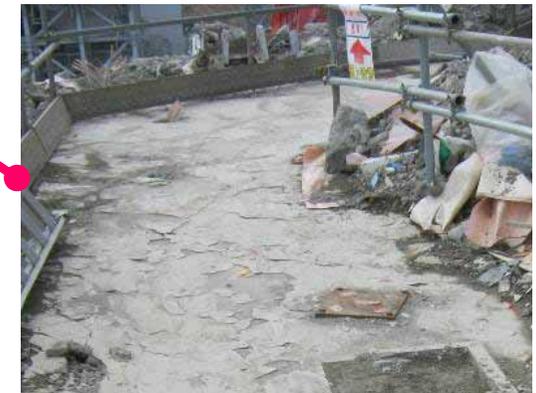
Floor  
(Partially damaged)

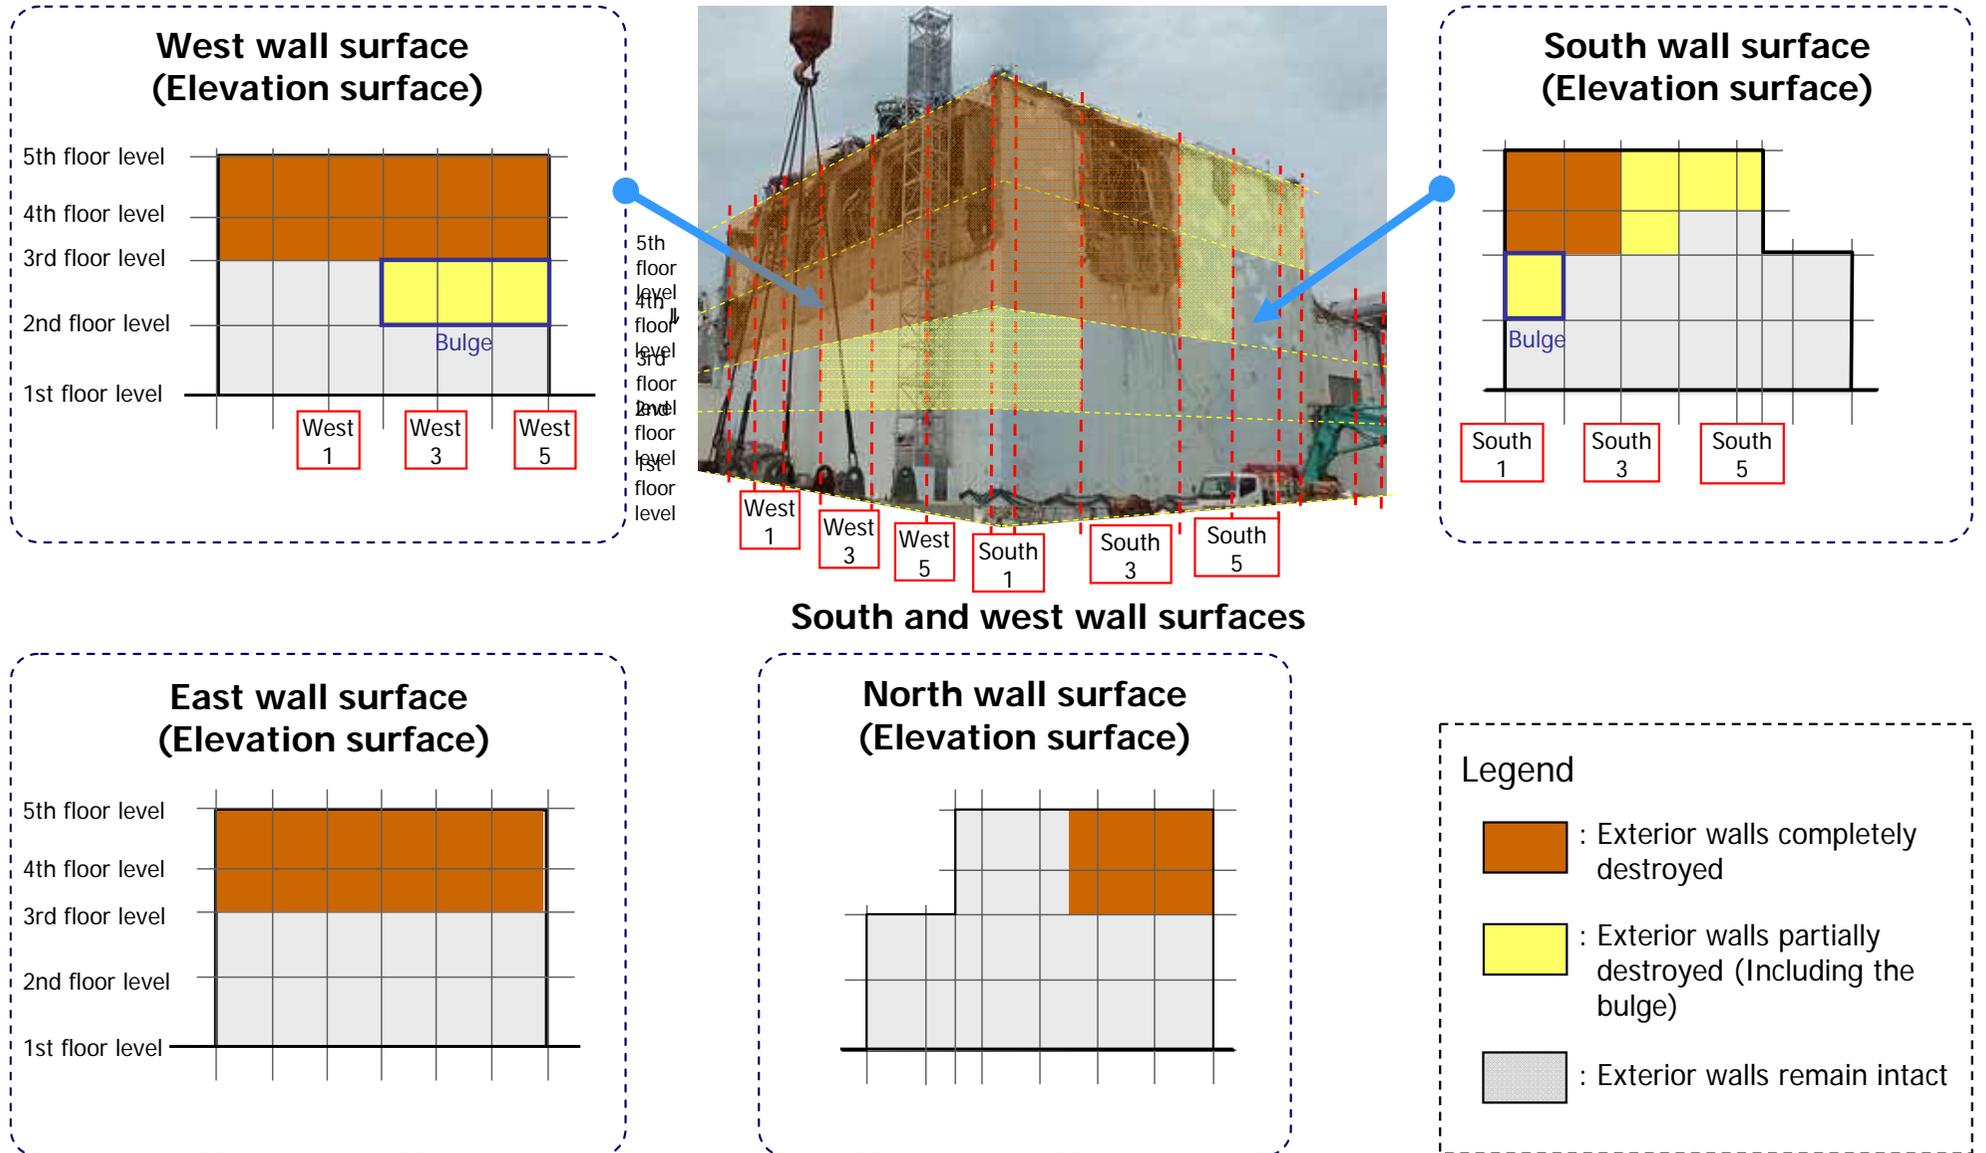
- The walls on the 3rd floor and above were entirely damaged by the hydrogen explosion, except for a part of the northeast surface.

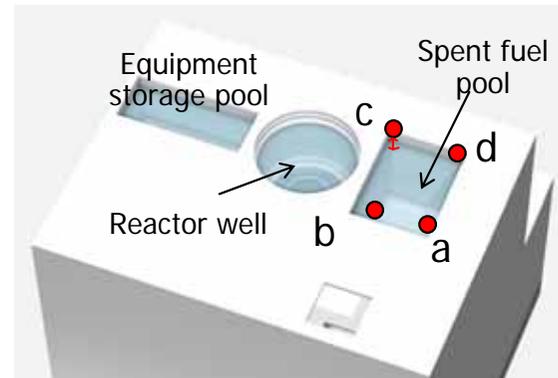
Measurement points (Floor surface of the 5th floor)

Since the water levels measured at the four corners of the pool were about the same as those measured before, it has been judged that the 5th floor surface, the spent fuel pool water surface and the reactor well water surface are parallel and therefore the building is not tilted.

Spent fuel pool	August 21, 2012 (Latest measurement)
a	453
b	453
c	452
d	452

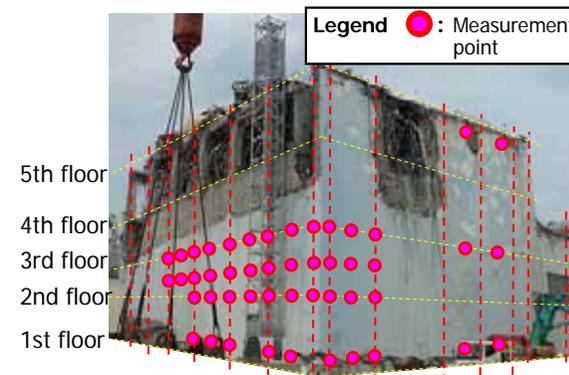
Measurement points

The horizontal difference\*2 measured this time was about the same as those measured in the first regular inspection (May 2012) and the detailed exterior wall inspection (June 2012), and the deformation found at each measurement point has a similar tendency. For the south and west exterior walls of the 2nd floor where partial bulge was found, the analysis was done without taking into considerations the wall rigidity. The results indicate no problem with the seismic safety of the reactor building.\*3

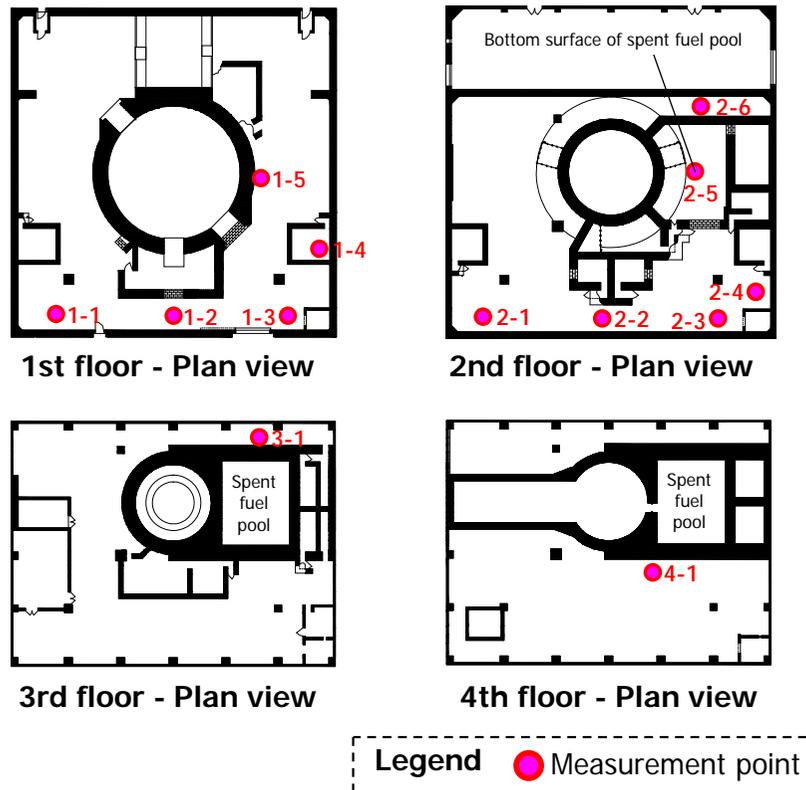
## Concrete strength measurement results

As the concrete strengths at all the measurement points were higher than the design basis strength (22.1 N/mm<sup>2</sup>) similarly to the previous inspection, it can be concluded that the building has a sufficient structural strength.
