Decrease in the Reactor Injection Water Amounts at Unit 1-3 of Fukushima Daiichi Nuclear Power Station

September 3, 2012

Tokyo Electric Power Company

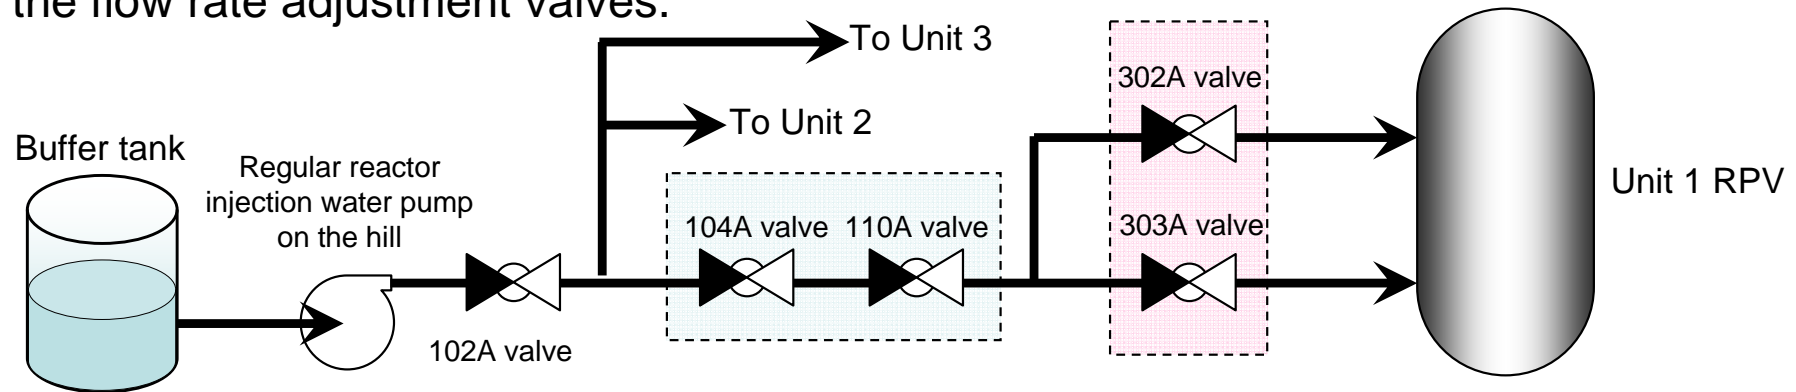
As flow rate decrease may be due to the flow rate adjustment valves not fully opened and the flow channel obstructed by substance stuck in the valves, flushing was done while opening and closing the flow rate adjustment valves.

Considering that the pressure on the upstream side of the flow rate adjustment valves (header pressure) decreased and the flow rate recovered right after the flushing, it was assumed that substance attached or stuck on the flow rate adjustment valves operating with low amount of opening may be causing the flow rate to decrease. However, the flow rate decreased as the header pressure increased a few hours later, and flow rate adjustment was done (After the flushing, adjustment was done twice on August 31, five times on September 1 and once on September 2).

Flushing through the flow rate adjustment valves at the exit of the regular reactor injection water pump on the hill (110A-C): While maintaining the total flow rate consistent, flushing was done by changing the opening amount of 110 valve (closing 104 valve and opening 110 valve).

Flushing through the flow rate adjustment valves of the feed water system line and reactor core spray system line (302A-C, 303 A-C): While maintaining the total flow rate consistent, flushing was done by temporarily increasing the flow rate of either one of the two lines (opening 302 valve and closing 303 valve (or the other way around)).

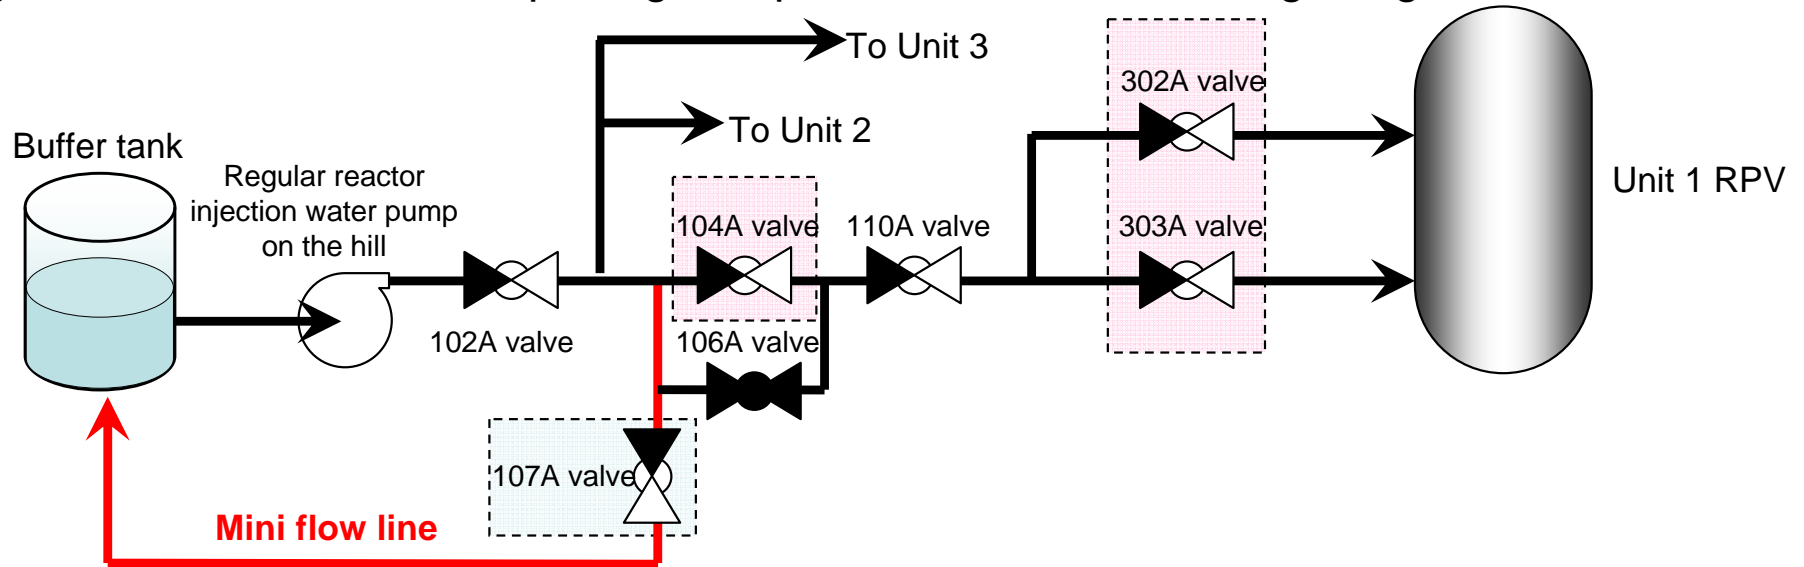
As the flow rate decreased again after the flushing, the minimum flow rate circulation line (mini flow line) was put in service to increase the amount of opening of the flow rate adjustment valves operating with a small amount of opening and prevent substance from getting stuck in them.

Opening the mini flow line valve (107A) (Putting the mini flow line in service): By opening 107A valve, a part of the water to be injected into the reactor is returned from the regular reactor injection water pump exit to the buffer tank through the mini flow line. *107B and 107C valves are not adjusted.

Increase the amount of opening of the feed water system/reactor core spray system flow rate adjustment valves (302A-C, 303A-C): The reactor injection water amounts for each unit were adjusted by increasing the amount of 104 valve opening (by opening 301 and 303 valves).
