Water Leakage from the Desalination System (Reverse Osmosis Membrane) 3

Location: In the temporary warehouse of the desalination system (Reverse osmosis membrane) 3

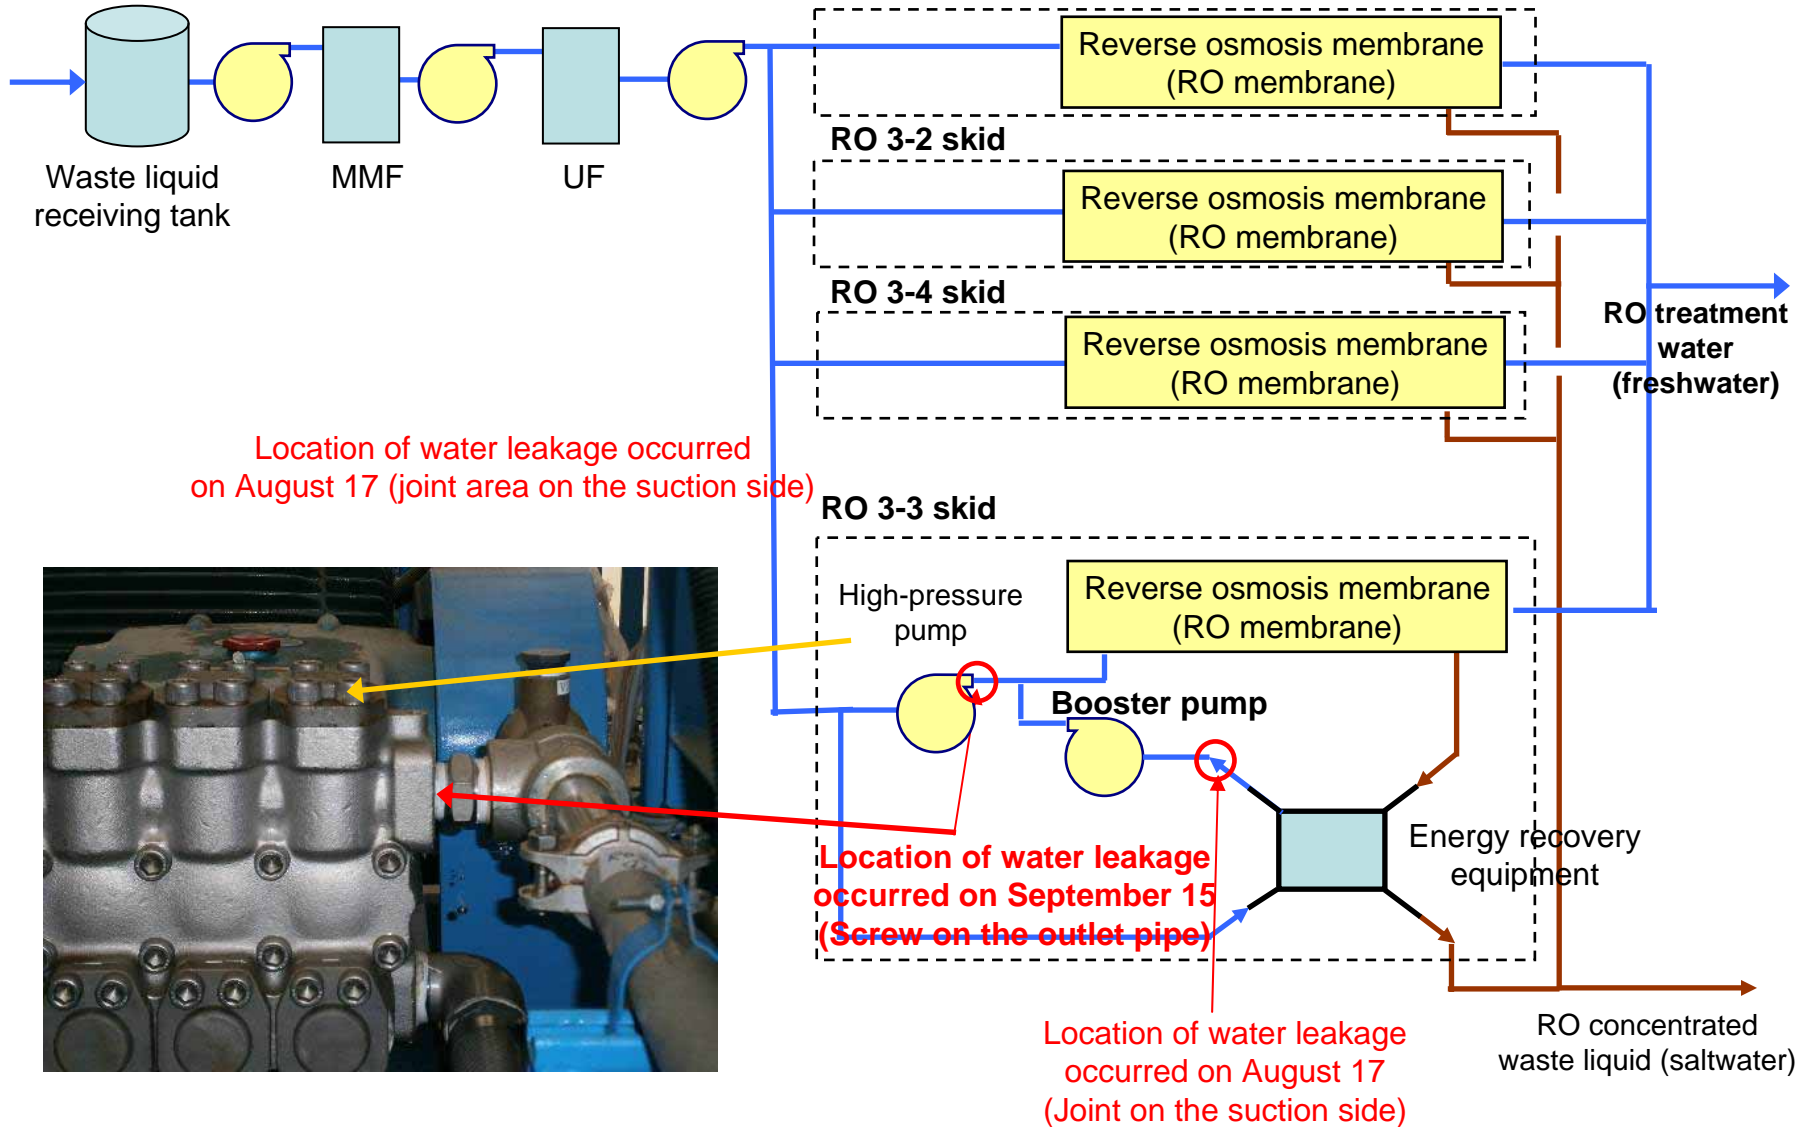
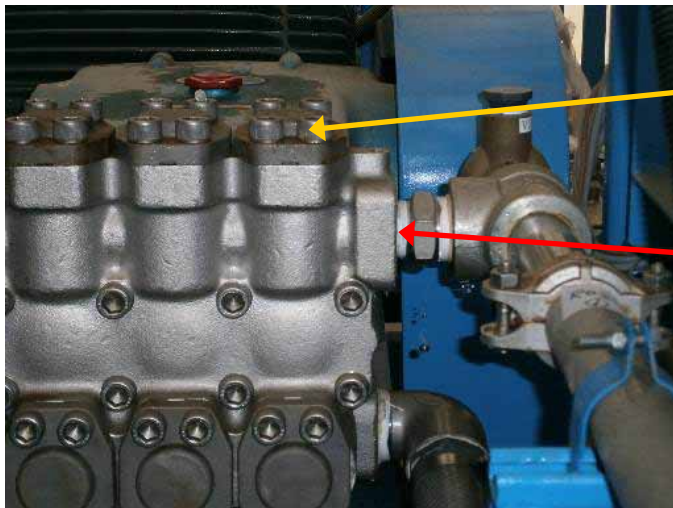
Water Leakage Area in the Desalination System (Reverse Osmosis Membrane) 3

Leakage area: Screw on the outlet side of the high pressure pump of Skid 3 of the desalination system (reverse osmosis membrane) 3

Cause: To be investigated (the system will be disassembled for inspection).

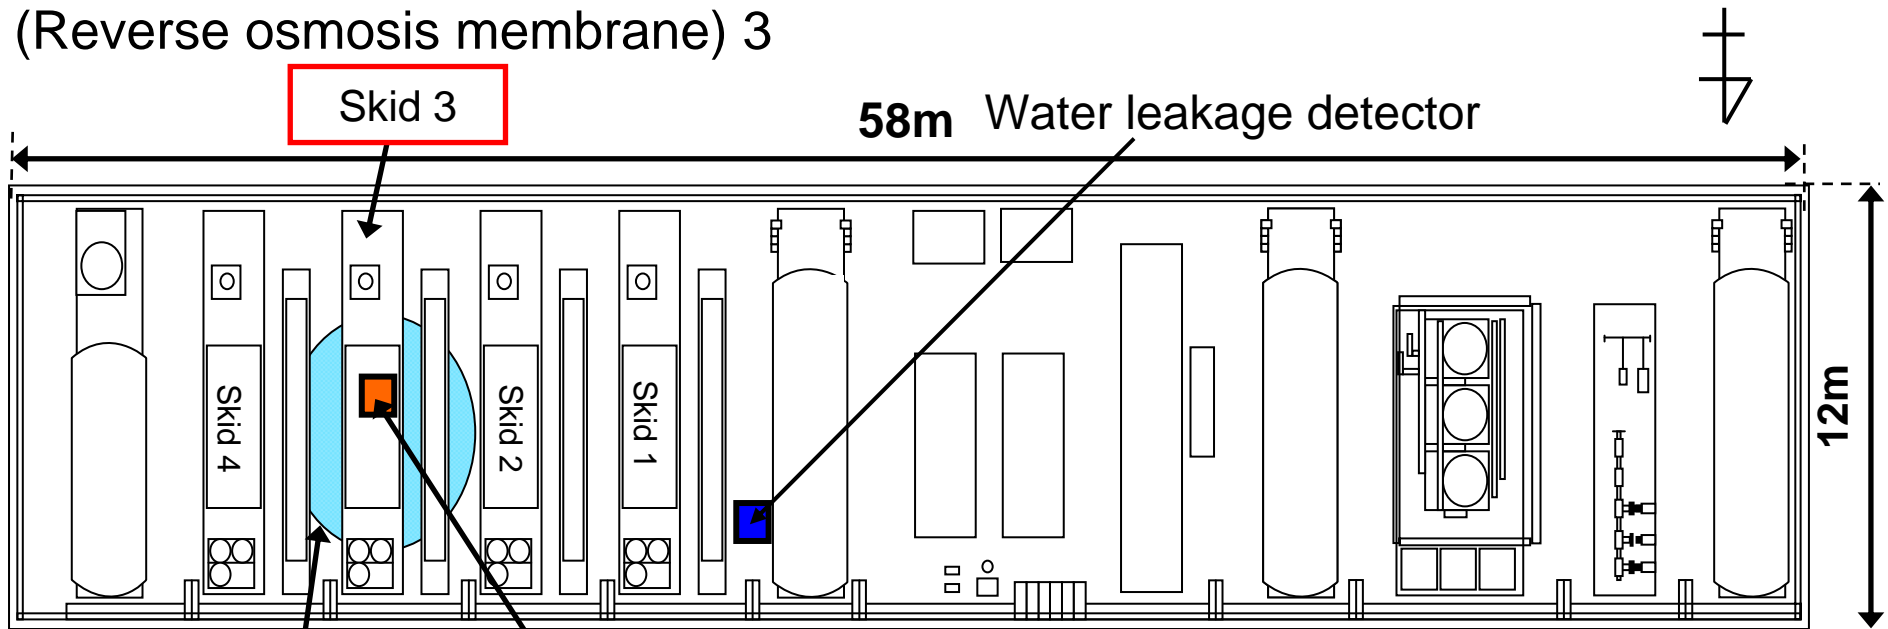
Water Leakage Location in the Desalination System (Reverse Osmosis Membrane) 3

Temporary warehouse of the desalination system
(Reverse osmosis membrane) 3

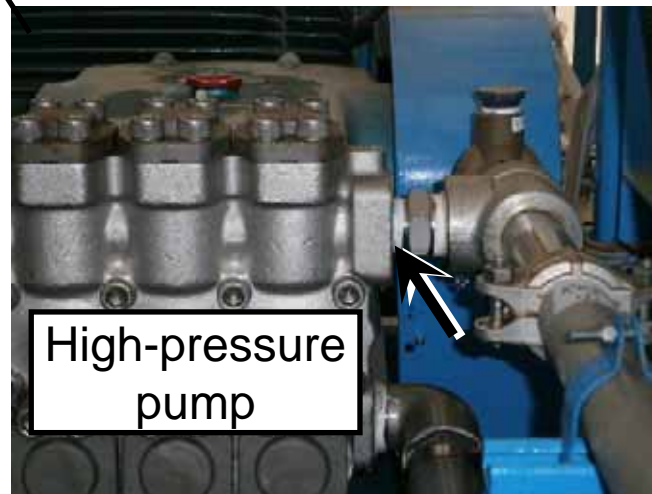
Leaked water

7m x 7m x 5mm (Depth)

(Estimated leakage amount: Approx. 0.25m³)
