Results of Reinvestigation of Unit 1 Operation Floor at Fukushima Daiichi Nuclear Power Station

Provide useful inputs on spent fuel removal by understanding the current condition of the operation floor on the fifth floor of Unit 1 Reactor Building.

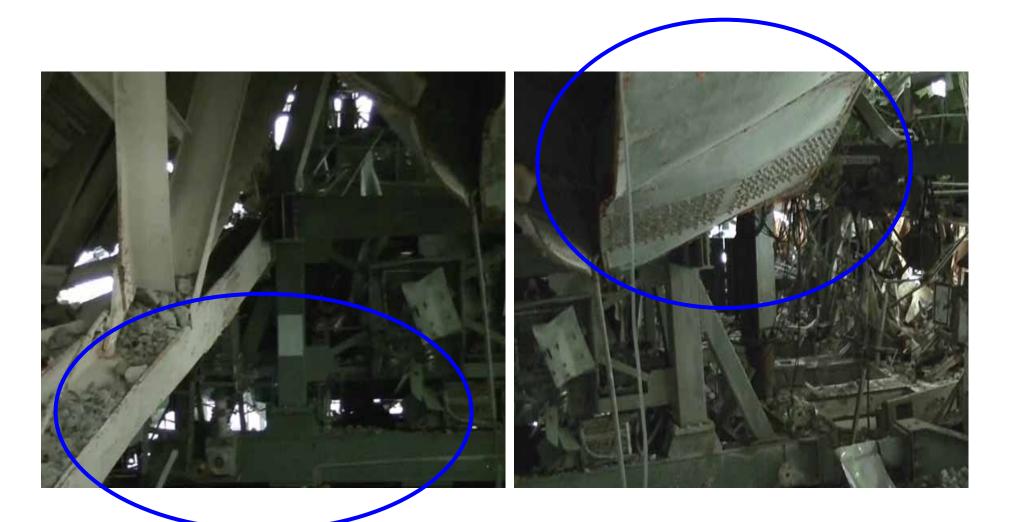
Investigation results (Reactor Building 5th floor-2)

Spent fuel pool water surface

Part of the overhead traveling crane
