# Investigation Results of Smoke Coming out from Electric Motors in the Cesium Absorption Tower Temporary Storage Facility at Fukushima Daiichi Nuclear Power Station

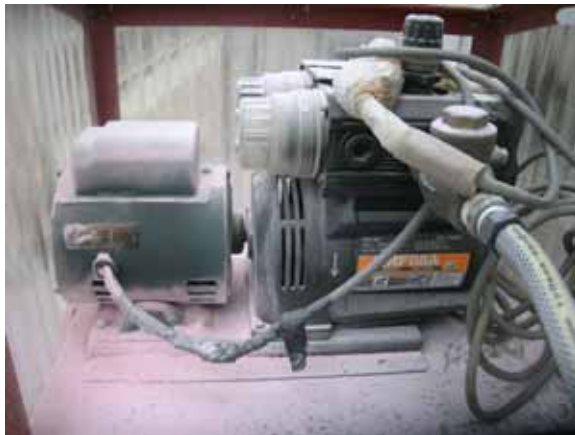
Discoloration (assumed to be due to heat) was found on the outer panel of the electric motor. Black soot was found on the corrugated panel on the left surface of the housing near the edge of the electric motor.

Appearance after the smoke stopped coming out (August 14)

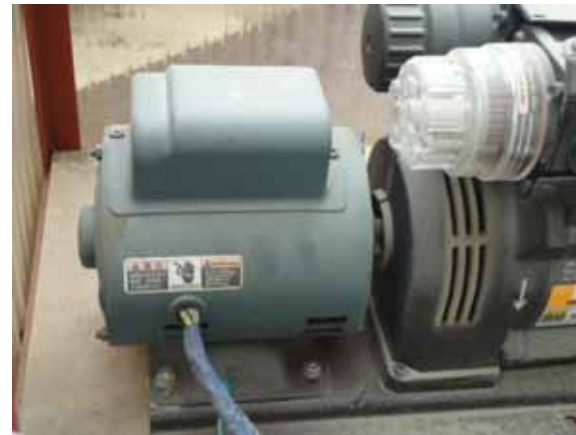
No deterioration by heat was found.

Appearance after the smoke stopped coming out (October 2)

The insulation resistance was 0.001M in some area (Though an insulation breakdown was about to occur in the coil in this area, only a small amount of smoke came out and the smoke stopped coming out right after the pump was turned off since it was not a short circuit)

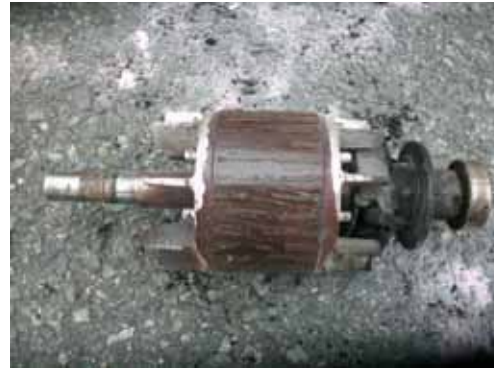
- The coil inside the electric motor was damaged by heat and the insulator was carbonized and powdery.
- The stator was burnt and stuck to the inside of the motor.
- The axes of the pump and the motor were able to be twisted by hand, no problem was found with the sliding portion such as the bearing.
- The cumulative operation hours of the motor was approx. 9,700 hours.

Inside the electric motor of  
G pump (rotor)

In both cases, the dust and salt accumulated inside the electric motor seem to have caused a micro discharge in some area of the stator coil, an insulation degradation of the enamel wire and a short circuit between the coils in the area.

- 1) In response to the incident on August 14, we started replacing the pumps which had been used for over a year. After the incident on October 2, the pump replacement was done more quickly and all the pumps have been replaced on October 3. From now on, regular pump replacement will be done after 5,000 cumulative operation hours or about six months.
- 2) When the incident occurred on August 14, the circuit breaker of the cord reel was turned on though it was off before the incident (since it was wrongly assumed that the wiring on the cord reel was wrong, not that of the motor). In order to prevent a mistake like this, the reliability of the electric wiring has been enhanced by changing its connection on October 11.

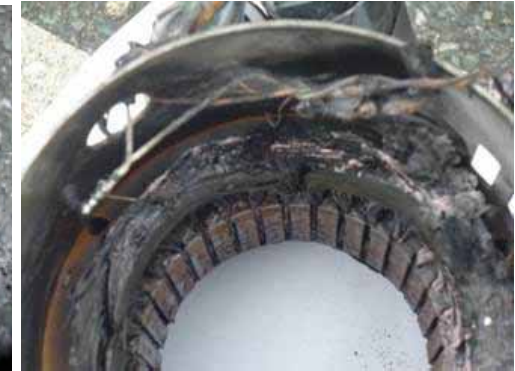
Inside the electric motor of  
G pump (stator)

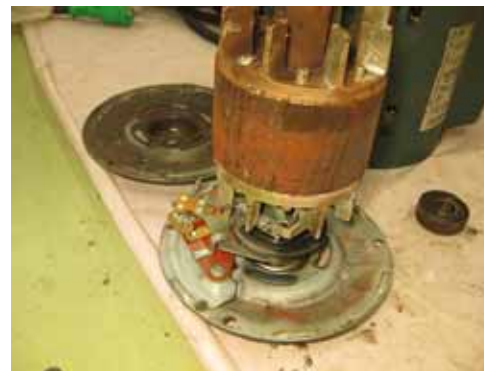
- Discoloration was found on the enamel covering on the stator coil.
- Rust was found on the inner surface of the stator and the outer surface of the rotor.
- No soot was found in the inside.
- The axes of the pump and the motor were able to be twisted by hand, no problem was found with the sliding portion such as the bearing.
- The cumulative operation hours of the motor was approx. 10,800 hours.

Inside the electric motor of  
H pump (rotor)

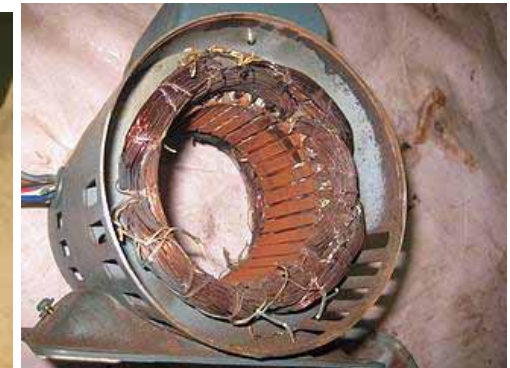
Inside the electric motor of  
H pump (stator)
