Smoke Coming out of Damaged Power Cable at Fukushima Daiichi Nuclear Power Station: Causes and Countermeasures

Day and time: November 2, 2012 at 9:25 AM

Location: Fukushima Daiichi Nuclear Power Station

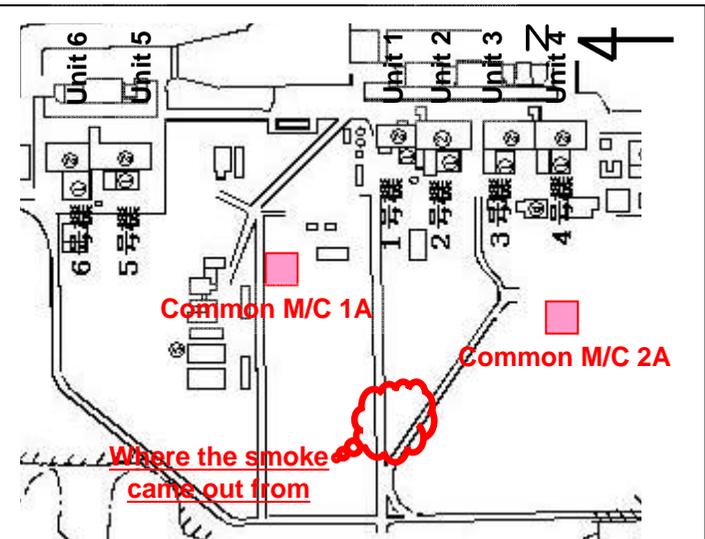
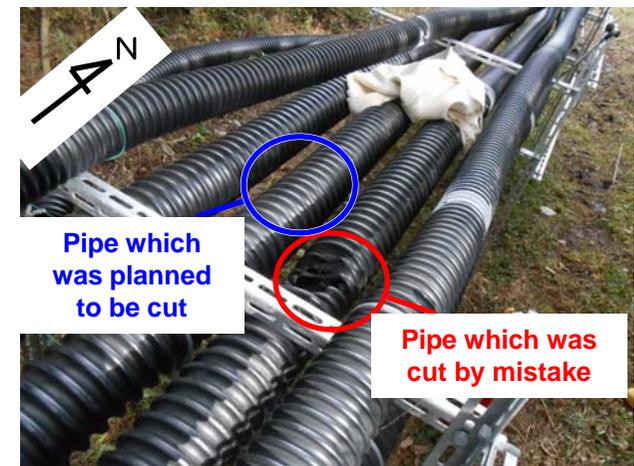
While installing cable connecting M/C 1B and 2B at Units 1-4, the Eflex pipe connecting the common M/C 1A and 2A was cut by mistake when trying to cut another Eflex pipe to prepare for high-voltage cable installation. As the cable got damaged, an earth fault occurred which resulted in smoke coming out from the location.

Photo taken on November 2, 2012 by TEPCO

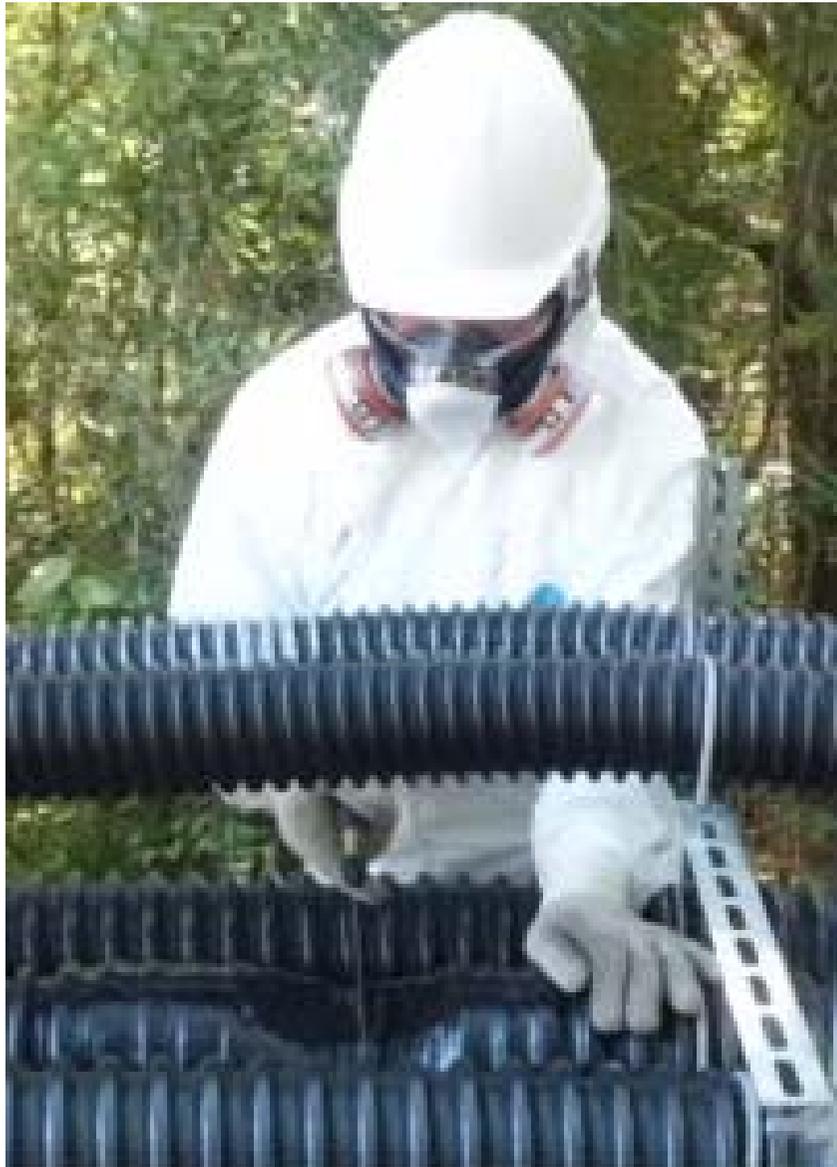
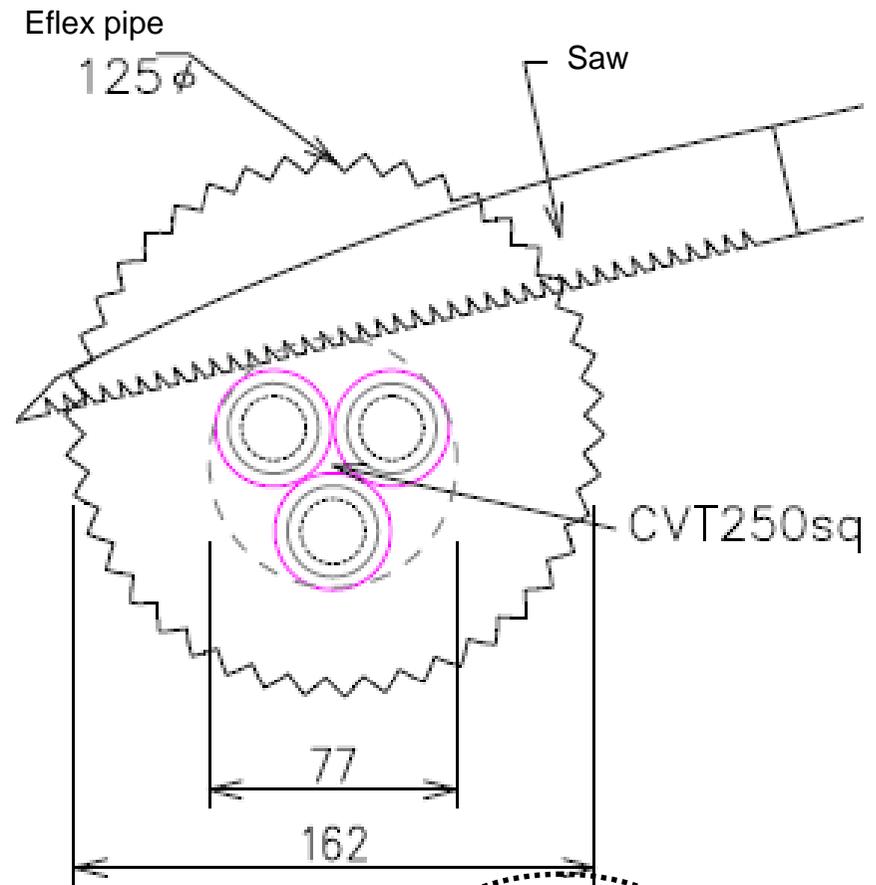
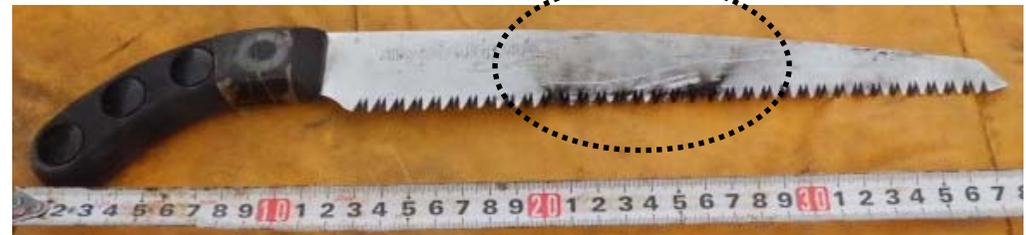
[Photo taken at the site (Cutting the Eflex pipe)]

- As the safety meeting (called "TBM-KY") was not held at the site, checking of the location to cut and safety measure implementation were insufficient.
- The lamp indicating that power goes through the cable inside the EFLEX pipe was not displayed near the place of operation.
- The EFLEX pipe was cut all at once without checking if there was cable running inside.

Photos taken on November 3, 2012 by Kandenko

Put a warning sign on the Eflex pipe in which power goes through the cable inside.

Check the inside of the pipe before cutting it all the way

Install easy-to-see signs for the cable
