# Countermeasure Implementation for the Water Leakage from the Second Cesium Absorption Apparatus (SARRY) Vent Line

< Reference >  
November 28, 2012  
Tokyo Electric Power Company

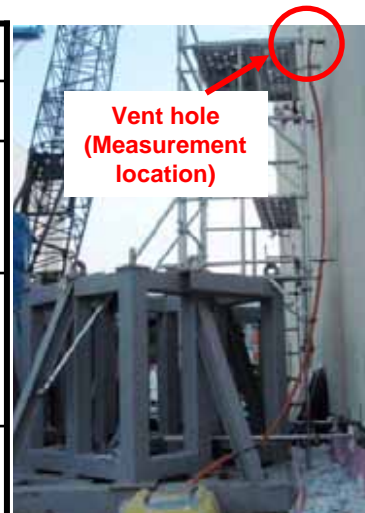
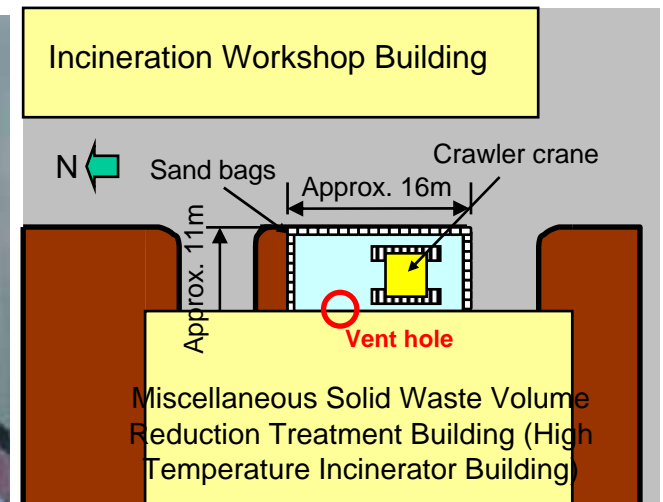
Nuclide analysis results of the radioactive materials in the air at the vent hole

The densities of the radioactive materials in the air collected at the vent hole are below the detection limits.

Thus, the amount of radioactive materials is considered to be substantially small.

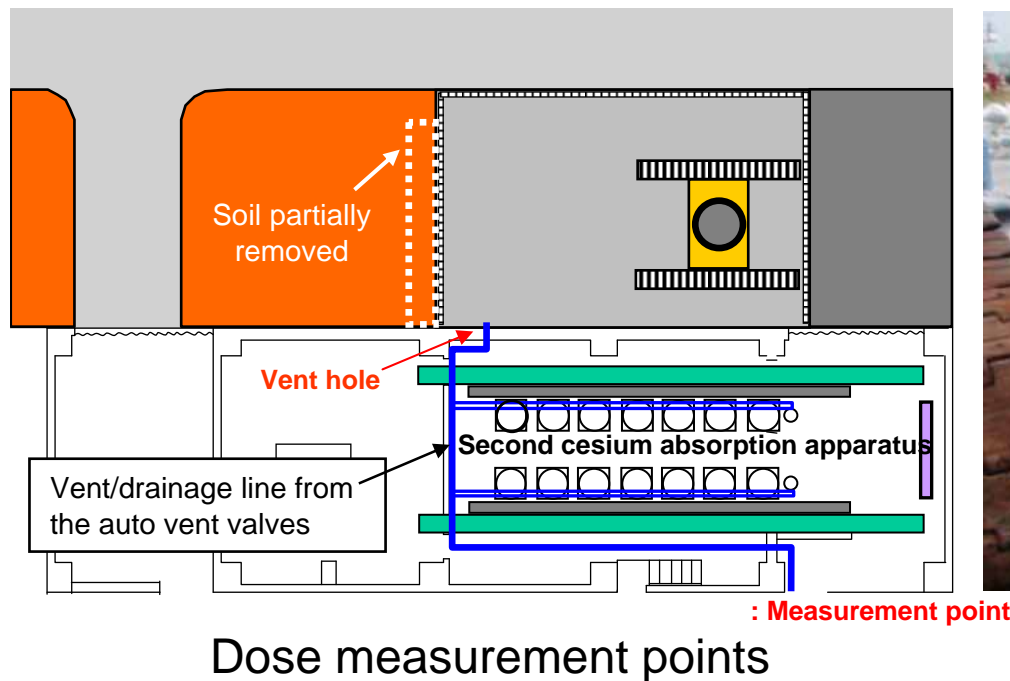
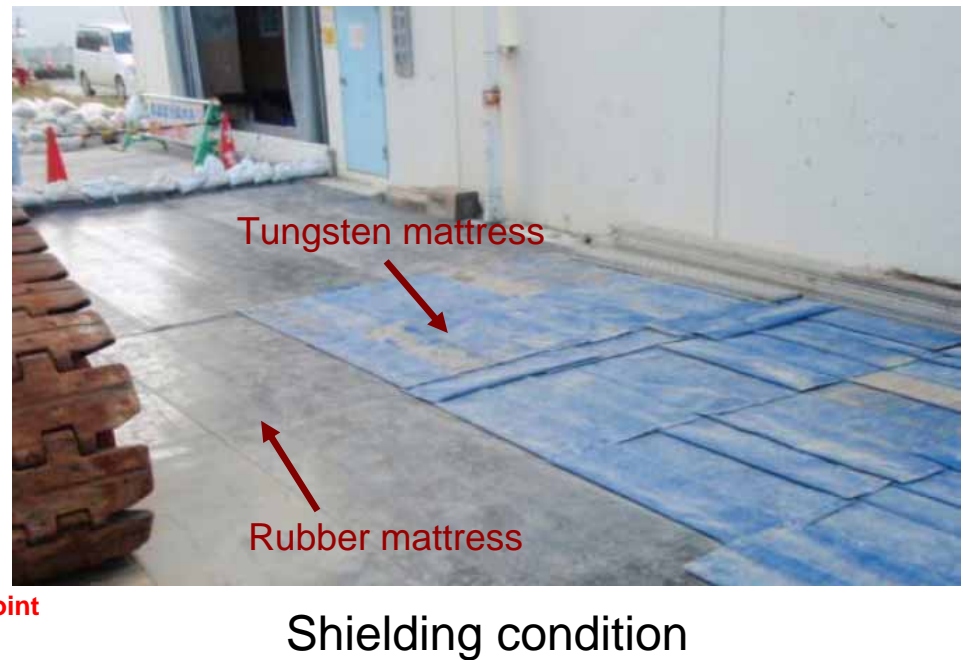
For the purpose of mitigating the radiation exposure, radiation dose measurement was done on the concrete surface and the border area (soil) and shielding has been applied in high radiation areas.

\*As the leaked water may have been absorbed into a part of the soil in the surrounding area, the soil around the concrete area has been removed before the system was restarted on November 22.

After shielding, the radiation dose in the area was reduced down to the level which ensures work safety. A part of the soil in the surrounding area where the leaked water may have been absorbed into has been removed before the system was restarted on November 22.
