## Water Leakage in Unit 3 Turbine Building at Fukushima Daiichi Nuclear Power Station

## **Outline**

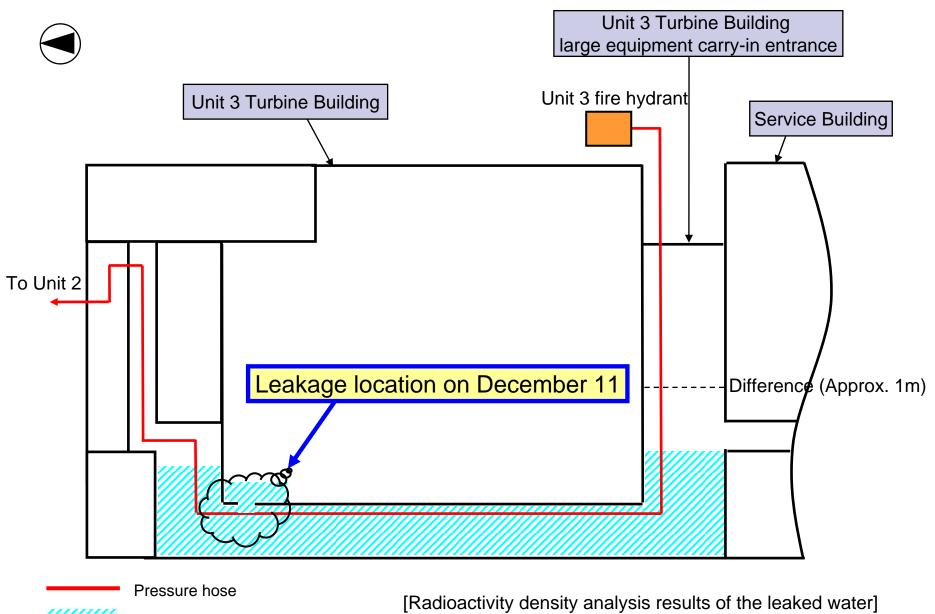
- At around 11:08 AM on December 11, 2012, a cooperative company employee found a water puddle on the aisle in the west side on the first floor of Unit 3 Turbine Building at Fukushima Daiichi Nuclear Power Station.
- Upon site investigation by a TEPCO employee, the entire aisle was found to be affected by the leakage and the amount was approx. 15m³ (Approx. 750m² x 0.02m (depth))
- The leaked water has not flowed out of the Turbine Building.
- As the leakage location is near the pressure hose used in the pressure test for (newly installed) Unit 1 polyethylene pipe, the leaked water is assumed to be filtrate water.
- The preparation for the pressure test was terminated at around 10:50 AM since filtrate water had not flowed in Unit 1 side. At 11:30 AM, the leakage was confirmed to have stopped.

Area affected by the leakage

Cs-134:  $4.2 \times 10^{1}$ Bq/cm<sup>3</sup>, Cs-137:  $7.4 \times 10^{1}$ Bq/cm<sup>3</sup>
