Water Leakage Found Near Units 5-6 Low Radioactivity Density Accumulated

Water Tank at Fukushima Daiichi Nuclear Power Station

Date and Time the leakage was found
December 25, 2012 at around 11:04 AM

Location
Units 5-6 low radioactivity density accumulated water tank area

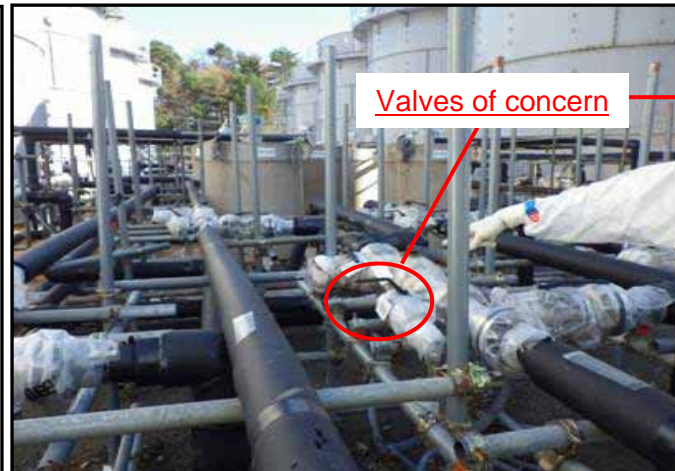
[Area surrounding the leakage location]

Outline
A TEPCO employee found water leakage from the sampling pipe outlet near Units 5-6 low radioactivity density accumulated water tank (located outside). Though the leaked water has been absorbed into the ground (gravel) and affected 1m x 1m area, it has not flowed outside since there is no drainage in the surrounding area. The amount of leaked water is estimated to be approx. 10L (max.).
