Location Map of Trenches and Pipe Lines on Seaside

Outline of Closing Pits

Roadmap of closing of vertical shafts and pits

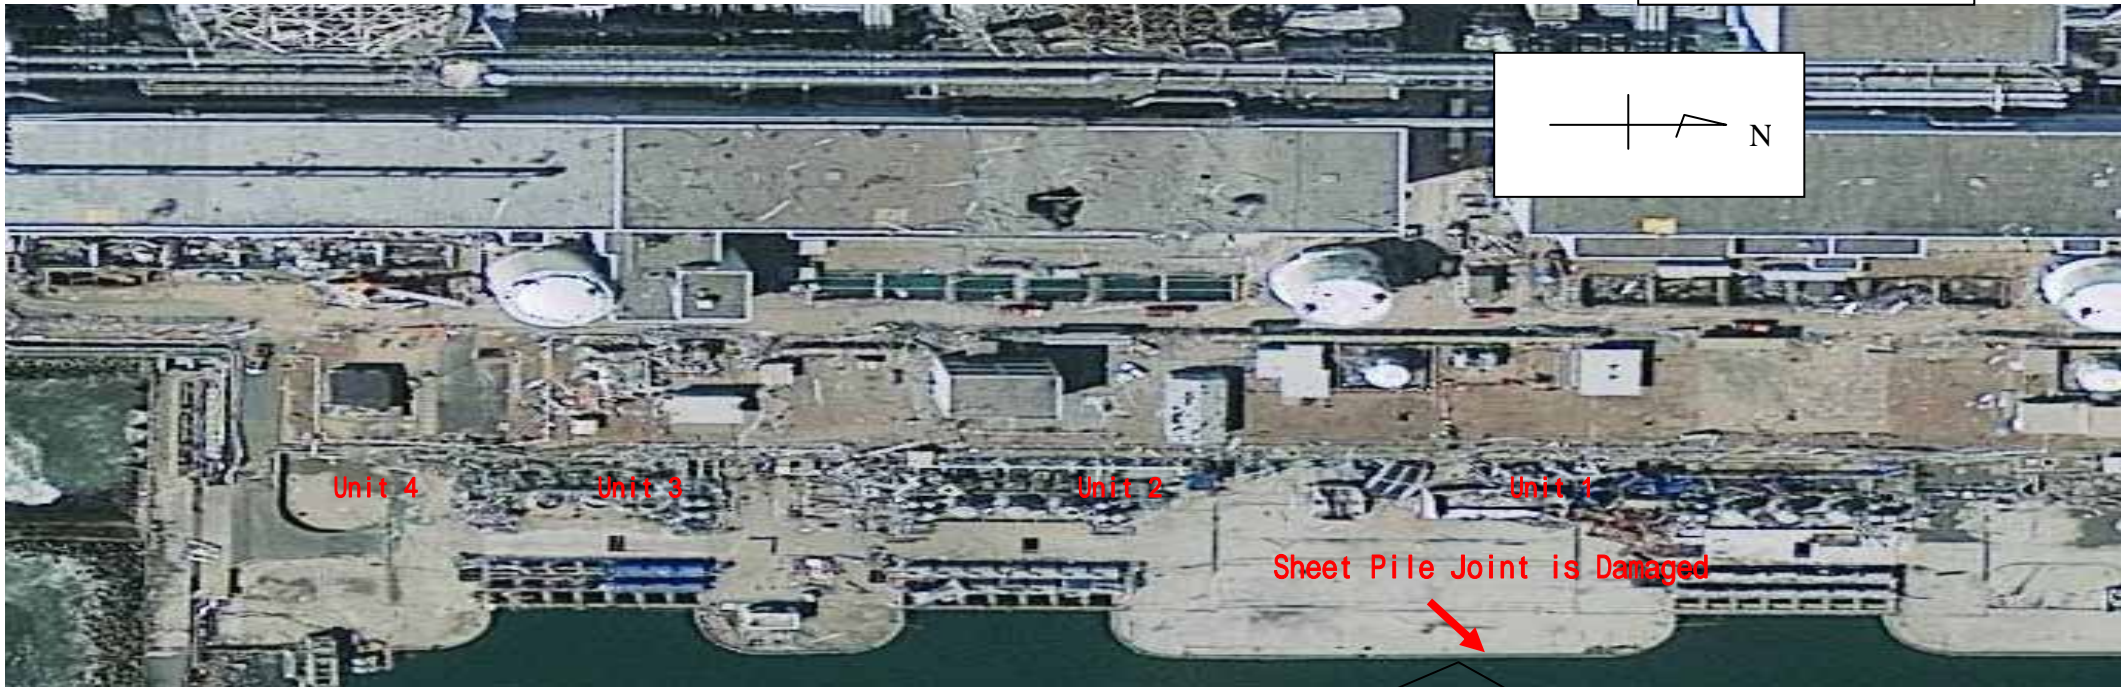
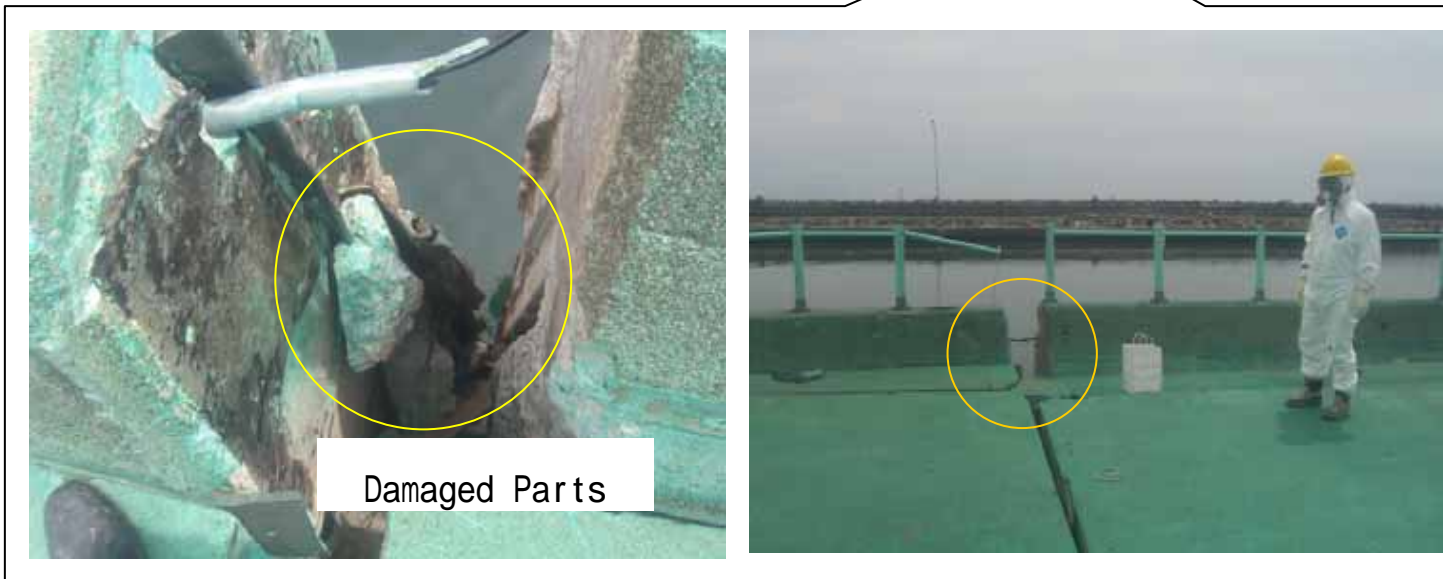
Shore protection Survey Result

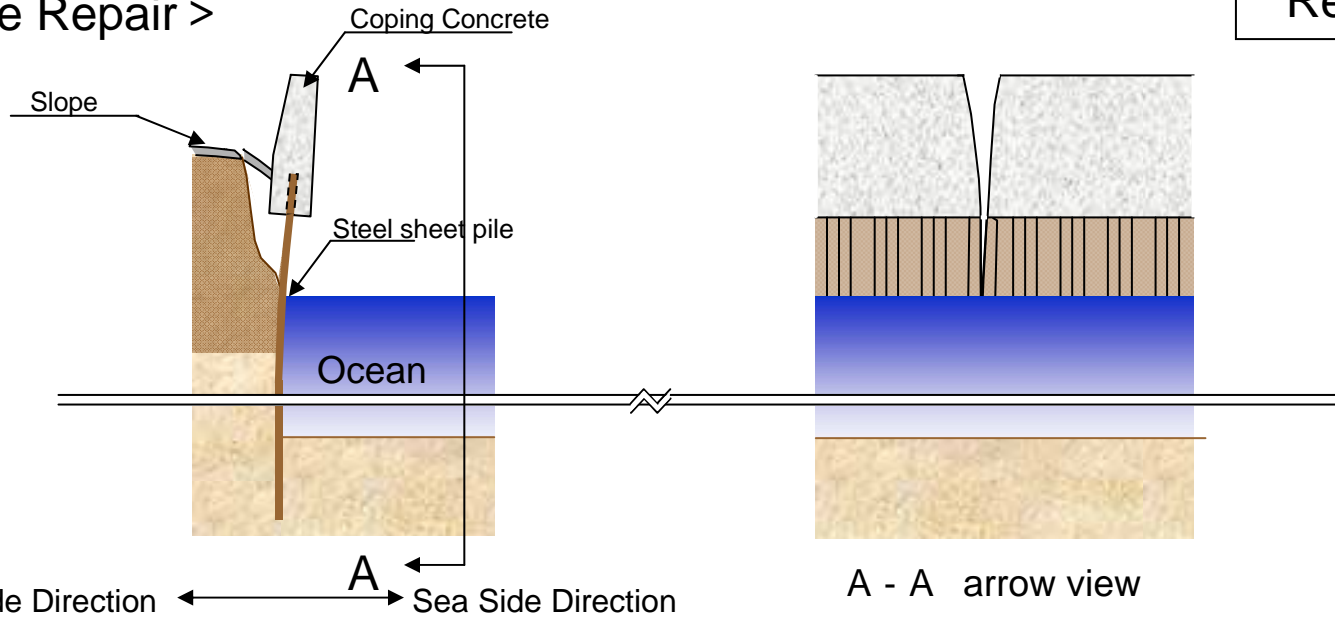
< Before Repair >

Image of repair of damaged shore protection
