# Fukushima Nuclear Accident Analysis Report

## ( Interim Report ) -Summary-

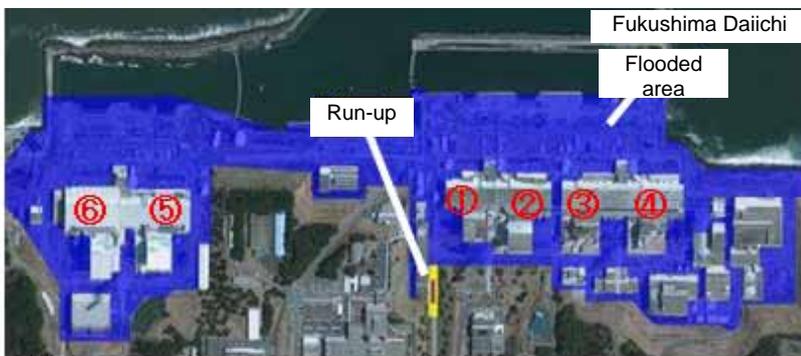
- Fukushima Daiichi Nuclear Power Station (hereinafter referred to as “Fukushima Daiichi”): The height of the tsunami was approximately 13m\*. The whole area surrounding the major buildings of Units 1 to 4 was flooded to a depth of approximately 1.5m to 5.5m. The depth of the water surrounding the major buildings of Units 5 and 6 was less than 1.5m (Detailed information is provided in the table below).
- Fukushima Daini Nuclear Power Station (hereinafter referred to as “Fukushima Daini”): The height of the tsunami was approximately 9m\*. The tsunami ran up the southeast road along the major buildings of Unit 1. The tsunami did not

Flooded area of Fukushima Daiichi

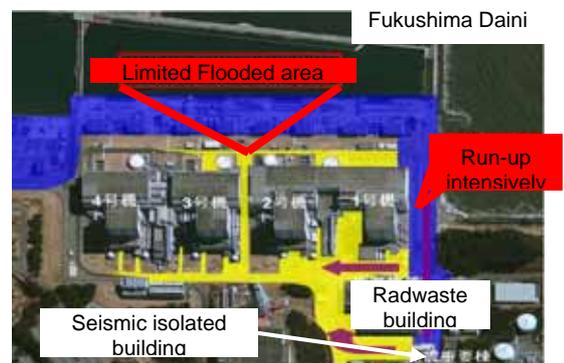
Flooded area of Fukushima Daini

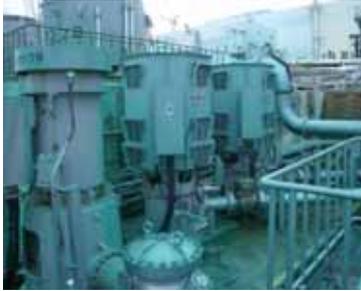
Regarding instruments on the field, many instruments have been damaged. Although the result of the visual investigation of the facilities in the field can not completely deny the impact by the earthquake, it is considered that the majority of the damage in the field was mainly caused by the tsunami.

Seawater facility in the field, Unit 1  
(Main seawater pump)

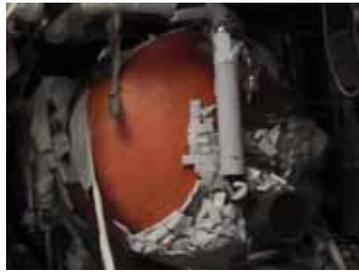
Visual investigation of the Unit 1 IC was conducted outside of the PCV that was able to be confirmed. The result found no damage to the vessels or piping, and no evidence of leaks of large volumes of high-pressure steam caused by piping ruptures was found. Regarding Unit 3 HPCI, based on interviews with operators who went to the field, it was concluded that damage such as piping ruptures did not occur.

Isolation Condenser (B), Unit 1

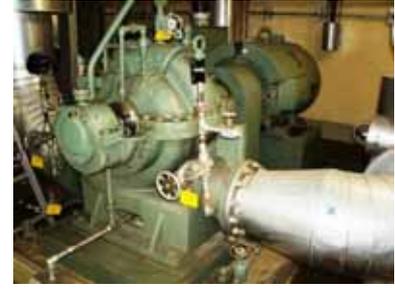
Turbine auxiliary cooling system  
pump, Unit 3

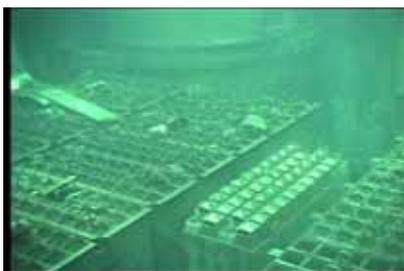
- On the morning of March 15, a loud explosive sound was heard and the upper part of the Unit 4 reactor building was found to be damaged. At first, the concern was that the SFP might have been damaged. However, an overhead visual inspection conducted by a helicopter revealed that there was still water remaining in the pool after the explosion, and that the spent fuel had not been exposed. Furthermore, a radionuclide analysis of the SFP water did not show any indication of fuel damage. Currently the water injection and cooling functions have been recovered for the SFP to date.

Inside the Unit 4 Spent Fuel Pool

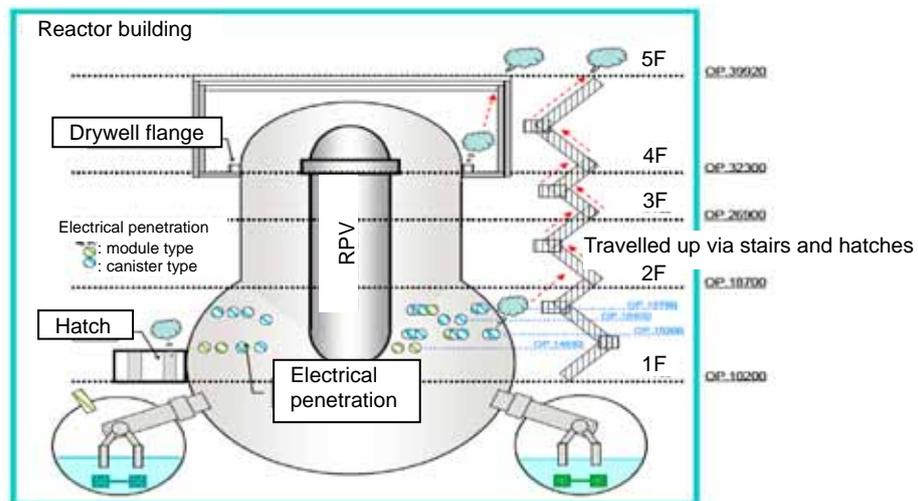
- Although the leakage path to the reactor buildings remains unknown, there is a hypothesis that the joint at the PCV head and the seals (sealed by silicone rubber) at the joints of the hatches used for the entrance/exit deteriorated due to the high temperatures.

Unit 1 and 3 Estimated leaking path of Hydrogen

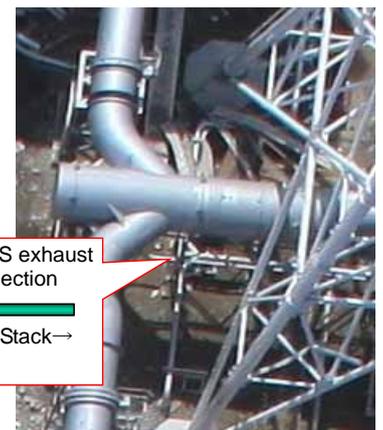
- The filter train of the standby gas treatment system (SGTS) at Unit 4 was investigated and it was found that the radioactive concentration accumulated at the outlet was higher than that at the inlet. This implies that contaminated gas flowed into the Unit 4 SGTS pipe from the outlet to the inlet.
- Another field investigation revealed that the main explosion at Unit 4 occurred near the SGTS duct on the 4th floor
- The above-mentioned findings are consistent with the hypothesis that the ventilation flow from Unit 3 travelled into the 2nd floor of Unit 4 and then into various areas of the Unit 4 reactor building via pipes and the SGTS ducts.
