Fukushima Nuclear Accidents Investigation Report

Attachment

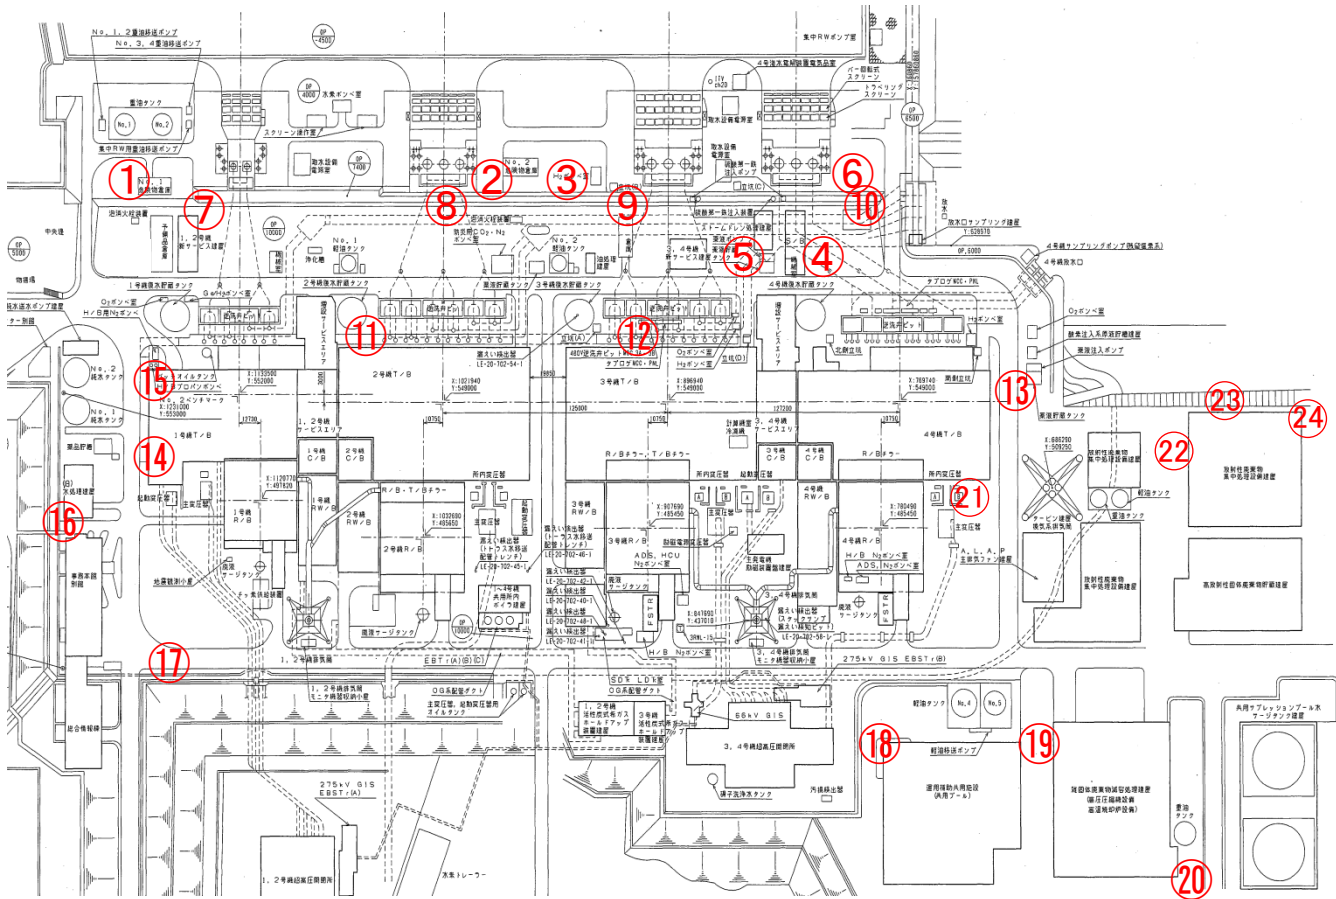
⑮ FP pipe/building interface
• No major external damage to pipes in trench

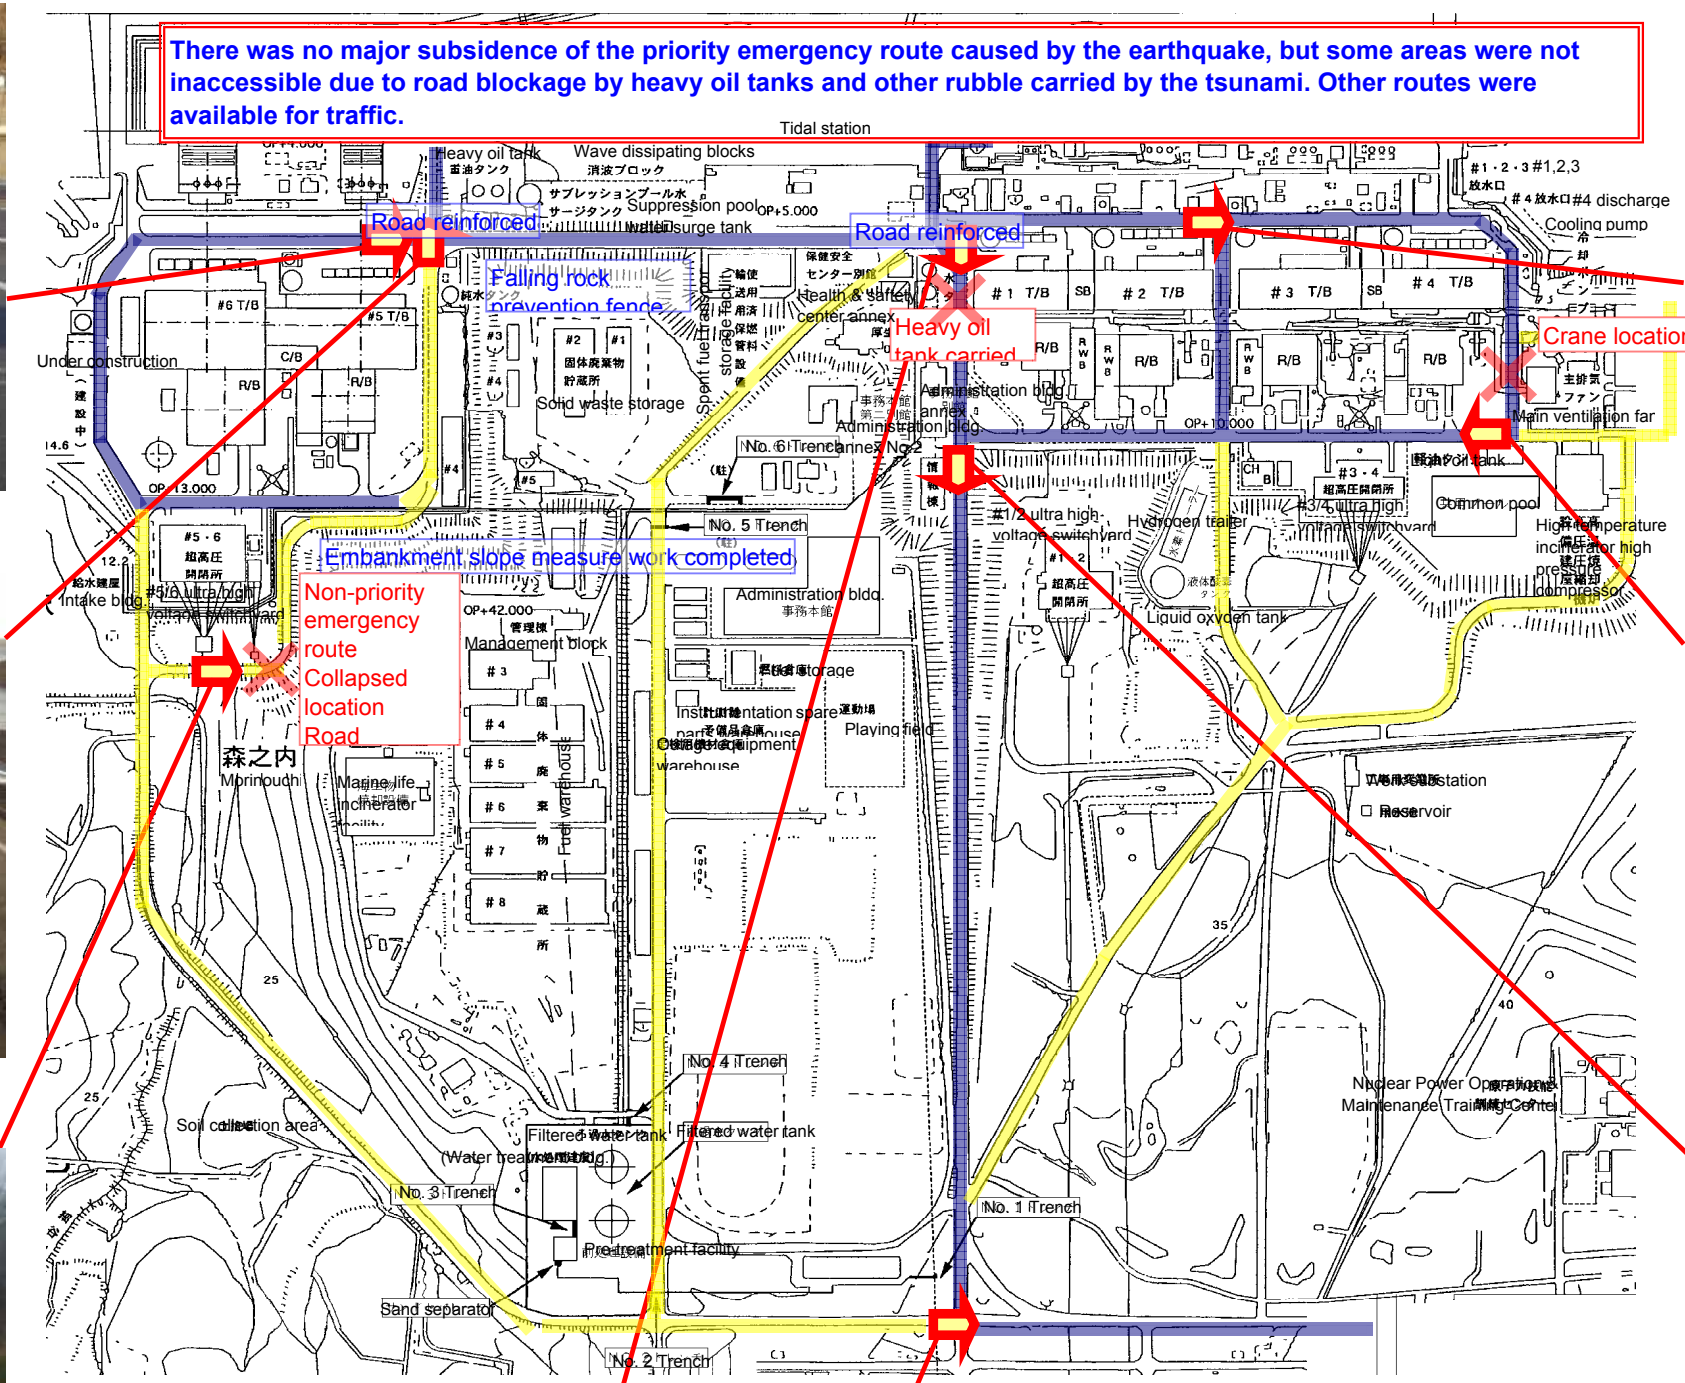
Though not a priority emergency route, the slope failed and the road was blocked and impassable. Photo taken 3/20

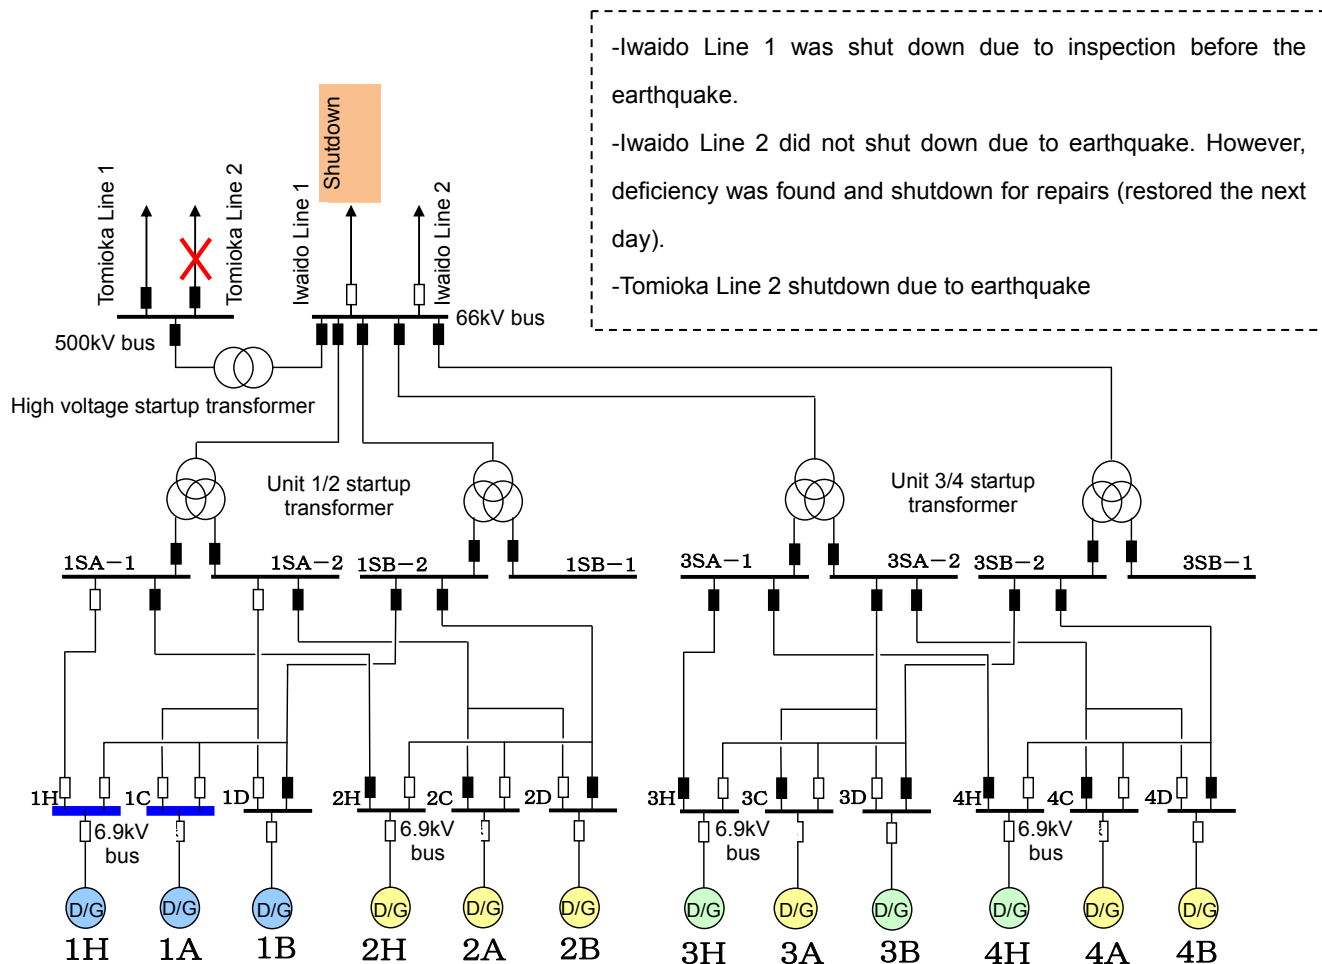
Fukushima Daini Nuclear Power Station Power System Damage Conditions Caused by Tsunami

-Iwaido Line 1 was shut down due to inspection before the earthquake.
 -Iwaido Line 2 did not shut down due to earthquake. However, deficiency was found and shutdown for repairs (restored the next day).
 -Tomioka Line 2 shutdown due to earthquake
