Permanent installation of a power panel (P/C 1D-2) in Unit 1 Seawater Heat Exchanger Building (December 27)

Carry-in and installation of the auxiliary facilities of emergency diesel generator (A system) in Unit 1 Reactor Building Annex (December 12)

Carry-in and installation of the charger and battery for the DC power supply (H system) in Unit 1 Reactor Building Annex (December 18)

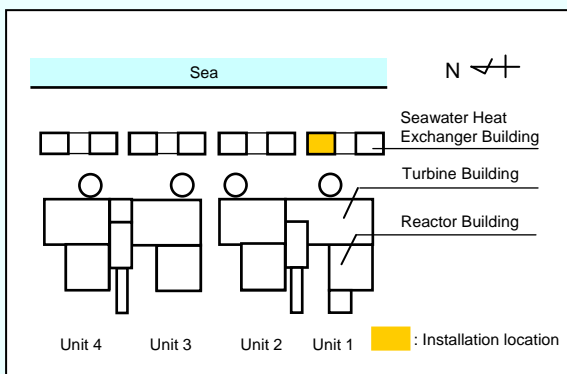
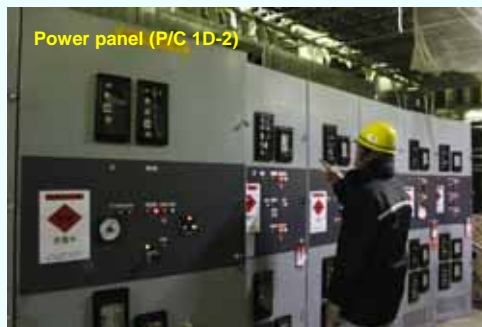
The power panel (P/C 1D-2) damaged by the Tsunami in Unit 1 Seawater Heat Exchanger Building was replaced with a newly manufactured power panel and has been permanently installed on December 27 after function check was completed.

Function check [Permanent installation completed on December 27, 2012] (Photo taken on December 27, 2012)

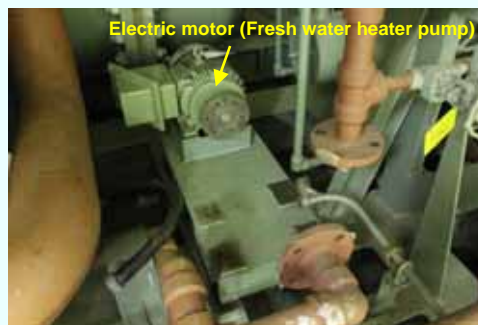
As for the emergency diesel generator (A) which was damaged by the Tsunami in Unit 1 Reactor Building Annex, the newly manufactured auxiliary facilities have been carried in and installed on December 12.

Electric motor installation (Fresh water heater pump*1) (Photo taken on December 11, 2012)

*1 Fresh water heater pump: Used for cooling the high temperature parts of the diesel engine such as the cylinder.

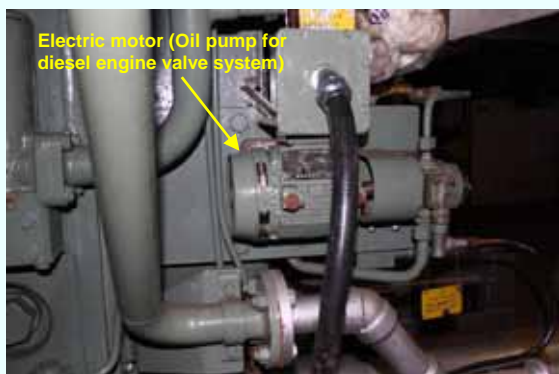
Electric motor installation (Oil pump for diesel engine valve system*2) (Photo taken on December 14, 2012)

*2 Oil pump for diesel engine valve system: Used for feeding lubricating oil to the sliding portion of the diesel engine valve system (Suction/exhaust valves and the link mechanism to open and close these valves).

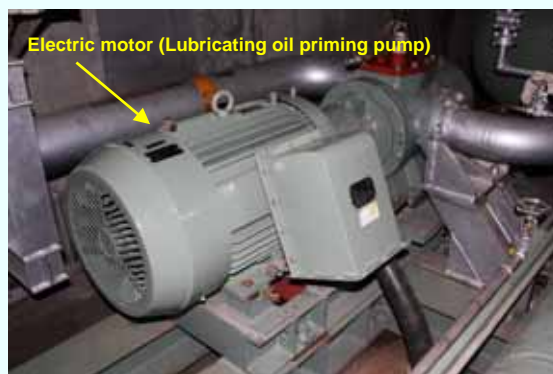
Electric motor installation (Lubricating oil priming pump*3) [Installation completed on December 12, 2012] (Photo taken on December 14, 2012)

*3 Lubricating oil priming pump: Used for feeding lubricating oil to the piston, main bearing, generator bearing, etc. while the diesel engine is suspended (in stand-by state)

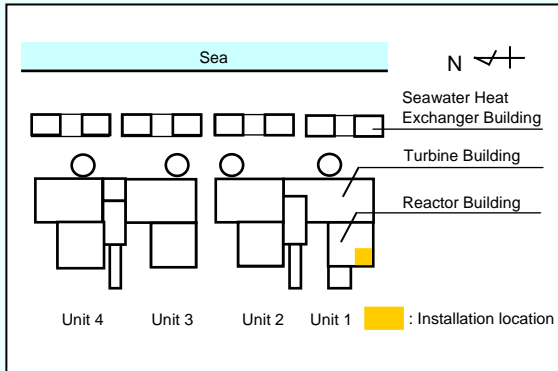
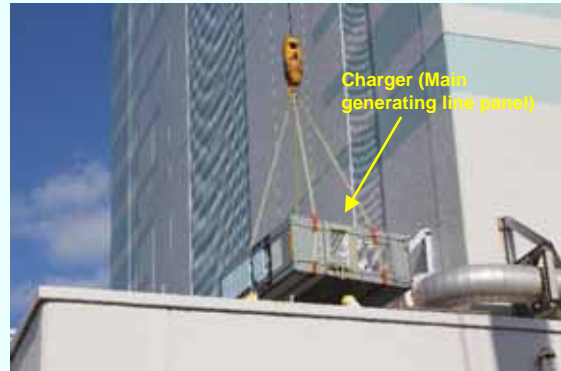
As for the charger and battery for the DC power supply (H system) which were damaged by the Tsunami in Unit 1 Reactor Building Annex, the newly manufactured charger and battery have been carried in and installed on December 18.

Charger (Main generating line panel) being carried in (Photo taken on November 21, 2012)

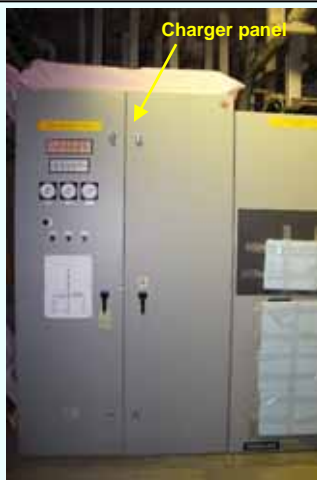
Charger panel installation
[Installation completed on December 3, 2012]
(Photo taken on December 25, 2012)

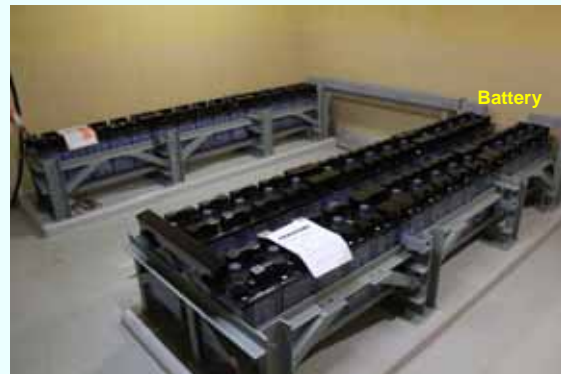
Battery installation
[Installation completed on December 18, 2012]
(Photo taken on December 25, 2012)

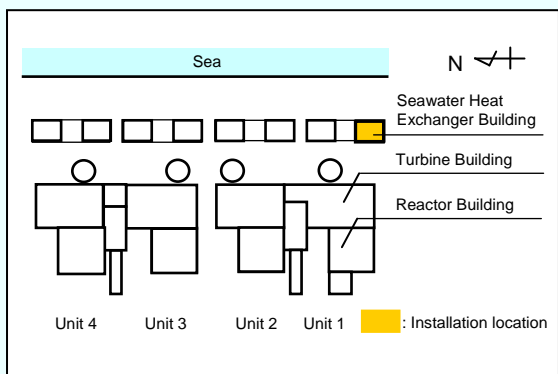
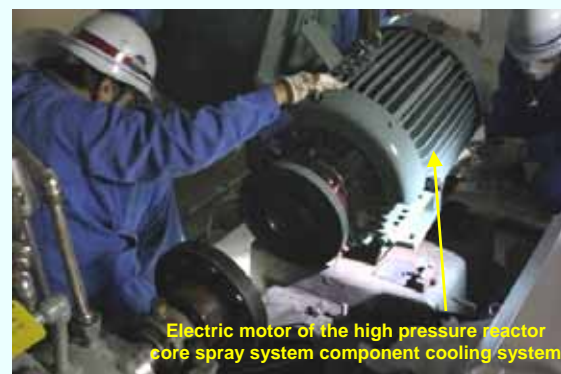
The electric motor of the high pressure reactor core spray system component cooling system which was damaged by the Tsunami in Unit 1 Seawater Heat Exchanger Building was replaced with a newly manufactured one. The new electric motor has been carried in and installed on December 13.

Electric motor installation [Completed on December 13, 2012] (Photo taken on December 13, 2012)

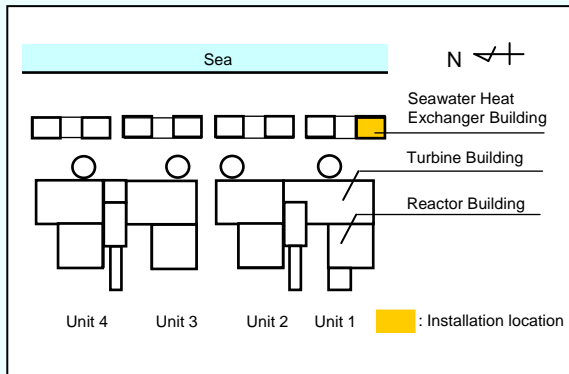
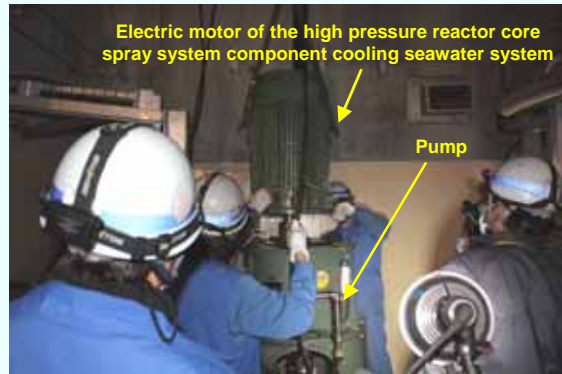
The electric motor of the high pressure reactor core spray system component cooling seawater system which was damaged by the Tsunami in Unit 1 Seawater Heat Exchanger Building was replaced with a newly manufactured one which has been installed on December 26.

Electric motor installation [Completed on December 26, 2012]
(Photo taken on December 26, 2012)

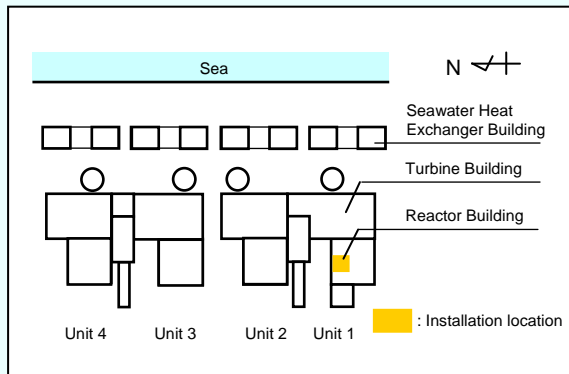
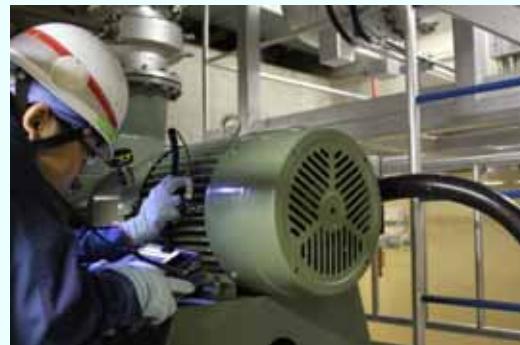
After the power panel (P/C 1C-1) in Unit 1 was permanently installed, power supply was provided to the electric motor of Unit 1 emergency gas treatment system (A system) on December 14. As the electric motor was confirmed to operate properly as a result of trial operation, Unit 1 emergency gas treatment system (A system) has been permanently installed.

Vibration measurement being performed on the electric motor of the emergency gas treatment system (A)
[Permanent installation completed on December 14, 2012]
(Photo taken on December 14, 2012)

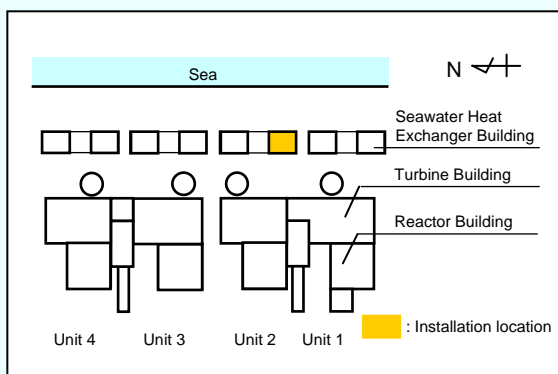
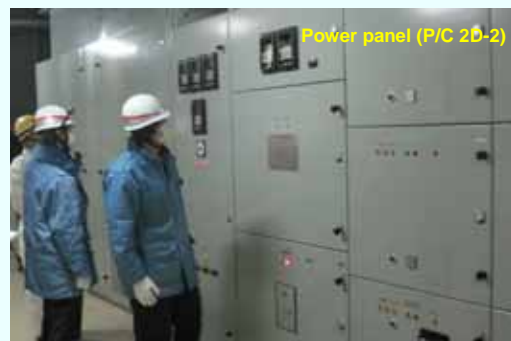
The power panel (P/C 2D-2) which was damaged by the Tsunami in Unit 2 Seawater Heat Exchanger Building was replaced with a newly manufactured power panel. After functional check was completed, the new power panel has been permanently installed on December 25.

Function check [Permanent installation completed on December 25, 2012] (Photo taken on December 25, 2012)

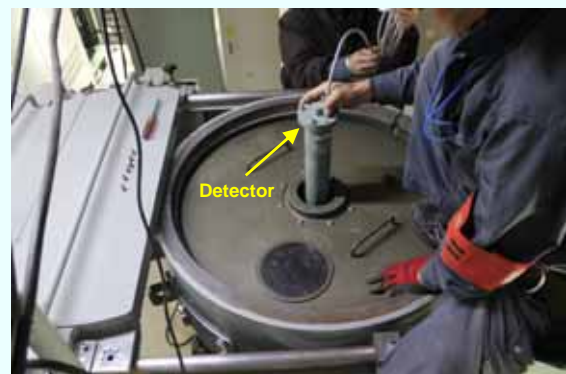
Units 1-2 discharge channel monitor which was damaged by the Tsunami was replaced with a newly manufactured one. The new discharge channel monitor has been carried in and installed on December 10. A function check is to be performed.

Units 1-2 discharge channel monitor (detector) installation (Photo taken on December 18, 2012)

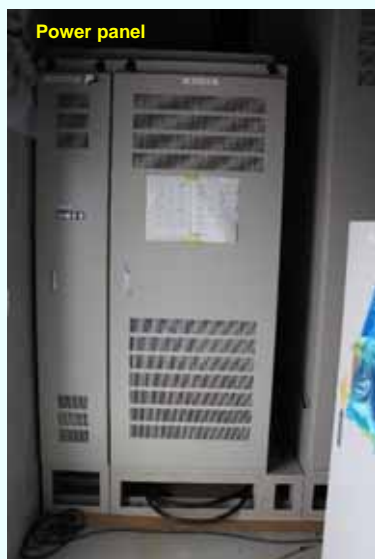
Installation of power panel of Units 1-2 discharge channel monitor (Photo taken on December 18, 2012)

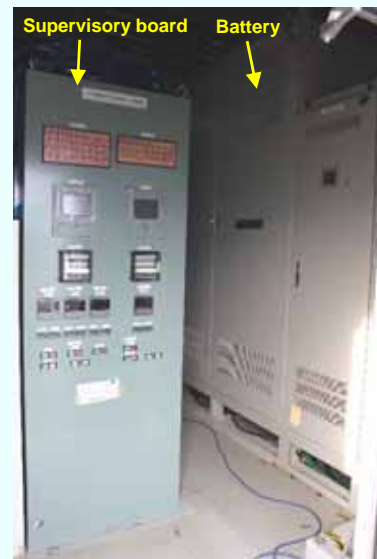
Installation of supervisory board, etc. of Units 1-2 discharge channel monitor [Installation completed on December 10, 2012] (Photo taken on December 18, 2012)
