Report on the Investigation and Study of
Unconfirmed/Unclear Matters

In the Fukushima Nuclear Accident

Progress Report No.2

Tokyo Electric Power Company, Inc.

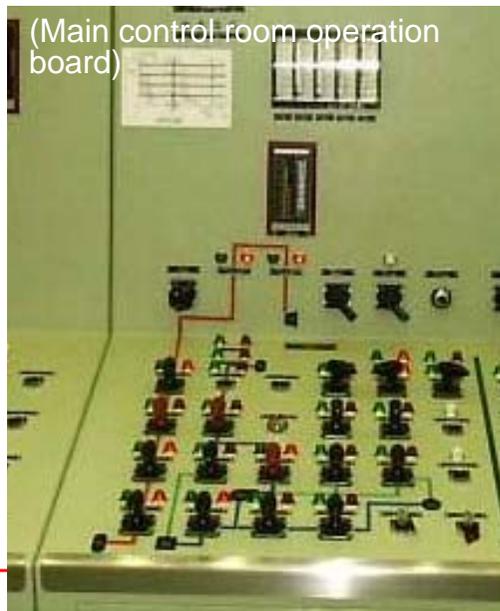
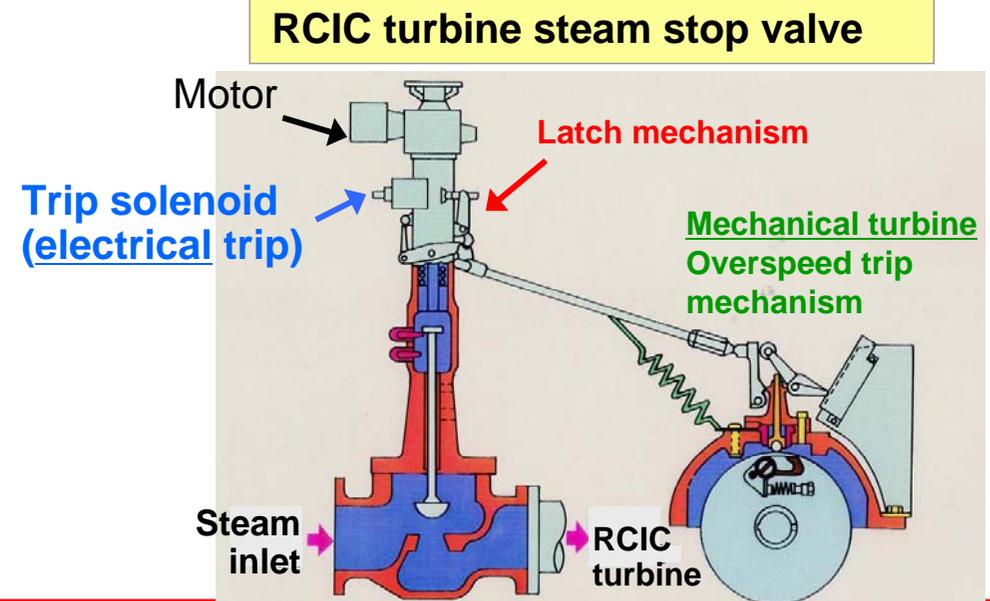
Based on the state of operations in the main control room and on conditions verified in the field, we believe that an electrical trip occurred.

- We found that the **turbine's steam stop valve**, which has a trip mechanism, **was closed**, causing shutdown.
- After shutdown, the stop valve was reset from the main control room in order to switch to standby (**the mechanical turbine overspeed trip** that would have been necessary for in-field reset operations **was not triggered**).
- As of the shutdown of 3/12, the main control room allowed RCIC valve operation and monitoring of condition indicator lamps and meters, and **the DC power source required for triggering an electrical trip had been secured**.
- Restarting after reset operations was followed by another stop valve shutdown and trip (the cause of the trip may have been the same).

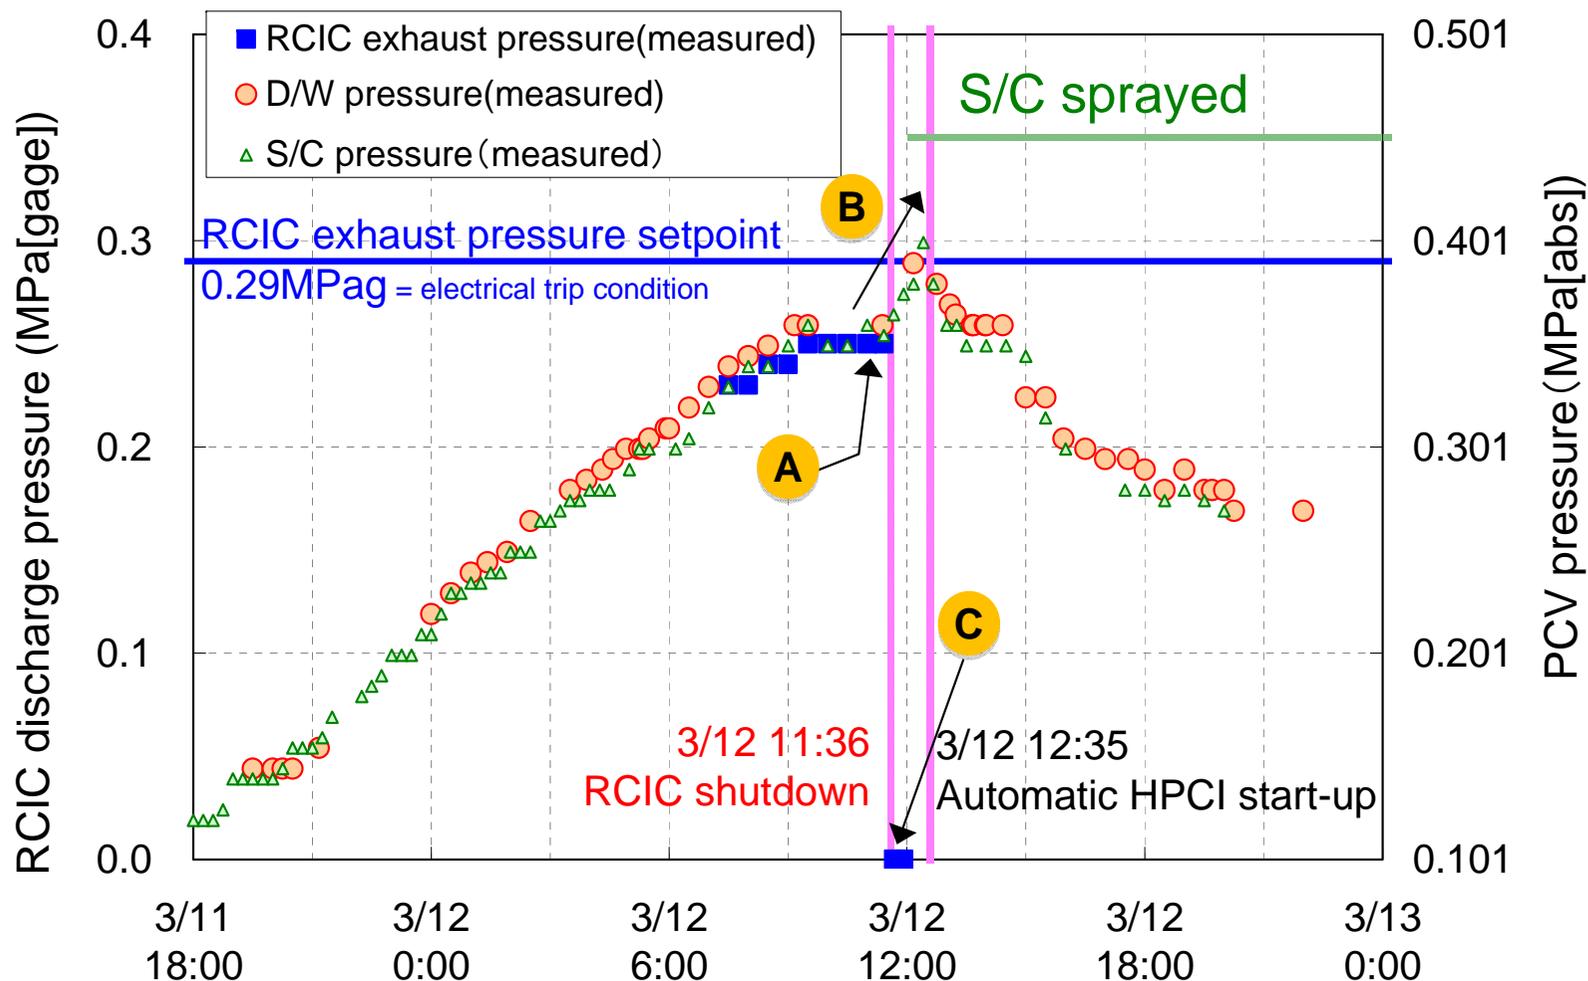
Out of electrical trip conditions, turbine exhaust pressure and S/C pressure were both on the rise, getting close to the trip set point.

A At 11:25 - immediately preceding shutdown - the exhaust pressure reading was 0.25 MPag. At this time, it had not reached the setpoint.

B S/C pressure rose steeply from 11:25 to 12:00.

C We do not have an exact record of exhaust pressure at the time of the shutdown (11:36). After the shutdown, exhaust pressure was back to 0 due to isolation from S/C.

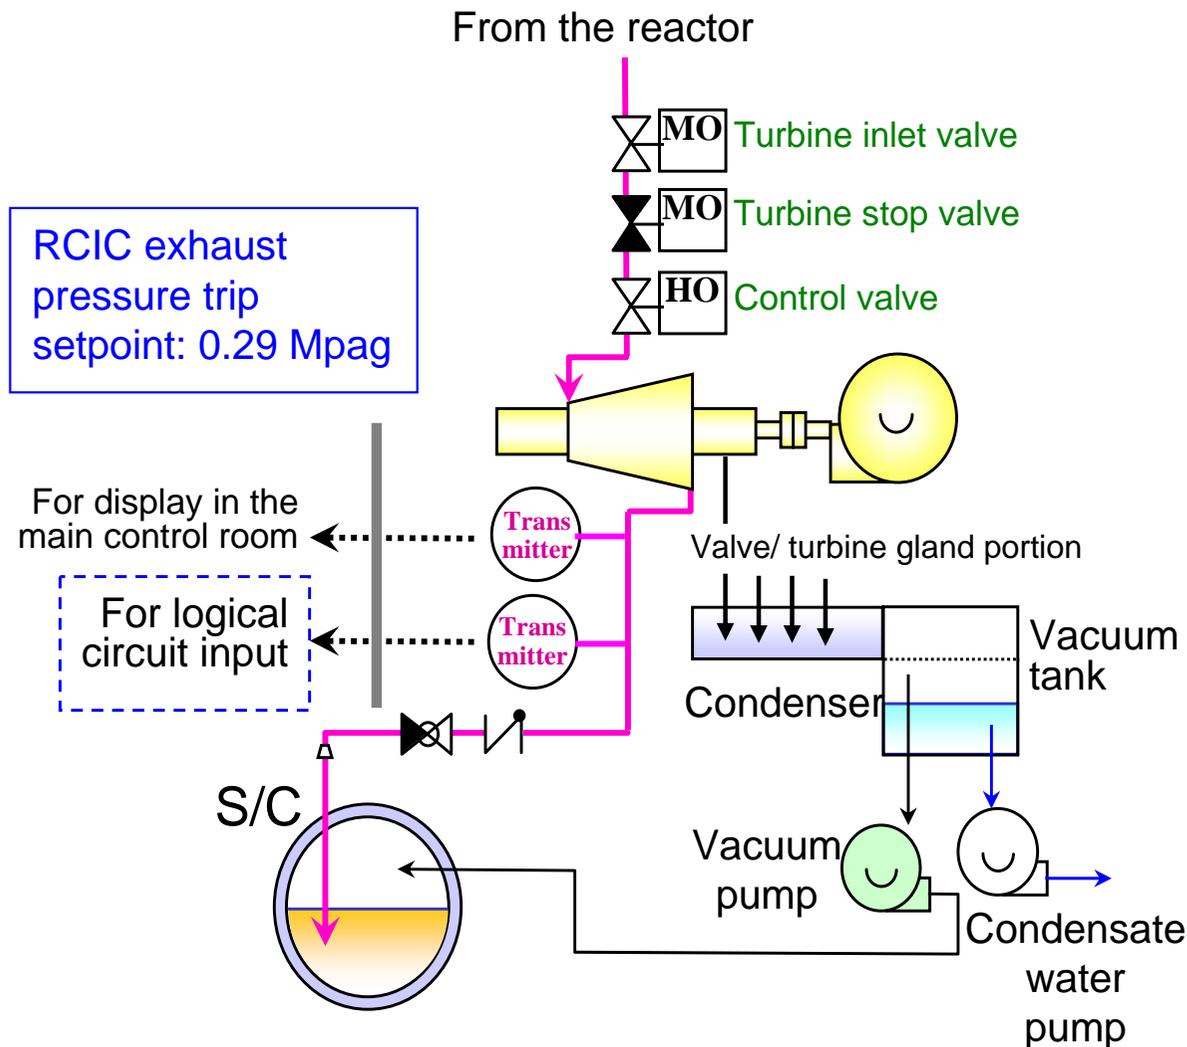
Trip due to high exhaust pressure is possible although there is no direct record

- S/C pressure at shutdown was about 0.25 MPag, which would have caused exhaust pressure to exceed the trip set point if we take into account the pressure drop in exhaust pipes (0.05 MPa according to trial run data).

→ Different pressure gauges are employed for display in the main control room and for logical circuit input; it is possible that, when S/C pressure rose at 11:36, the latter may have reached the trip set point.

- Another trip occurred again as steam began to flow following start-up, in spite of successful reset operation. This sequence of events can be explained based on the above (trip conditions were momentarily cleared upon exhaust pressure reaching 0).

In addition to measures for bolstering the function of the water injection under high reactor pressure, **an operational procedure is being prepared to release the interlock for high turbine exhaust pressure**

- In the response procedures for Tsunami Accident Management, which assume a station black out, an operational procedure is being prepared to release the interlock for high turbine exhaust pressure in order to prioritize the continuation of RCIC operation even while S/C pressure is on the rise.

The procedure will be based on the notion that RCIC equipment will not be damaged immediately even if turbine exhaust pressure exceeds the trip set point, thus putting continued RCIC operation before equipment damage risks.

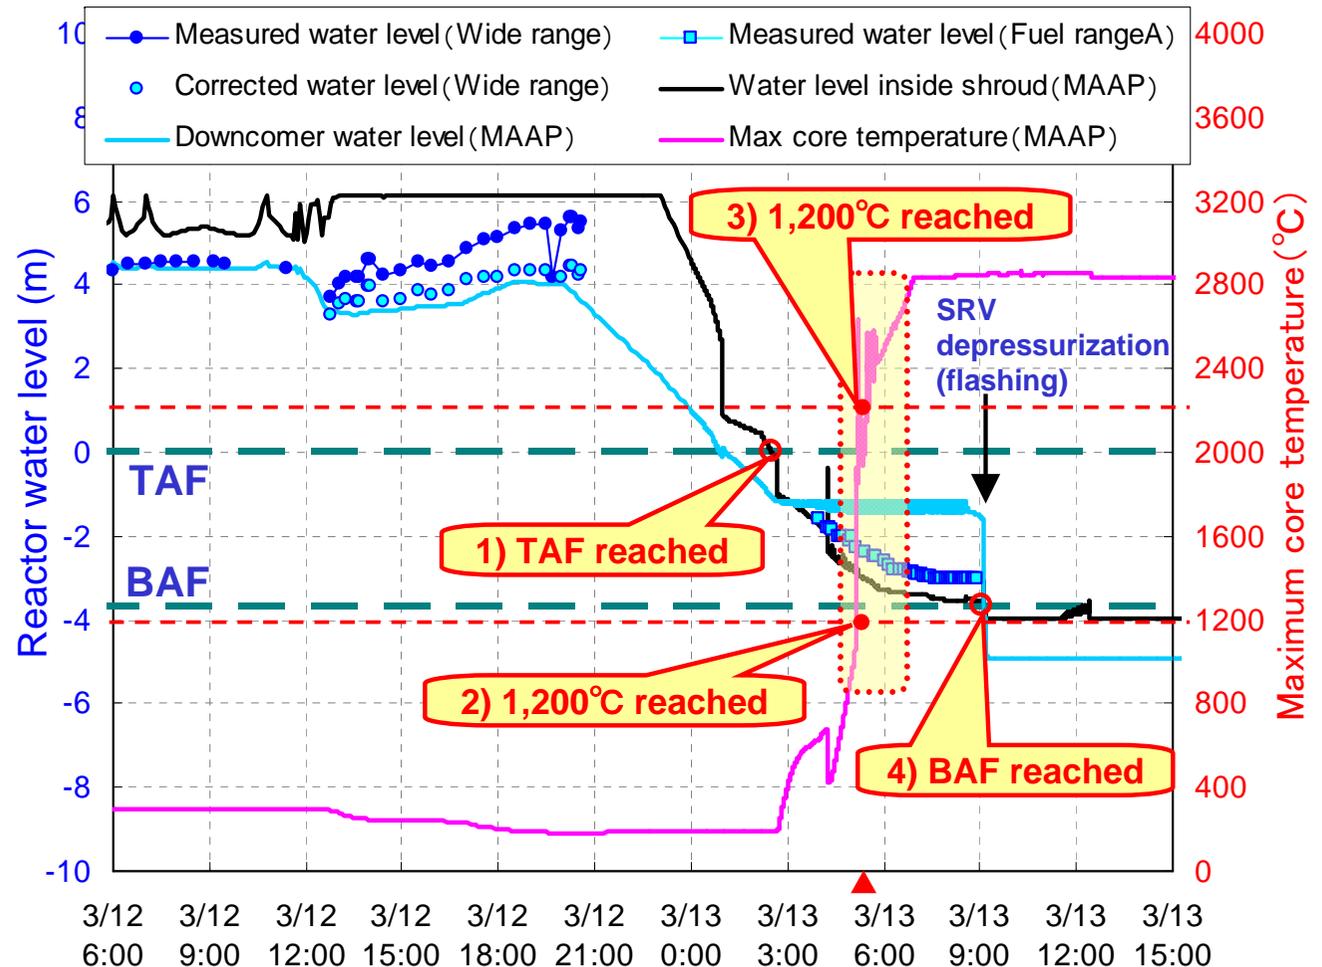
Fuel began melting before the water level reached the fuel's bottom.
We estimate that it was the heat from the zirconium-water reaction caused as the water level dropped to cause the fuel to melt.

1) TAF reached	About 2:30 on 3/13
2) Maximum core temperature 1,200°C reached	About 5:10 on 3/13
3) Maximum core temperature 2200°C reached	(Fuel melting) About 5:30 on 3/13
4) BAF reached	About 9:10 on 3/13

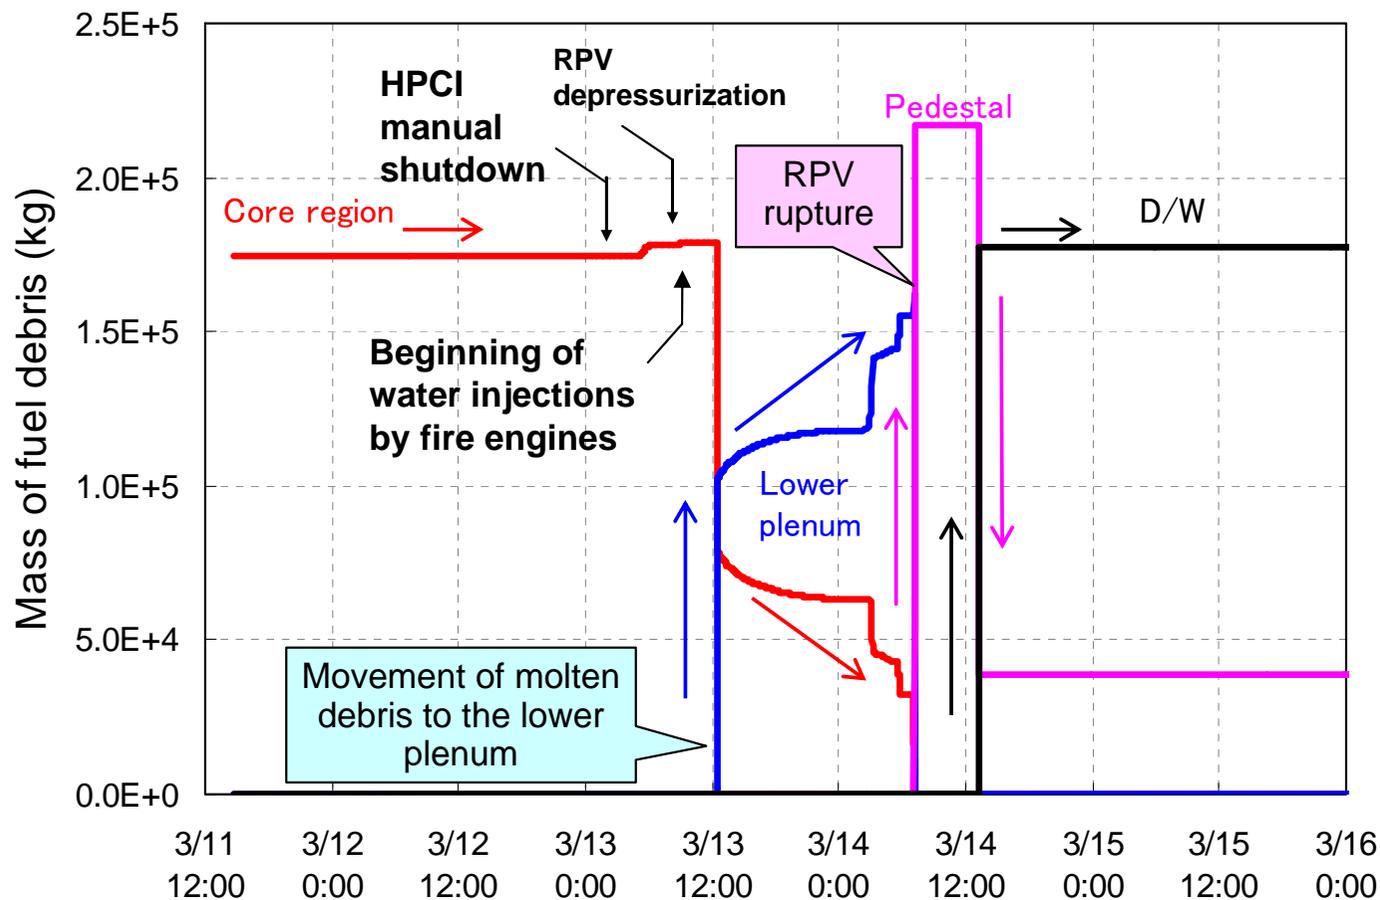
By taking into account the state of HPCI operation, simulation result shows that the majority of fuel fell dropped

- ✓ The water injections made starting on September 1, 2011 from the core spray system caused a decrease in RPV temperature. Therefore, we believe there may be fuel debris in the core as well.
- ✓ Whether the RPV is ruptured is largely determined by the volume of cooling water injected from fire engines; model and analysis conditions entail considerable uncertainty.
- ✓ Simulation resulted in Debris on the PCV of 100%, but there are issues with the MAAP model (in MAAP, RPV rupture case tends to result in entire debris' dropping).

Developments since fuel melting remain largely unclear (molten core's behavior in dropping to the lower plenum, damage to pressure vessels, MCCI, etc.). We will need to study model improvements and input conditions.

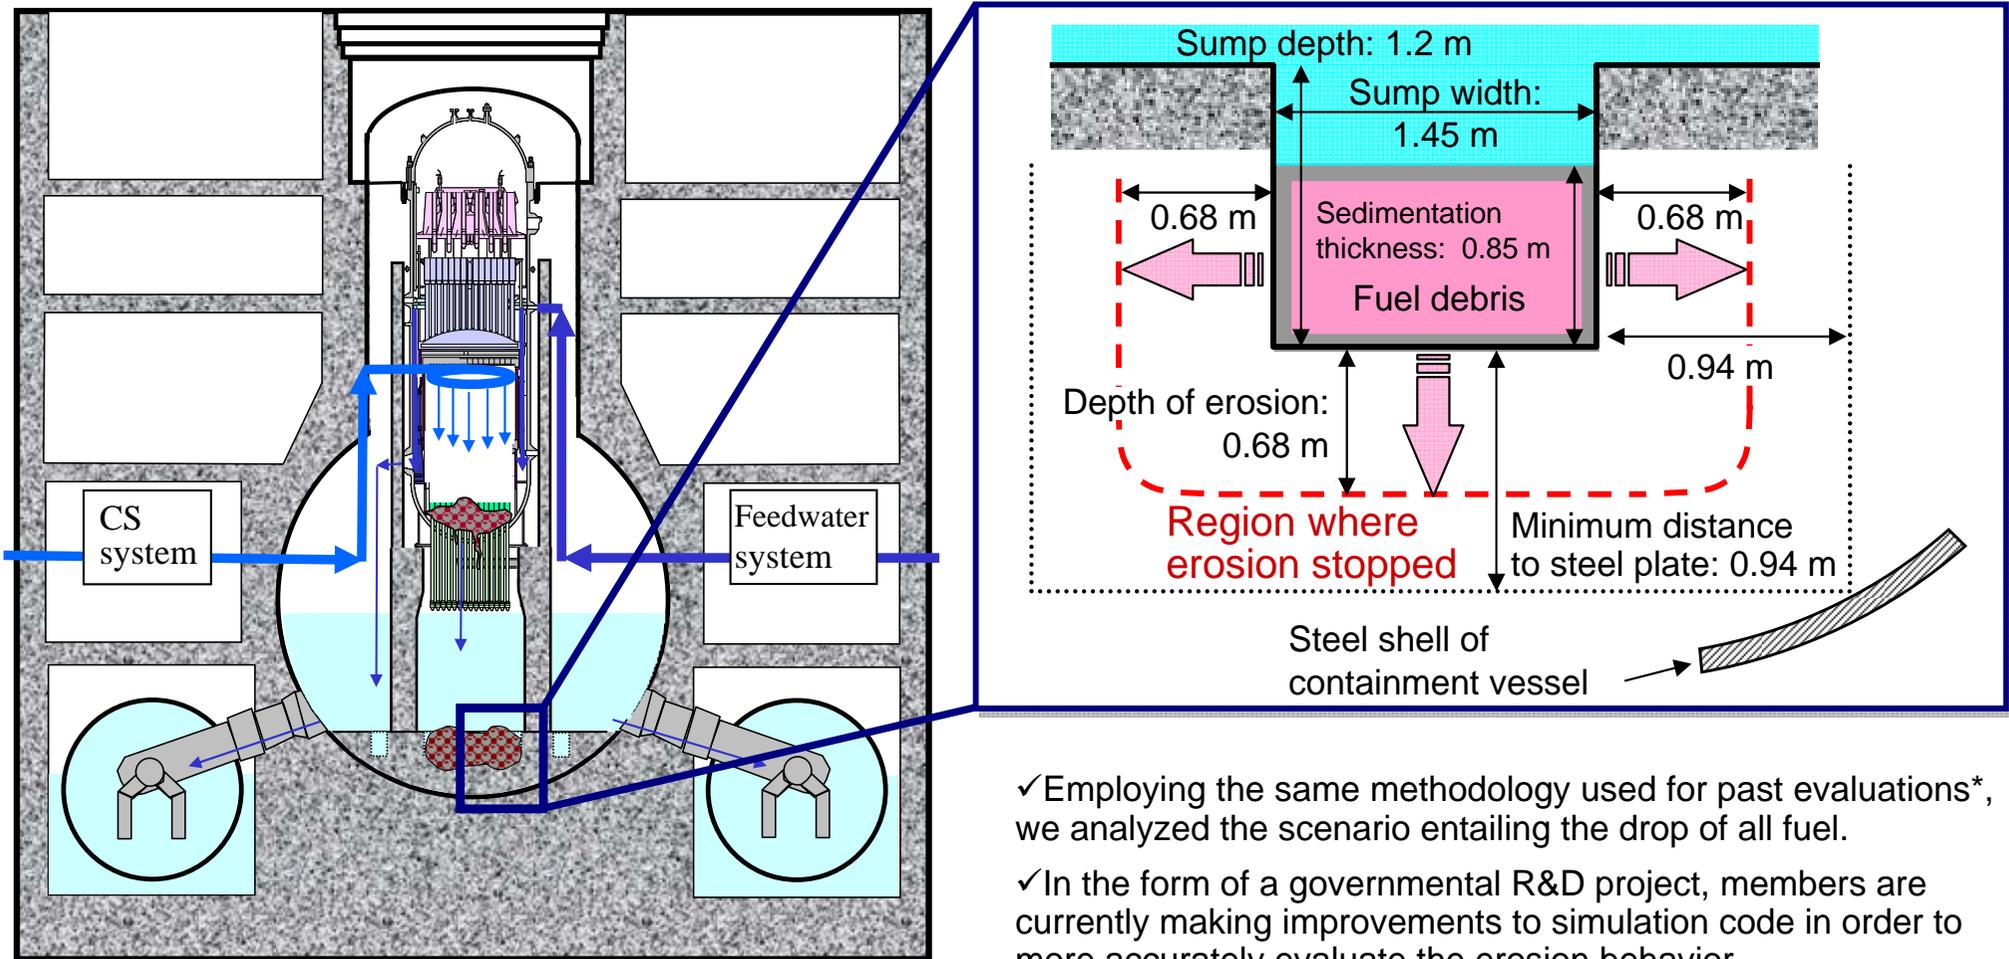
We estimated the degree of concrete erosion by MCCI.
**While our analysis entails some degree of uncertainty,
 erosion was limited to within the reactor containment vessel.**

- ✓ Employing the same methodology used for past evaluations*, we analyzed the scenario entailing the drop of all fuel.
- ✓ In the form of a governmental R&D project, members are currently making improvements to simulation code in order to more accurately evaluate the erosion behavior.

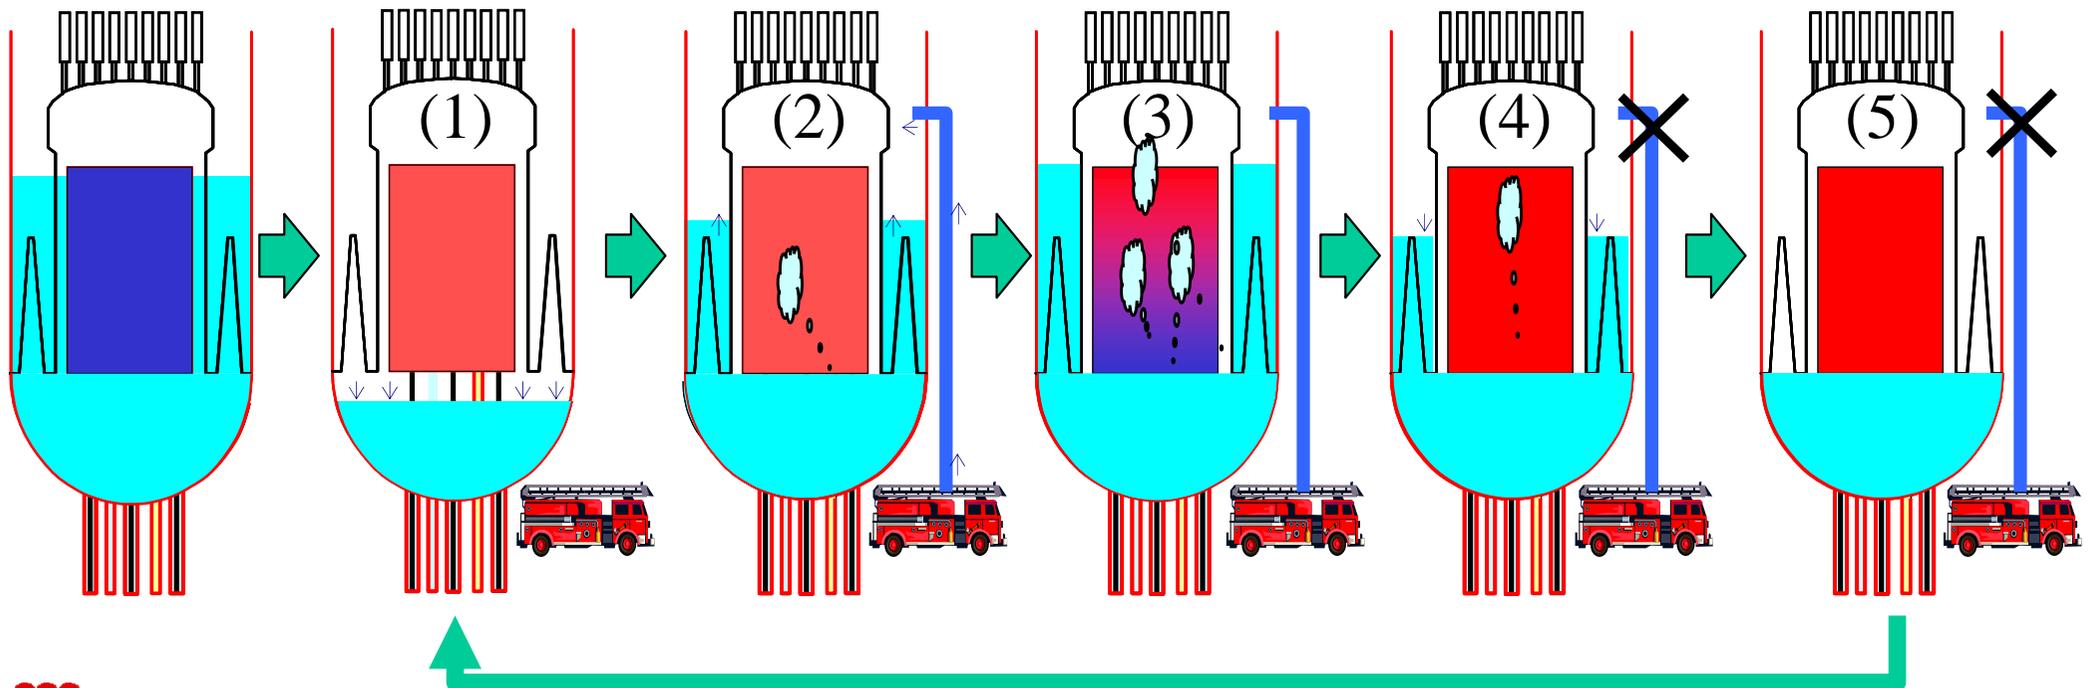
We estimate a scenario where, after reactor depressurization, the steam generated by cooling water injection from fire engines caused a zirconium-water reaction, in turn causing reactor pressure to rise and lead to fuel melting.

- (1) On the reactor's forced depressurization, flashing caused the water level to drop steeply, completely exposing the core.
- (2) Water level was restored by water injections from fire engines.
- (3) Steam generation caused a zirconium-water reaction, in turn generating hydrogen and large amounts of heat, and causing reactor pressure to rise.
- (4) Cooling water injections from fire engines were suspended due to the rise in reactor pressure.
- (5) The suspension of cooling water injections brought steam generation under control, letting pressure drop.

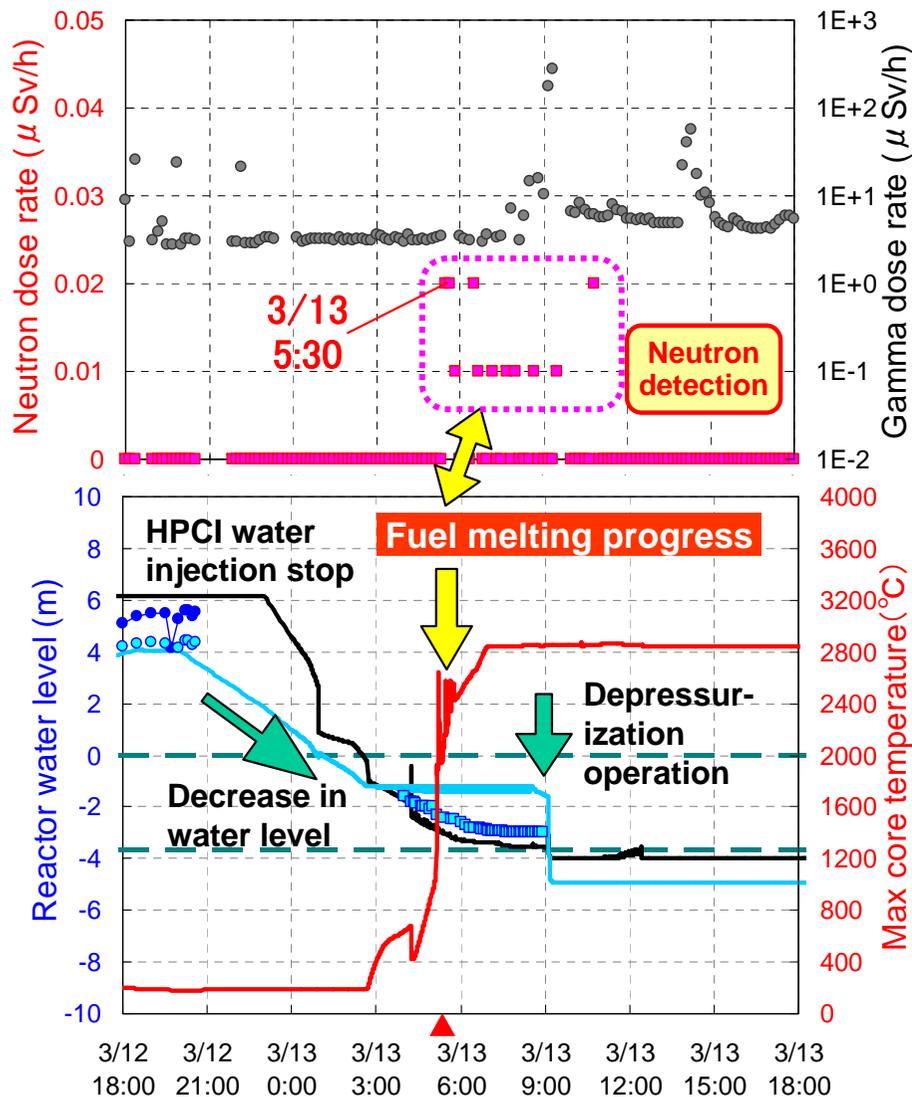
The timing of neutron detection on the morning of March 13 coincides with that of fuel melting at Unit 3.

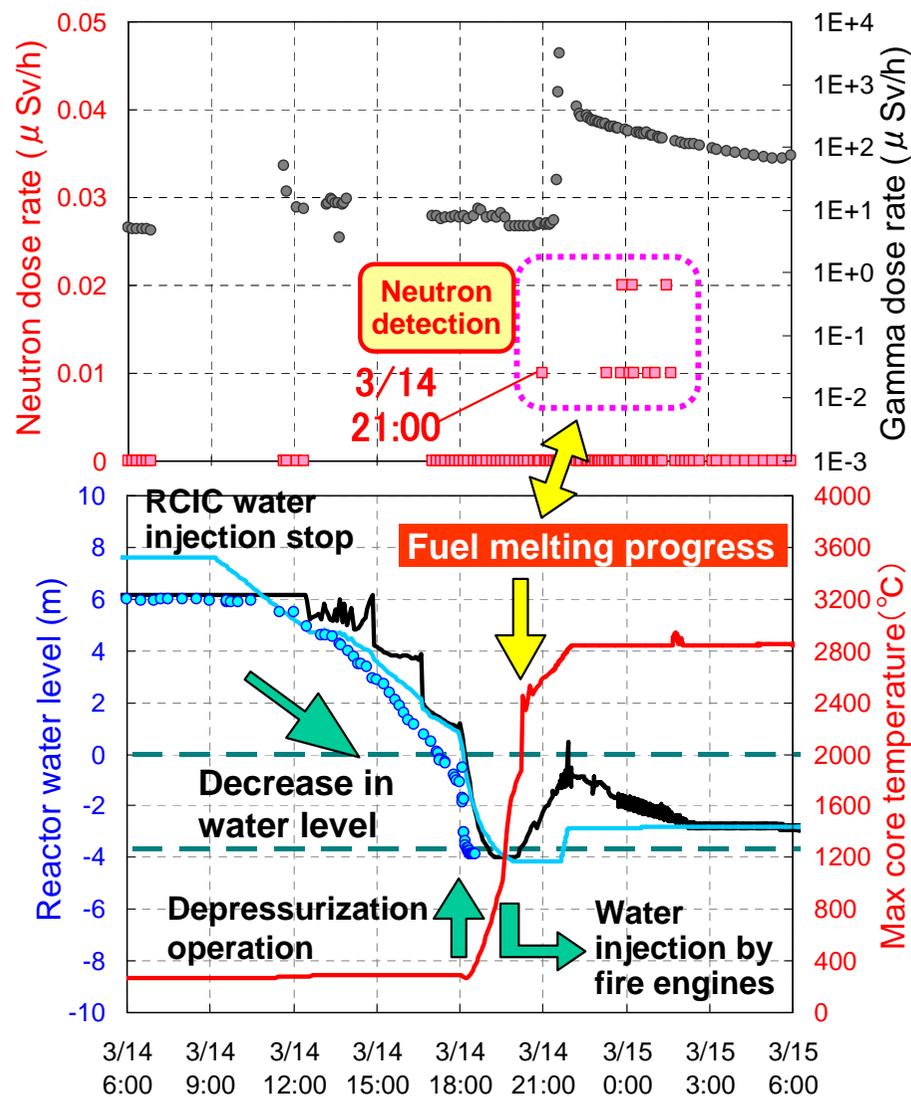
The timing of neutron detection in the night of March 14 coincides with that of fuel melting at Unit 2.

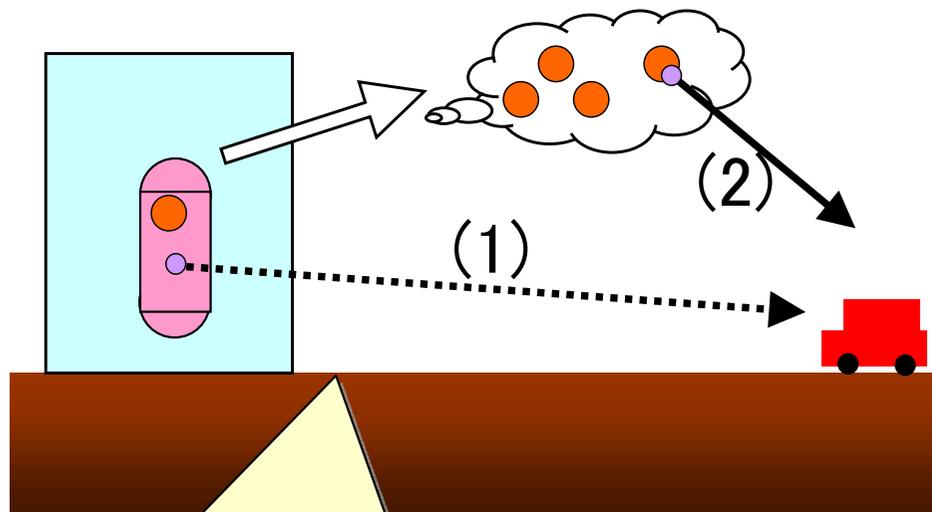
The neutrons observed near the main gate may have been generated by the spontaneous fission of released actinides in the course of fuel melting at Units 2 and 3.

The concentration in soil sampled in the Fukushima Daiichi site was similar to that preceding the accident. However, based on the detection of actinides with relatively short half-life, such as Cm-242 and Cm-244, we believe these may have been originated in the Fukushima Daiichi accident.

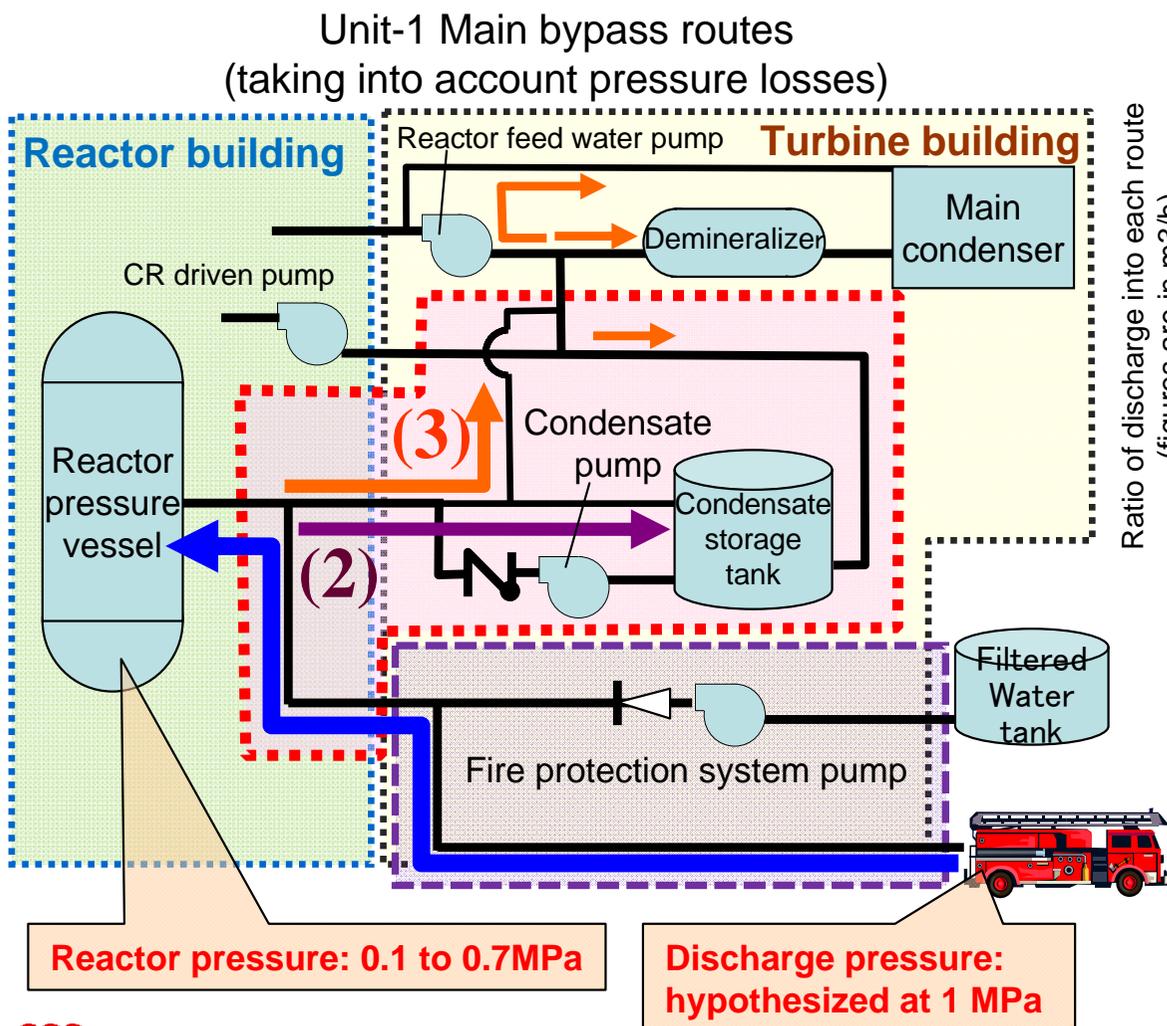
If we assume fire engine discharge pressure to have been constant at 1MPa, then about 20% to 50% of water injected reached the reactor.

Note, however, that records of discharge pressure and flow rate, etc. from fire engines are few, and leave many aspects unclear, thus requiring further study.

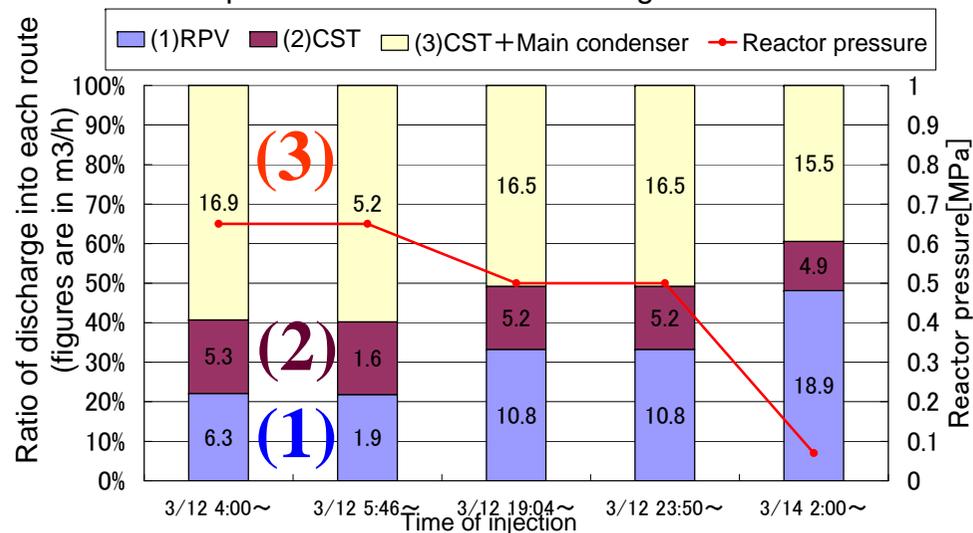
Reactor pressure and ratio of discharge into each route

- At times, fire engine discharge pressure fell below 1 MPa.
- No D/W pressure response while water injection from fire engines were suspended
- These results may overestimate the volume of water injected into the reactor.
