Evaluation of the situation of  
cores and containment vessels of  
Fukushima Daiichi Nuclear Power Station  
Units-1 to 3 and examination into unsolved  
issues in the accident progression

Progress Report No. 2

August 6, 2014

Tokyo Electric Power Company, Inc.

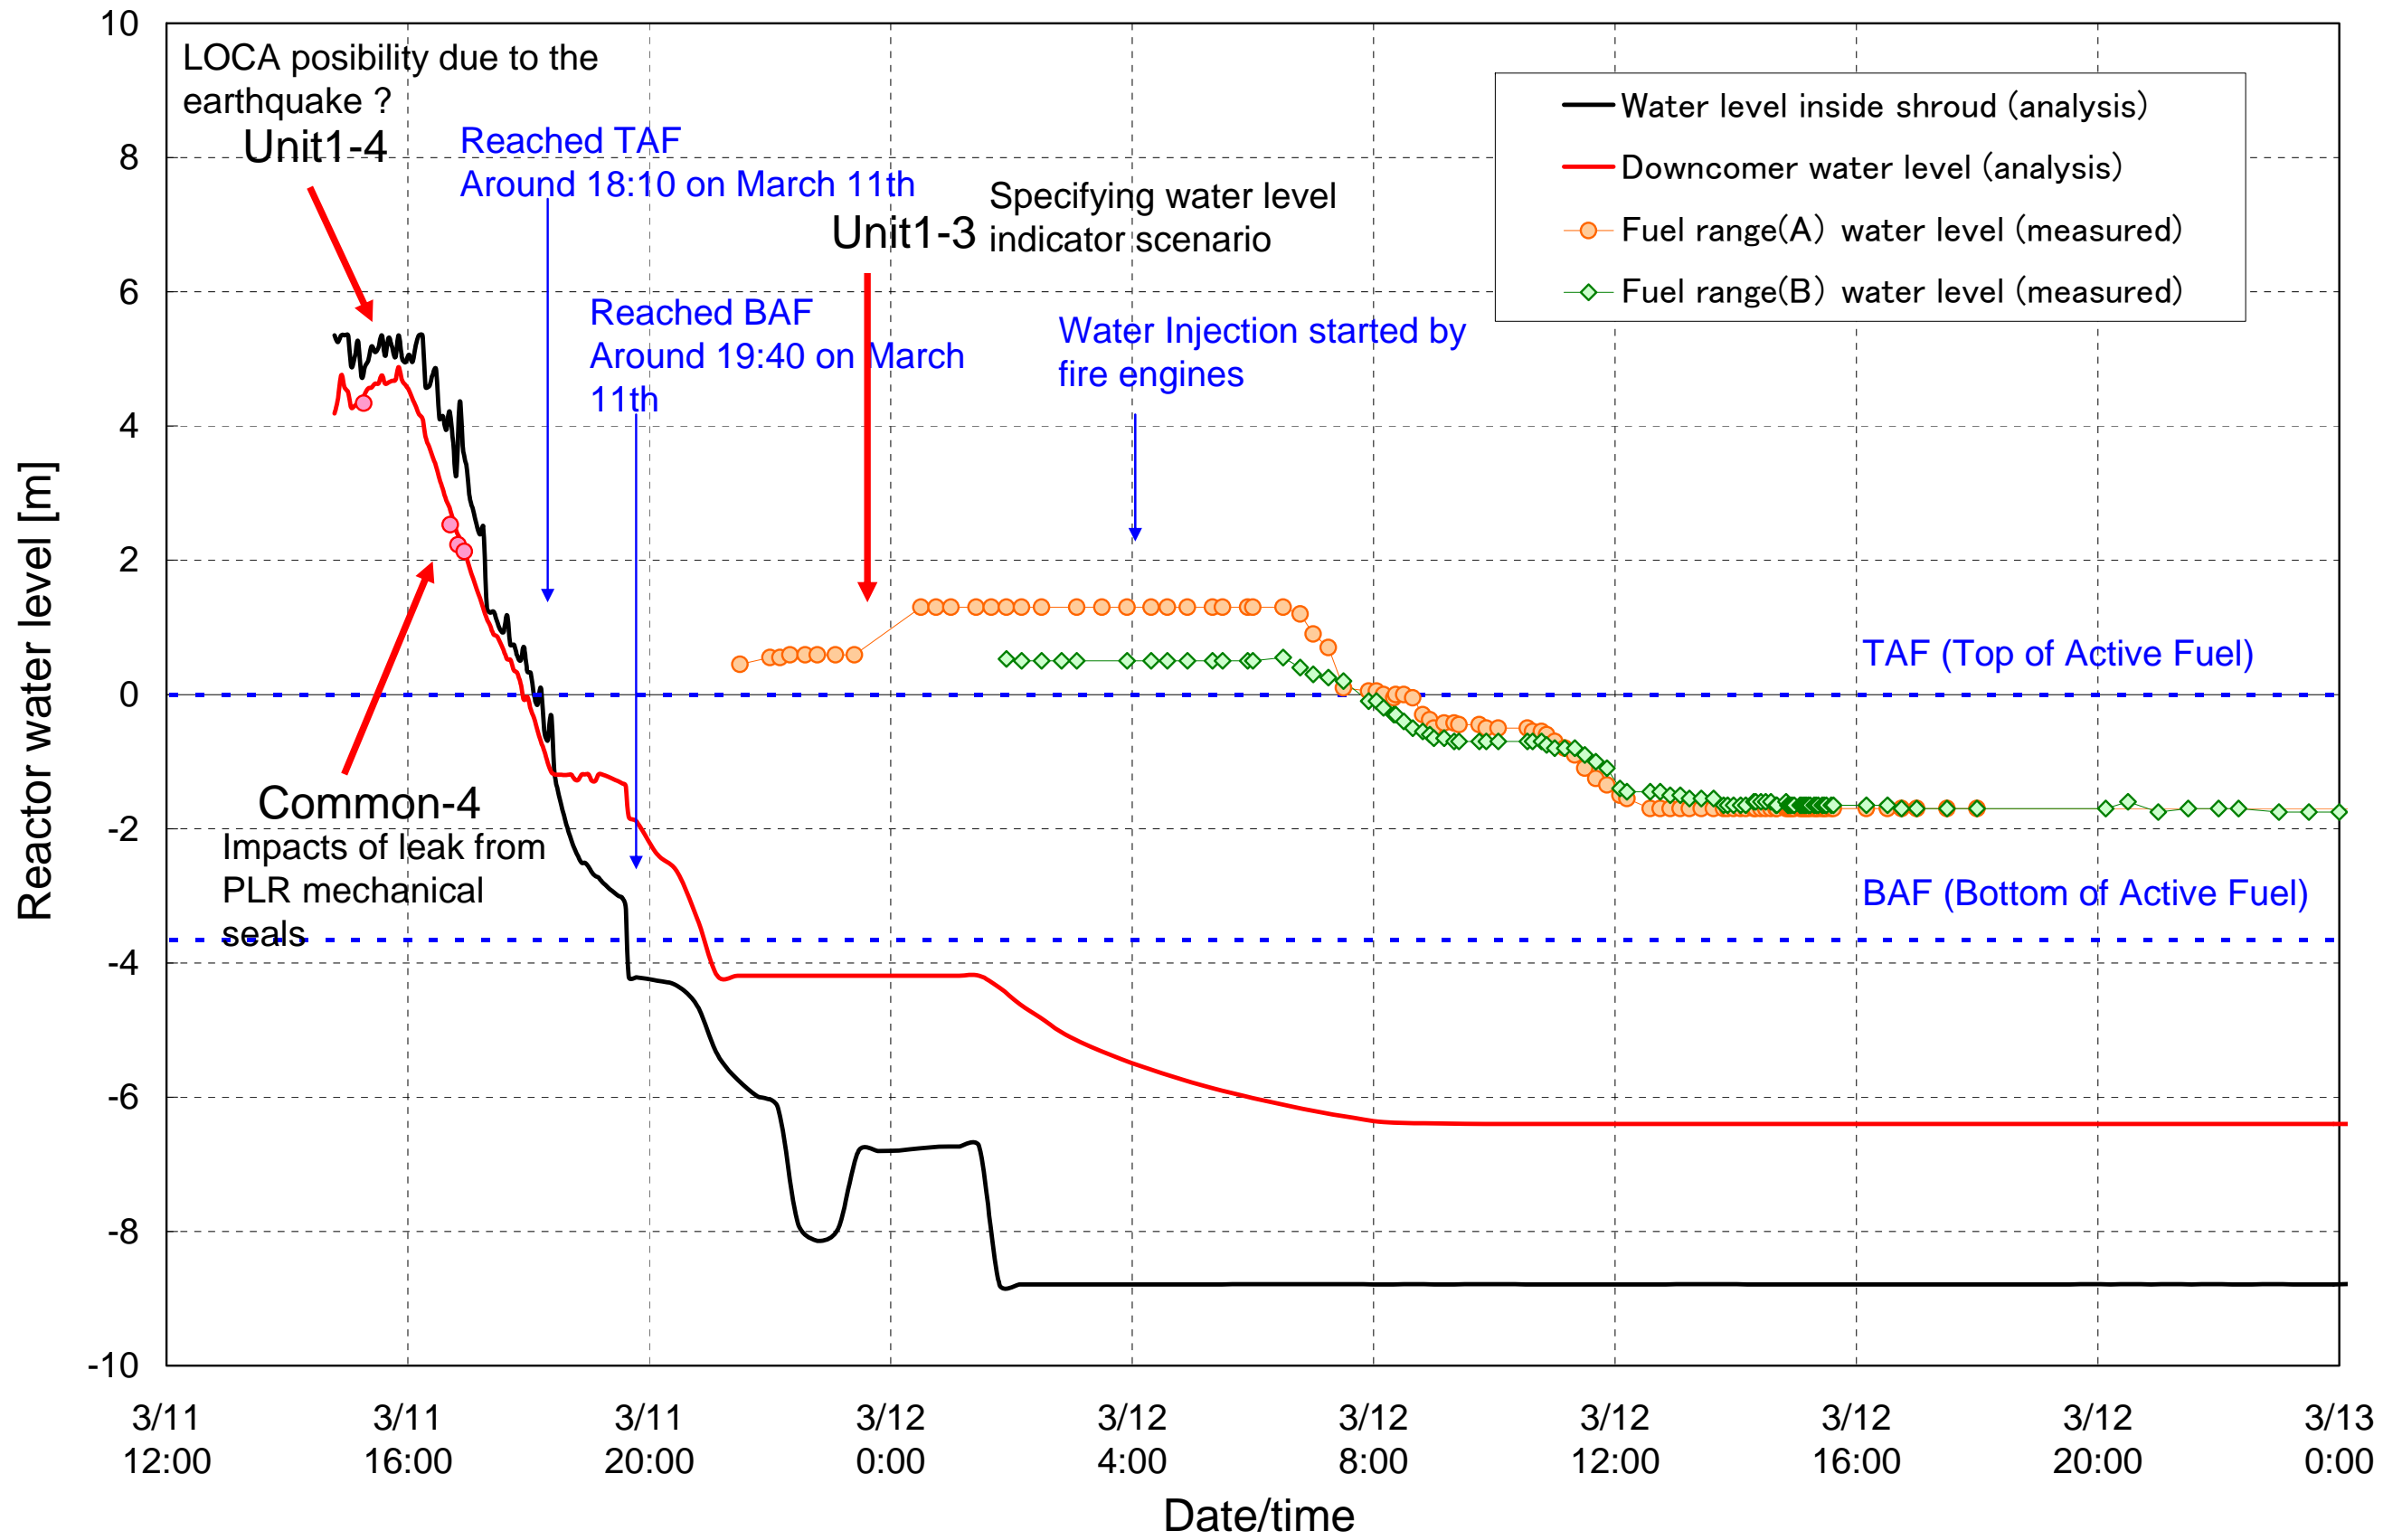
Figure 3.2.1 Issues derived from reactor water level change of Unit-1

It is considered that noncondensable hydrogen gas generated by the water-zirconium reactions deteriorates the heat removal performance when it stays in the IC cooling tubes. But further examinations are needed because it is unknown how much the heat removal capability was deteriorated (Unit-1/Issue-1).

When operation of the fuel range water level indicators were recovered at 21:19 on March 11<sup>th</sup> by the temporary power supply, they showed TAF+200mm but the reactor water level indicators seemed to have been already defective. But still, as the pressure difference between the pipes on the reference water level side (reference leg) and reactor side (variable leg) can be known from the water level measurements, some information might be obtained on the accident progression. Examinations shall continue from this standpoint (Unit-1/Issue-3).

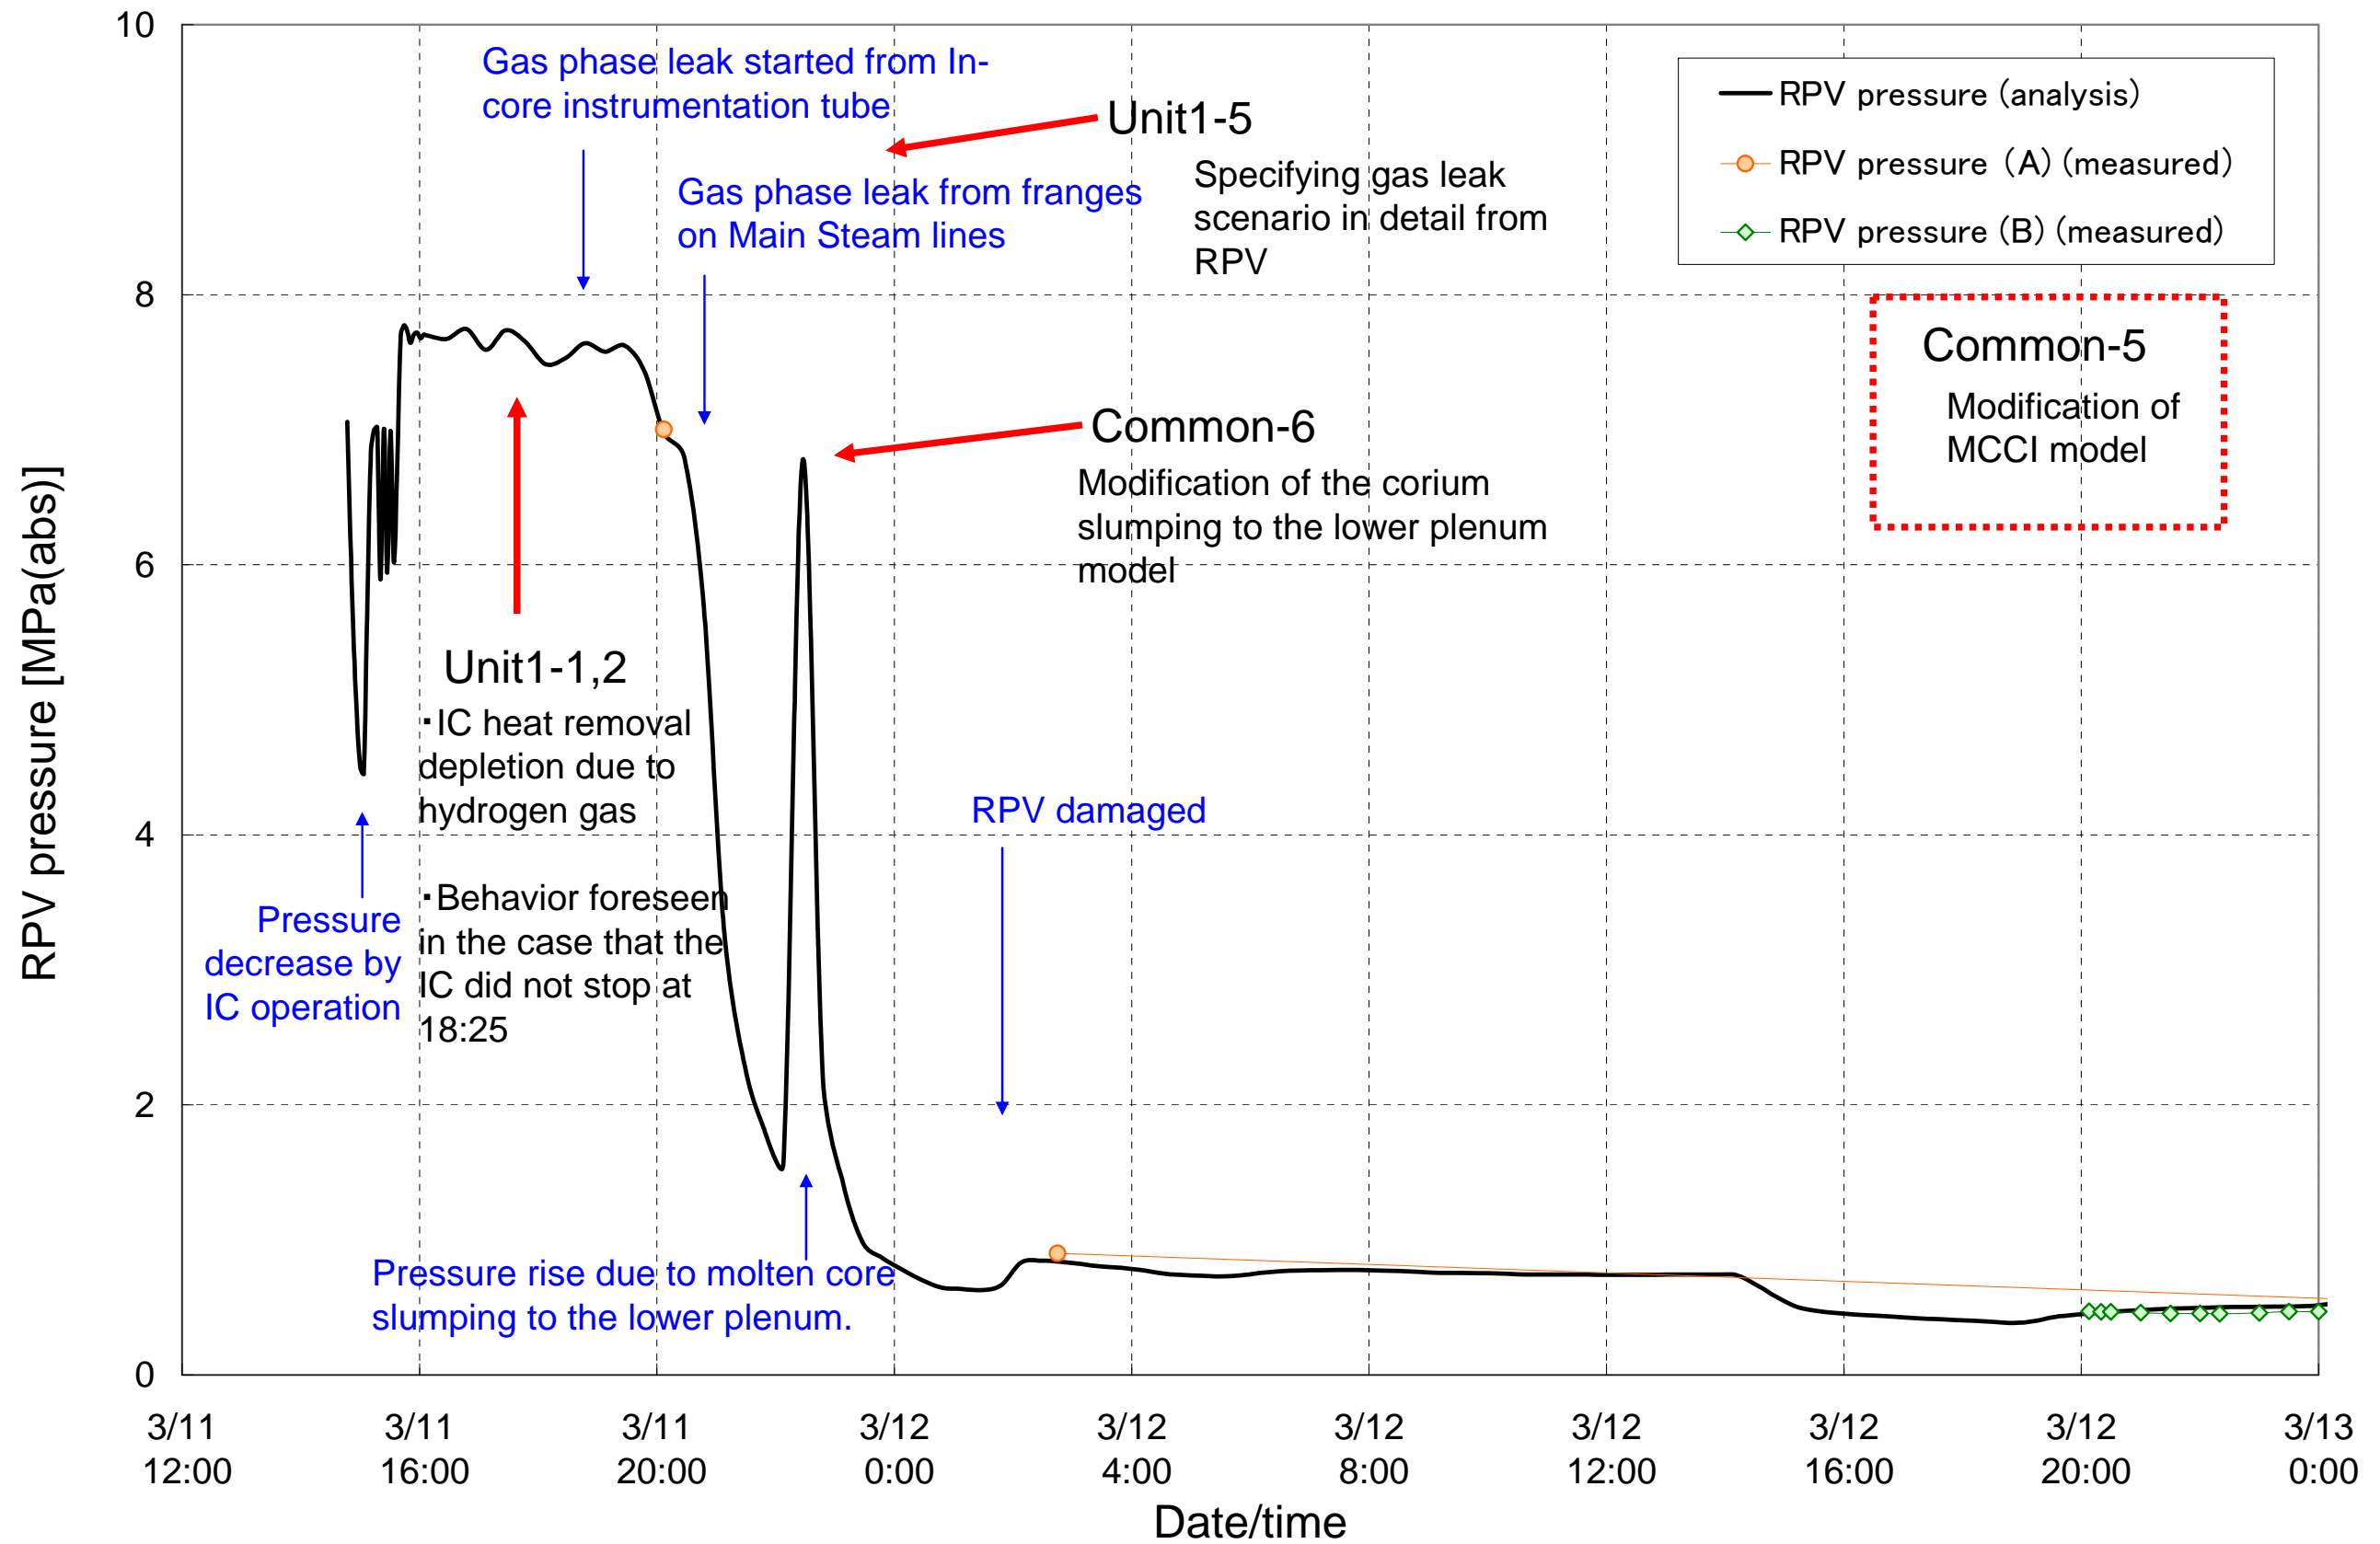
Figure 3.2.2 Issues derived from reactor pressure changes of Unit-1

The reactor pressure of 7.0MPa[abs] was measured at 20:07 on March 11<sup>th</sup>, and D/W pressure of 0.6 MPa[abs] at about 23:50; on March 12<sup>th</sup>, the D/W pressure of 0.84 MPa[abs] was measured at 02:30 and the reactor pressure of 0.9MPa[abs] at 02:45. In the meantime, although the exact timing is unknown, it was observed that at a certain time after 20:00 on March 11<sup>th</sup>, the PCV pressure showed a sharp rise and the reactor pressure decreased despite no depressurization actions.

In order to reproduce this pressure changes, a scenario was assumed in the analysis that steam had leaked to the D/W via in-core instrumentation dry tubes or main steam pipe flanges due to temperature rises in the vessel caused by overheating of uncovered fuels and fuel melting. But no direct evidence has been obtained showing any actual leaks at these locations, from either the measured parameters or the observed facts. Further

In the analysis results, the reactor pressure showed a sharp peak at about 22:00 on March 11<sup>th</sup>. It came from a model used in the MAAP analysis that the molten core collects and stays for a while on the core support plate, and then drops down after the plate is damaged to the lower plenum at one sweep, thus generating a big amount of steam. The relocation mechanism of molten fuel to the lower plenum is based on the knowledge of the TMI accident. As it is difficult to say that the model well simulates the complicated BWR structures, further examinations are needed to evaluate the molten BWR fuel relocation mechanism (Unit-1/Issue-6).

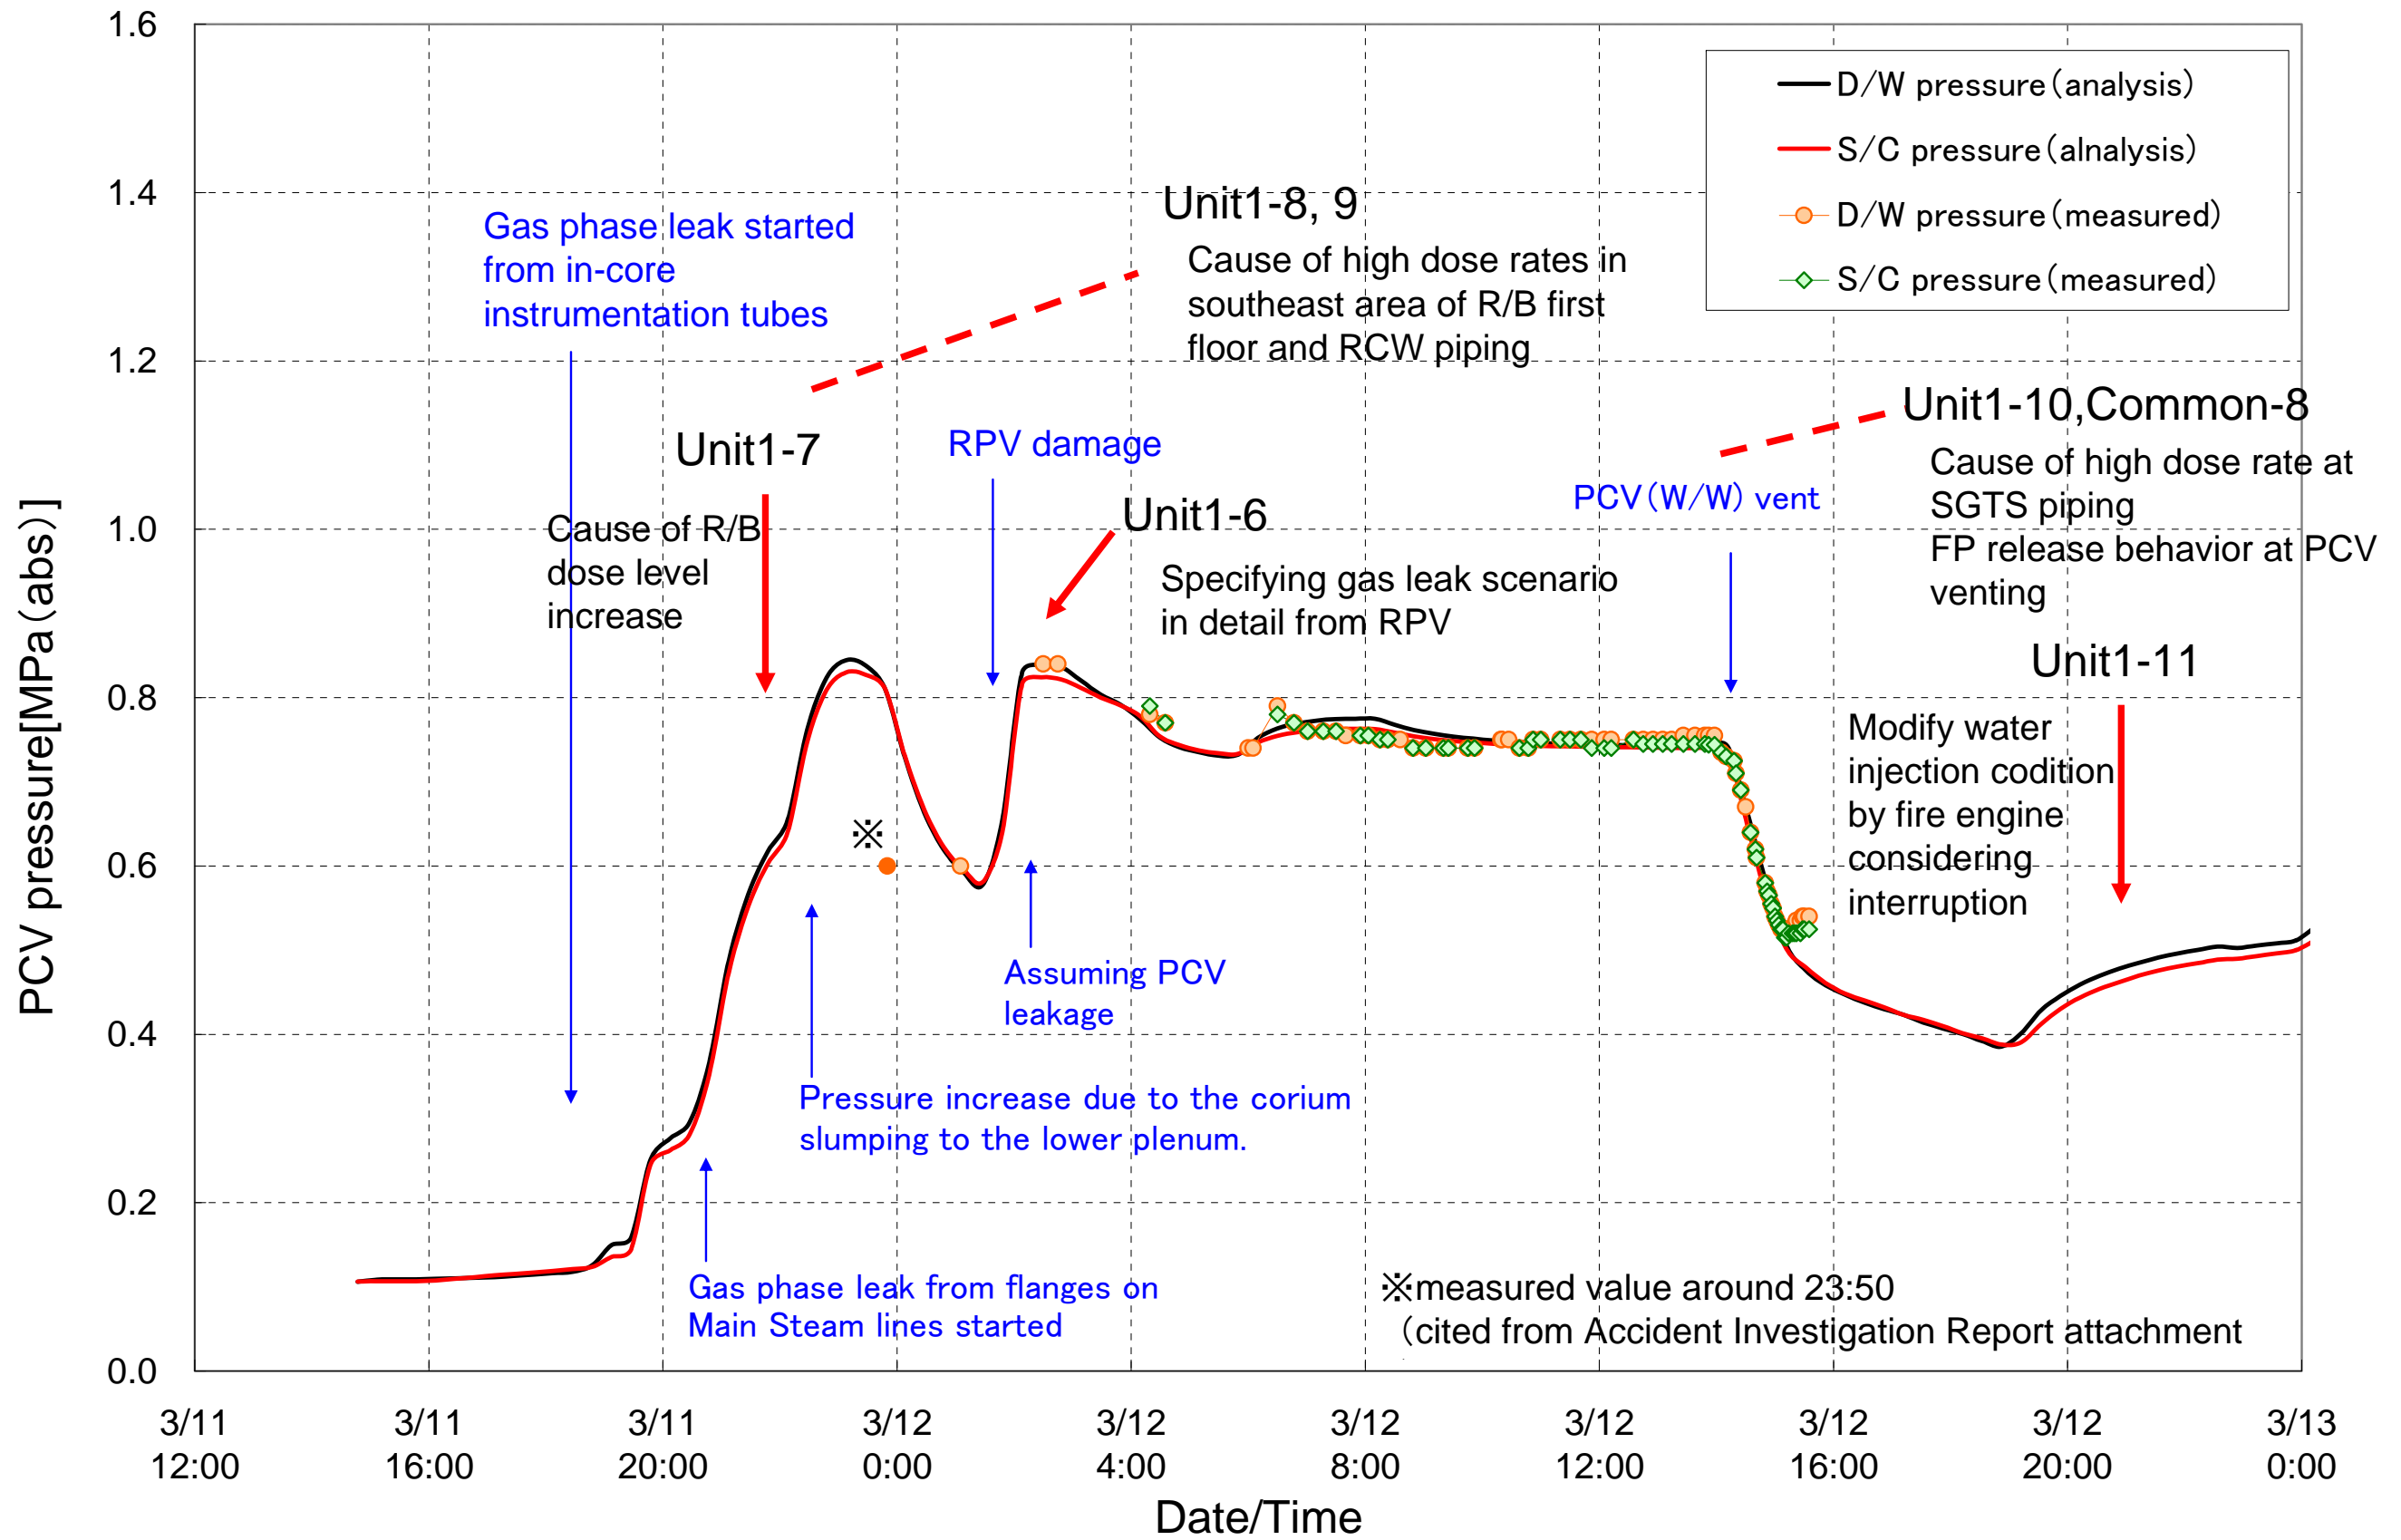
Figure 3.2.3 Issues derived from PCV pressure changes of Unit-1

The D/W pressure was being maintained at about 0.7 MPa[abs] to 0.8 MPa[abs], after reaching 0.84 MPa[abs] at about 02:30 on March 12<sup>th</sup>, until PCV venting was successful. This fact of constant PCV pressure gives a strong suggestion that the PCV was leaking, because the PCV pressure is expected to rise, when steam is produced due to water injection, PCV temperature rises, and gases are generated by core-concrete reactions, etc.

In the analysis, a gaseous phase leak was assumed from the PCV about 12 hours after the earthquake (at about 03:10 on March 12<sup>th</sup>) so that the D/W pressure measurements could be well reproduced. But no direct evidence was obtained from the parameters measured or facts observed on when and from where the actual leak occurred. Further examinations are needed (Unit-1/Issue-6).

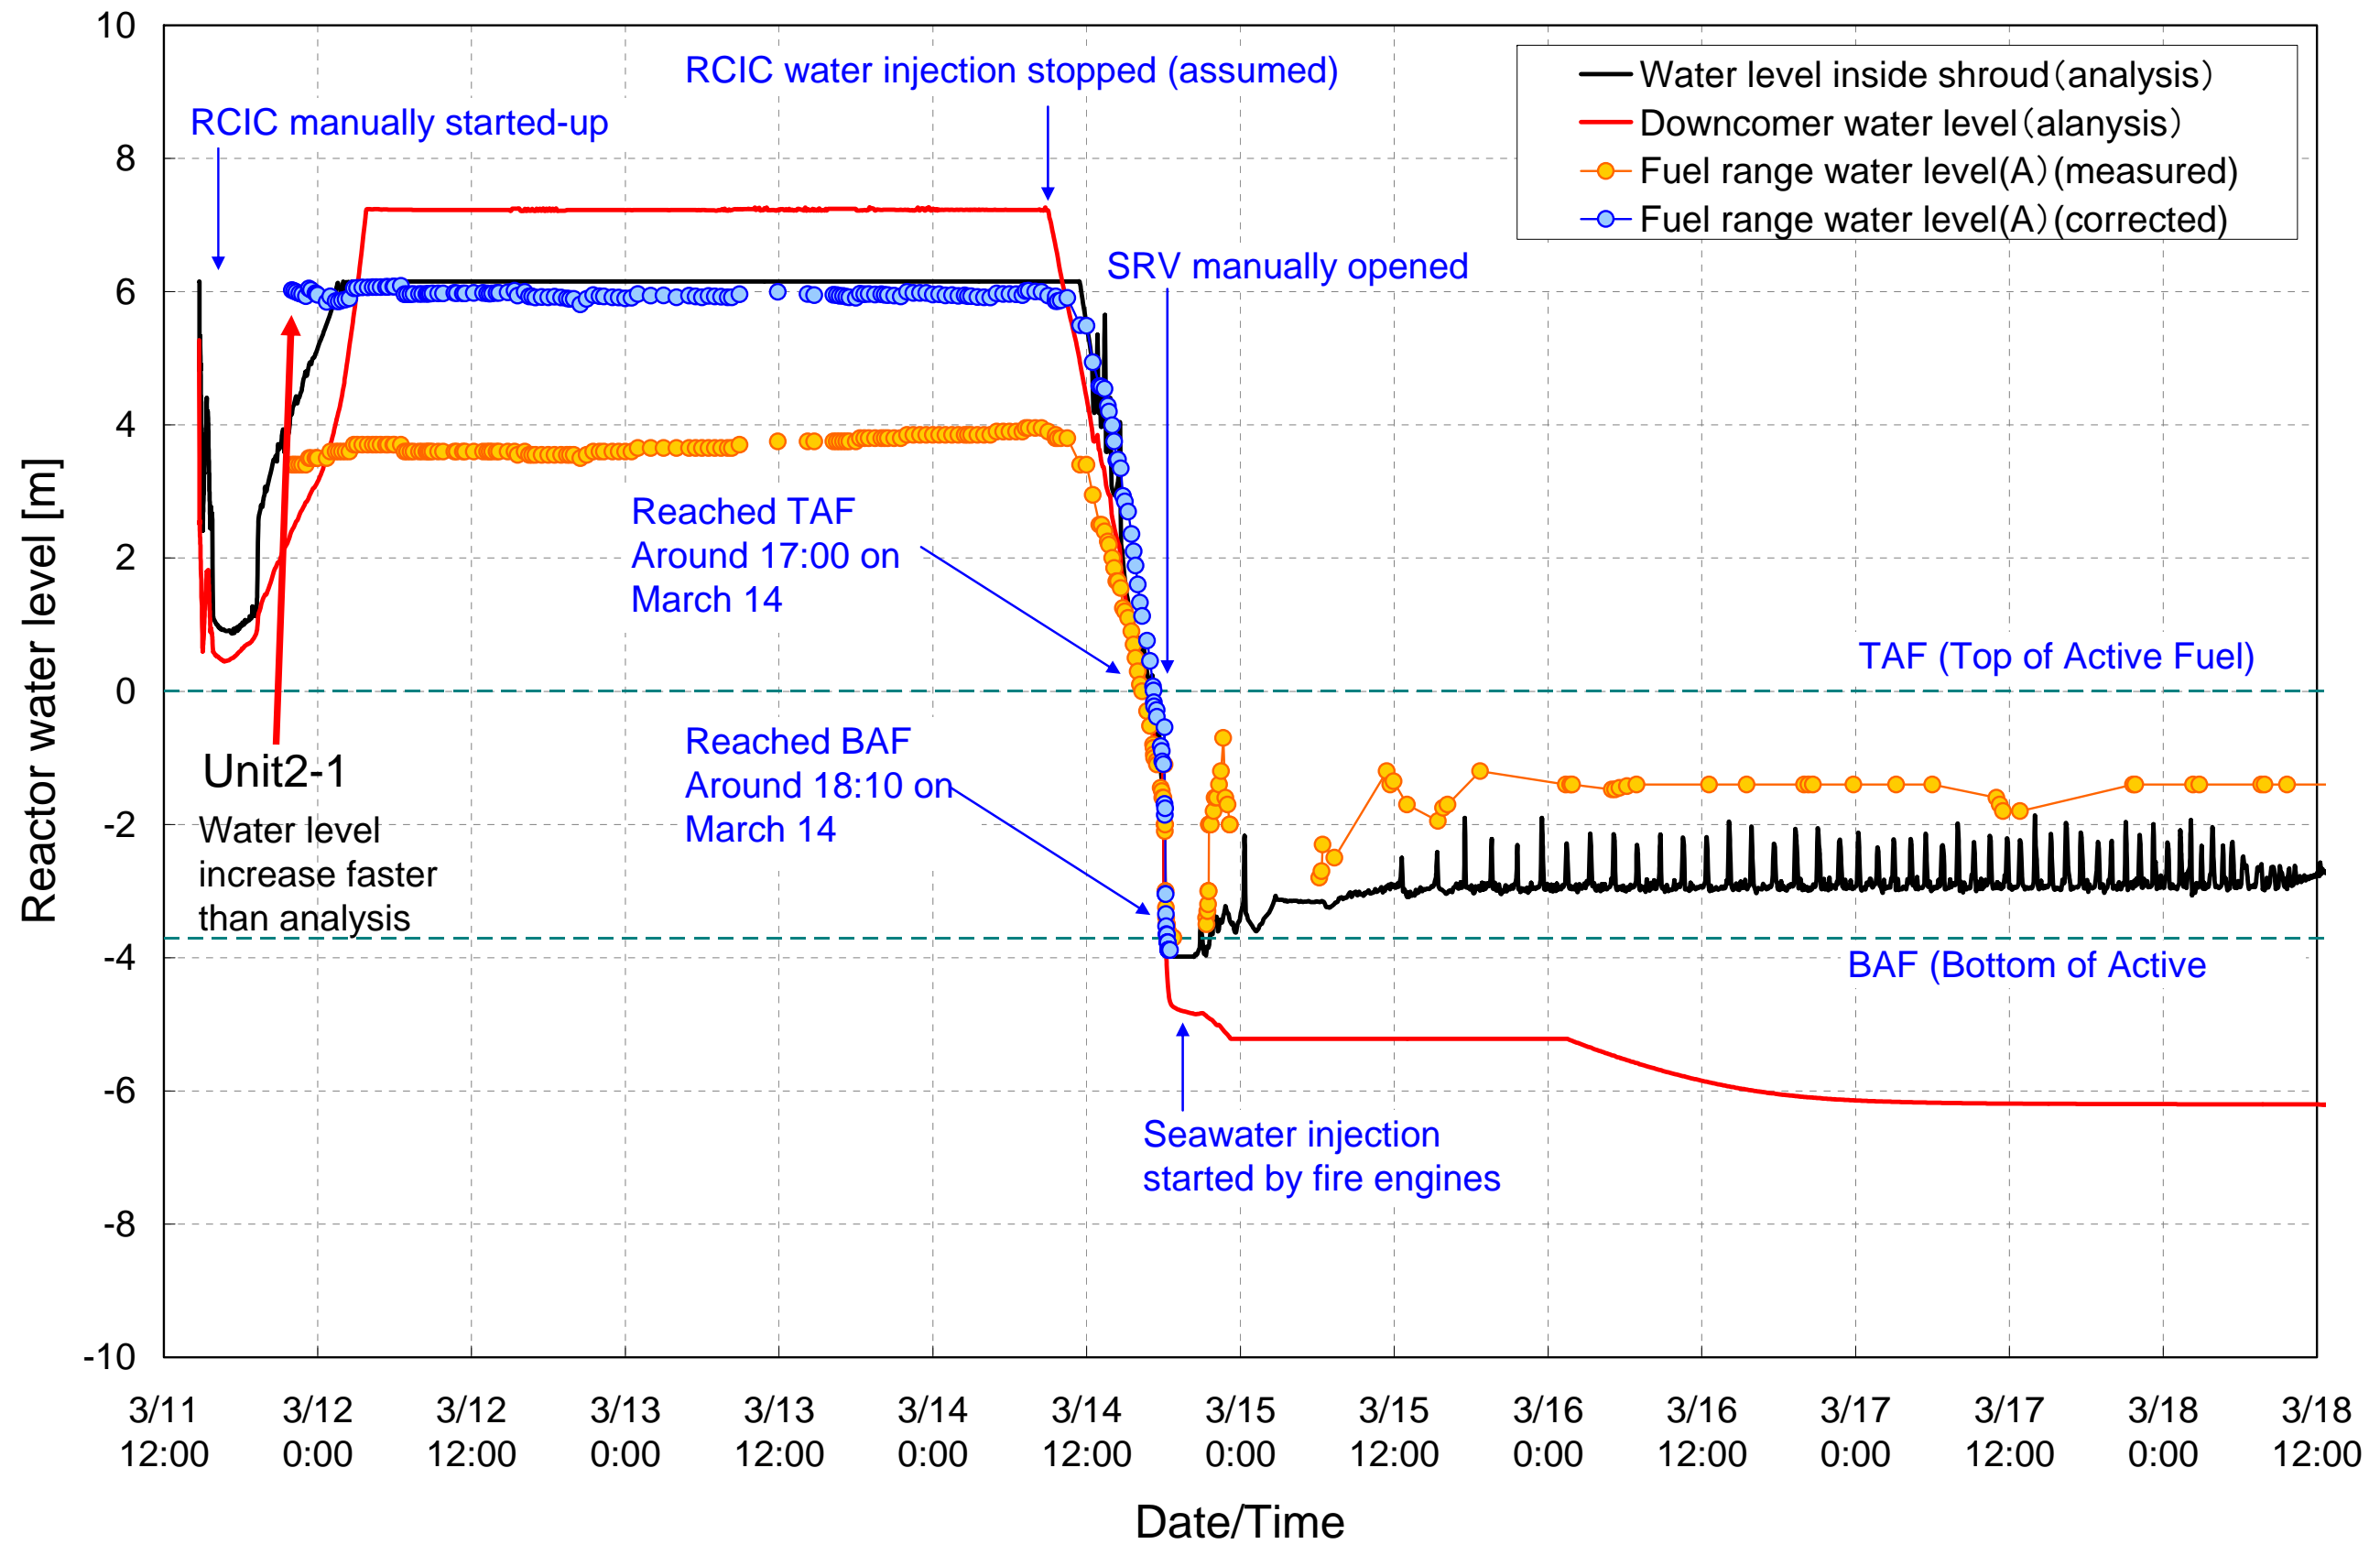
Figure 4.2.1 Issues derived from the reactor water level changes at Unit-2

condition, the reactor levels calculated during the time period prior to the water level increase up to the main steam line increased more slowly than the measured values. This raises the need to investigate the RCIC behavior after loss of power supply due to tsunami (Unit-2/Issue1)

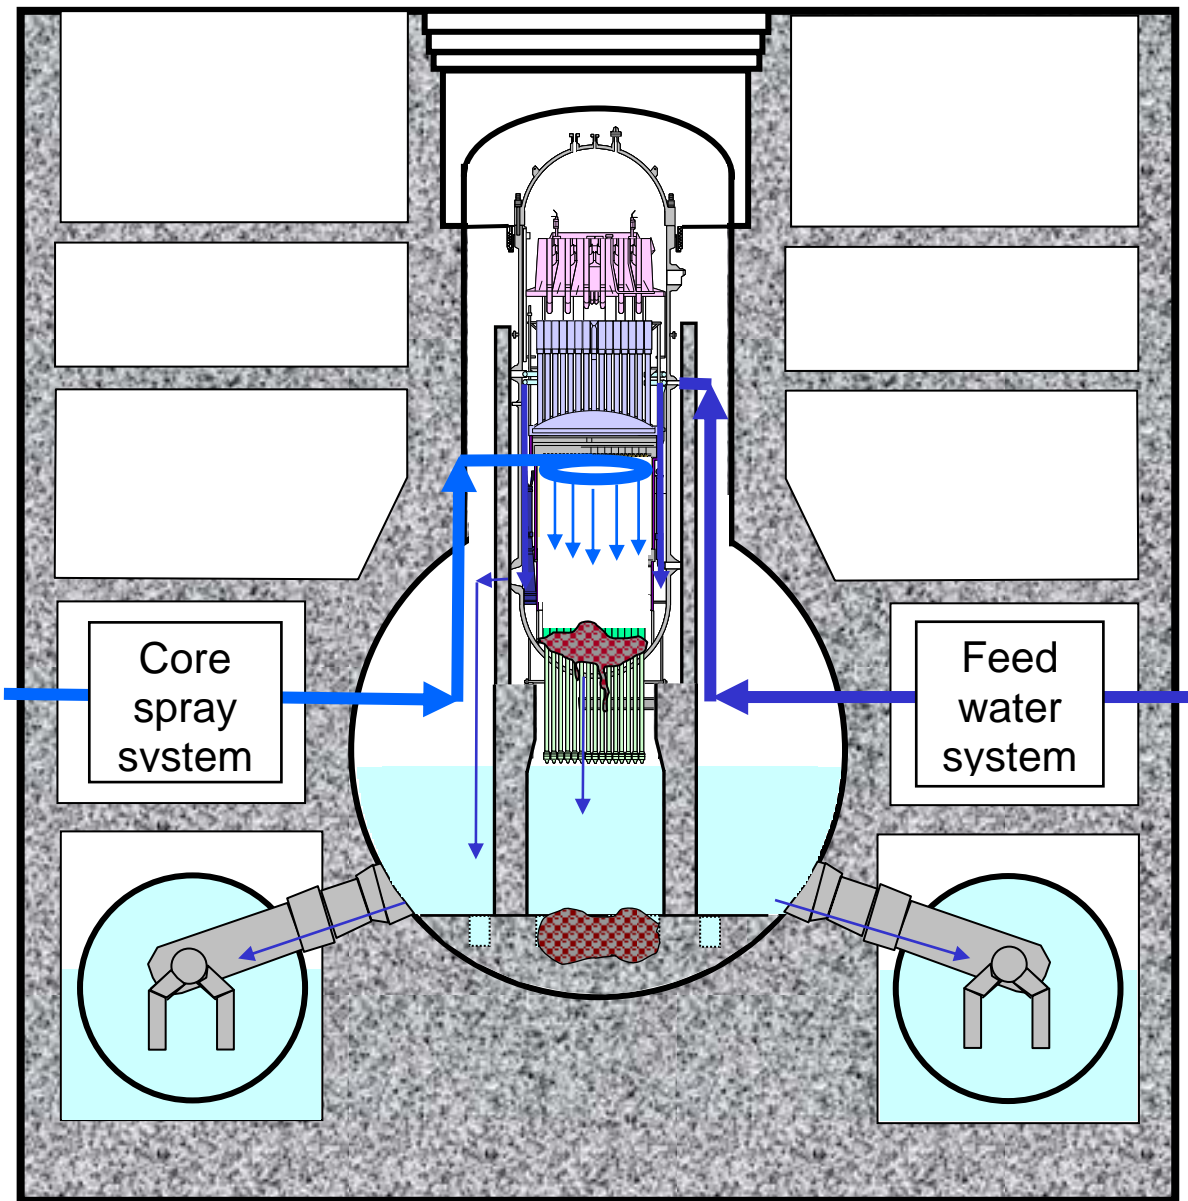
Figure 6.3.1 Estimated conditions of the core and PCV of Unit-3

The situation of Unit-3 core estimated based on the above facts and aforementioned examination results, is illustrated in Figure. 6.3.1. As can be seen in the figure, part of the melted fuel generated in the accident fell down to the lower plenum below the reactor pressure vessel or to the PCV pedestal. Some of the fuel may remain in the original core location. It has turned out, however, that there had been a situation of not sufficient water injection possibly due to HPCI manual shutdown by the operators. This indicates the accident progression was faster than the earlier estimation. In the figure, more fuel than before is assumed to have dropped to the PCV. On this matter, further detailed examinations are needed, including the molten core concrete interaction (MCCI) development behavior.

No measured values are available so far concerning the D/W water level. But it could be estimated to be about 5.5 to 7.5m above the floor by converting the S/C pressure to water head. The S/C pressure was obtained from its existing pressure indicators, not calibrated since the accident, so they do not have high accuracies but they could be reliable as a trend to a certain extent because they have followed the pressure changes according to the water injection. In May 2014, water leaks were witnessed around the expansion joint at the PCV penetration of main steam piping D. This point is at the same elevation as the estimated water level in the containment vessel. This indicates most water leaks from the containment vessel occurred at this point.
