List of issues to be investigated

List of issues

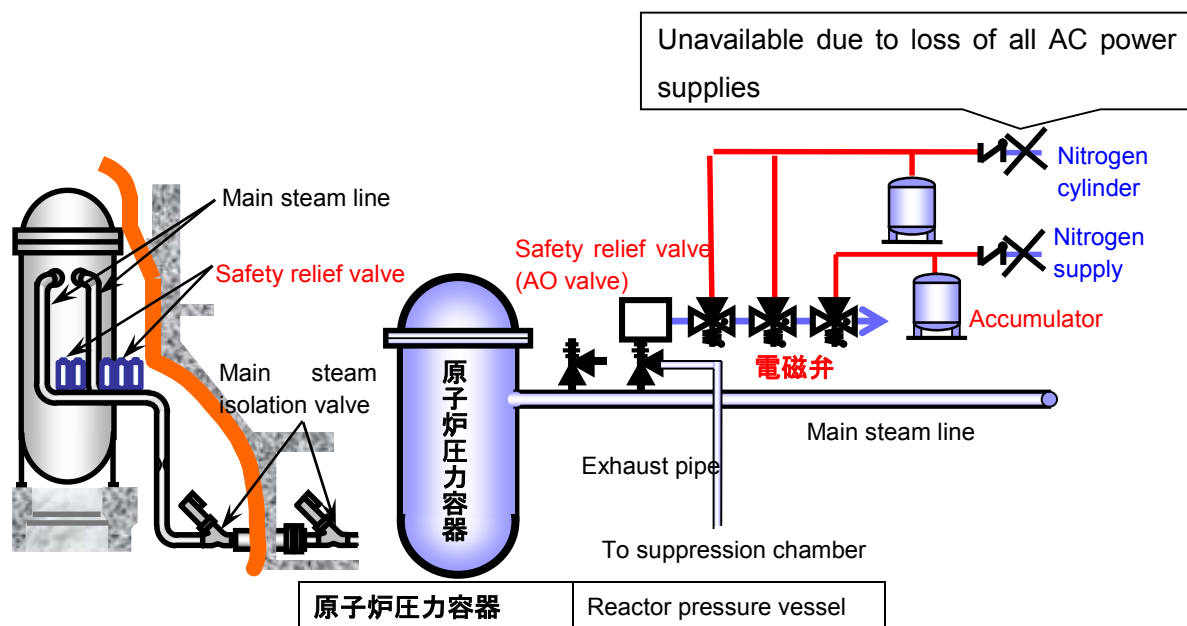
Figure Schematics of the main steam safety relief valves.

For example, at Unit-3, the SRV opening operation was attempted from the main control room (MCR) control panel after the HPCI had been manually shutdown at 02:42 on March 13, but no response was observed in the reactor pressure. Therefore, the operators recognized that the SRVs had not worked.

Possible causes of SRV failure to function may include insufficient pressure of driving nitrogen gas and the insufficient voltage to activate motor-operated valves. But other relevant matters, such as the SRV opening/closing operation after core damage or reactor pressure changes, are also to be examined in order to clarify the causes why the SRVs did not function, because there is not enough knowledge on the SRV functionality under severe accident conditions.

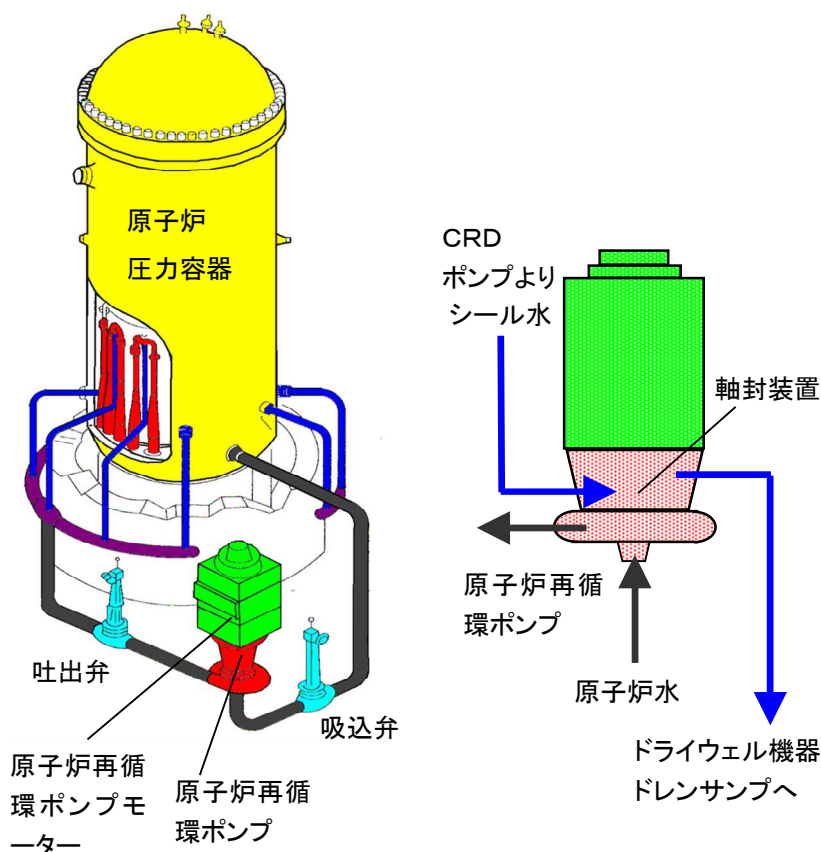
Figure Illustration of PLR pumps

Mechanical seals are mounted on the primary loop recirculation (PLR) pumps as the shaft seal. During normal operations, sealing water for the shaft seals provided from the control rod drive (CRD) pumps prevents reactor water from leaking. When the external power supply is lost, CRD pumps are shut down and sealing water is lost from the CRD pumps; then the high pressure reactor water is discharged to the drywell (D/W) equipment drain sump via the PLR pump shafts and shaft seals.

As a matter of fact, at Unit-4 of the Fukushima Daini NPS, which did not need to run the D/W spray, it was found during a post-earthquake patrol in the PCV that water had filled the pedestal, which had housed the equipment drain sump, and reached even the diaphragm floor (the D/W bottom floor). Water discharge from the equipment drain sump stopped after the earthquake. Therefore, it is highly possible that this water was the leaked water from the reactor via the PLR pump shafts

As long as the mechanical seals are not damaged, the water leak from the reactor is expected to be below the design leak rate and has little impact on the reactor behavior. But, if the seal functions were lost in the process of accident progression, as O-ring damage for instance, the leak rate might have increased. It is necessary to clarify whether leaks actually occurred which might have influenced the reactor water levels, and the PCV temperatures, pressures and water levels.

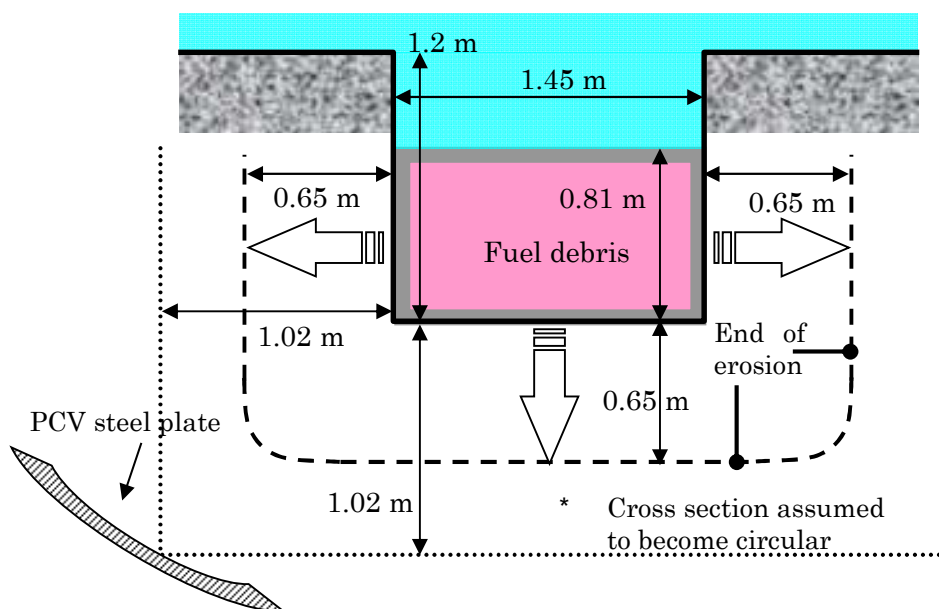
Figure Estimation of the scale of Unit-1 core-concrete reactions

TEPCO presented the analysis results of core-concrete reactions at Unit-1, which was thought to have had the largest fraction of fallen fuel debris to the PCV, in the Technical Workshop on “Estimation of the damage status of reactor cores of Fukushima Daiichi Units-1 to 3” (organized by the former NISA and held on November 30th, 2011).

There is also a possibility of shell attacks which could open leak paths from the PCV by direct contact of molten fuel and PCV liners. However, no clear evidence has been observed to date which supports the occurrence of shell attacks: the pressures increased at Units-1 and 2 when nitrogen gas started to fill the PCV, while at Unit-3 the PCV water level was sufficiently high to have prevented them.

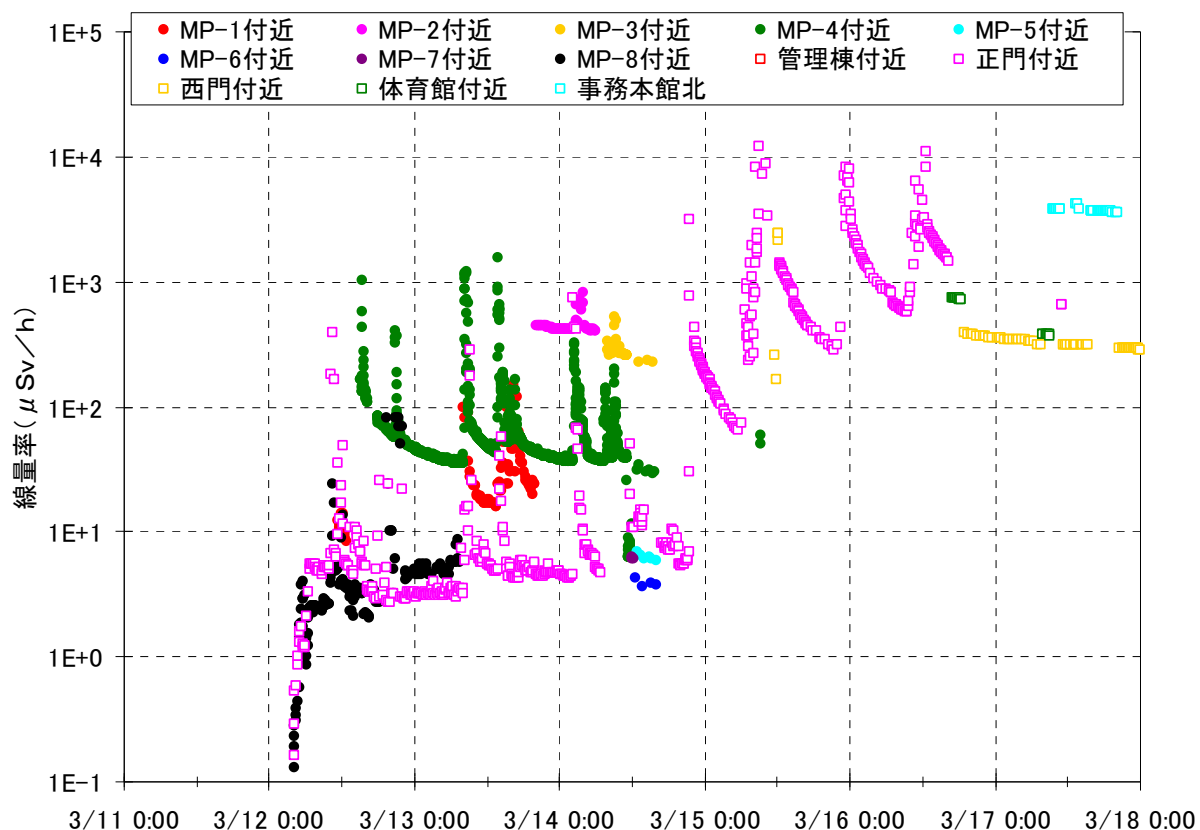
Figure Air dose rate changes on the site during March 11th to 18th.

Some of the radioactive materials released from the fuel during the accident progression were eventually released to the air via the PCV venting, the reactor building explosion, direct leaks from the PCV, etc. To date, TEPCO has been investigating the amount of radioactive materials released to the air per each main incident in the course of accident progression, and the reason of high contamination in the northwest area of the Fukushima Daiichi NPS. The investigations are based on the air dose rates observed by the monitoring cars and the meteorological data such as precipitation observed at a meteorological weather station

However, not every correlation is clear yet between the air dose rate changes measured on the site boundary measured by the monitoring cars, etc. and the radioactive materials release behavior from their origin. The air dose rates do not tell everything about the release situation from the origin of the radioactive materials but these rates provide information that is useful in interpreting the release conditions. The attenuation behavior of air dose rates may provide some information relevant to the contribution of deposits of radioactive materials released or their nuclear species.

In order to interpret the accident progression resulting in the release of radioactive materials, it is necessary to evaluate the air dose rate changes and the correlation of these rates with the timings, origin and paths of the radioactive materials released.

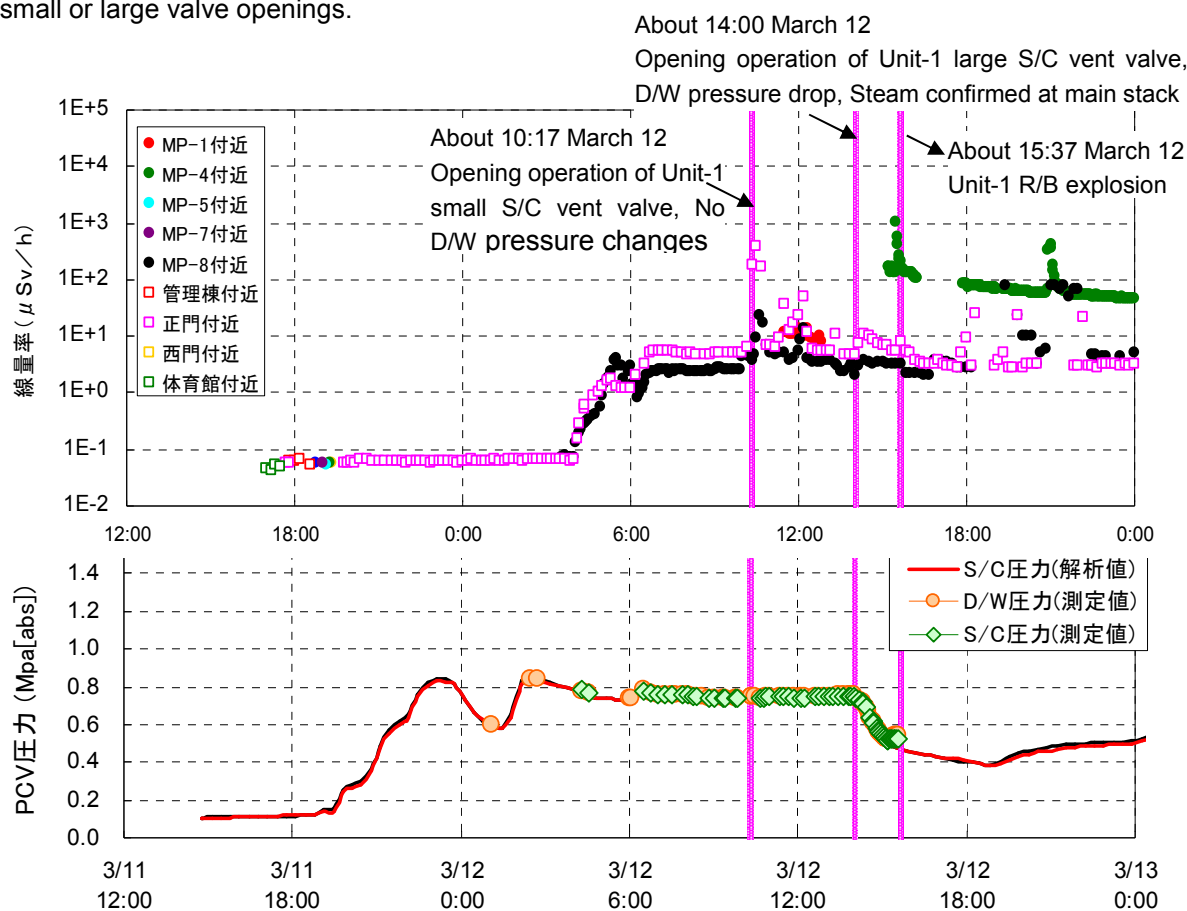
Figure Air dose rate changes from March 11th to 12th, and the changes of D/W and S/C pressures

At Unit-1, three attempts were made from the MCR to open the small S/C vent valve, at 10:17, 10:23 and 10:24 on March 12th. No clear decrease was noticed in the D/W pressures, but the air dose rates near the main gate showed a short increase at 10:40. Thereafter, a temporary air compressor was connected to open the large S/C vent valve and it was activated at about 14:00 on the same day. Steam exhaust from the stack was observed on the live camera monitor and the D/W pressure showed a decrease through 14:30 to about 14:50. At this timing, no increase was noticed in the air dose rates measured by the monitoring car near the main gate (southwest) and near Monitoring Point 8 (south).

As seen in these incidents, the D/W pressures and the air dose rates at the monitoring car occasionally responded to the S/C vent valve operations, but occasionally they did not. This may indicate a possibility that a small release of radioactive materials through the small vent valve, not sufficient to cause noticeable D/W pressure changes, might have occurred, or a possibility that a direct release to the air from the reactor building might have occurred. The opening of the small vent valve causes only a small vent flow rate change and the D/W pressure decrease may be too limited to notice. It is necessary to clarify the radioactive materials release behavior in detail upon PCV venting by the small or large valve openings.

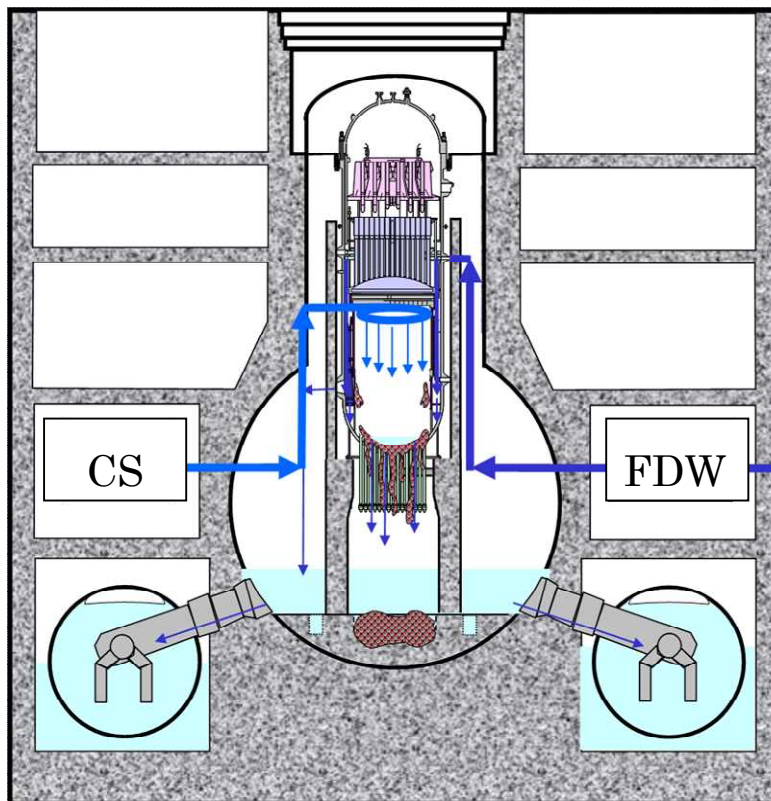
Figure Estimated conditions of the core and PCV of Unit-1

MAAP predicts that almost the whole Unit-1 core dropped to the RPV lower plenum and most of it fell further to the PCV pedestal, while the Unit-2 and Unit-3 cores remained in the core region, although there were partly molten fuel pools. Unit-1 lost all its existing water injection functions at an earlier stage and considerable time was taken to start water injection by fire engines. On the other hand, at Unit-2 and unit-3 the RCIC (Unit-2 and Unit-3) or HPCI (Unit-3) could continue injecting water to the reactor till a later stage. As a consequence, decay heat was lower when no more core cooling became possible by existing water injection means and less time was taken thereafter for the fire engines to start injecting water.

It should be noted, however, that MAAP analysis has uncertainties in setting its conditions, the analysis itself and the modeling. The results obtained have also uncertainties accordingly. MAAP predicts no RPV damage in Unit-2 and Unit-3, but the results depend greatly on the amounts of water injected to the reactor. As a matter of fact, the plant conditions thereafter indicate the reactor water levels were at very low levels and the RPVs are very likely to have been damaged. Further, core damage might have occurred even earlier at Unit-3 because the water injection by HPCI had been insufficient after the RPV pressure had decreased.

Currently, the location of debris, the ultimate result of the accident progression, is still unknown. It should be noted that the calculation results still have large uncertainties. Since this information is important input to decommission planning, further examinations are needed, based on the outcomes of the investigative research and development projects of the PCV and RPV, and other relevant projects.

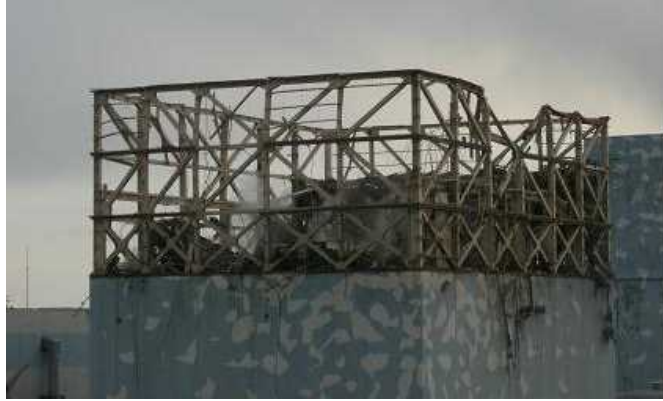
Figure Unit-1 reactor building after the hydrogen explosion

At Unit-1, the D/W pressure decrease was confirmed from 14:30 through around 14:50 on March 12th following the large S/C vent valve opening operation. At 15:36 on that day, hydrogen exploded in this reactor building and the roof and the outer walls of the top floor were heavily damaged.

At Unit-3, the D/W pressure decrease was observed at 09:24 on March 13th, confirming the PCV venting. At 11:01 on March 14th, hydrogen exploded in this reactor building, damaging the top floor upward and the north-south outer wall of one floor below the top floor.

These hydrogen explosions are considered to have been caused by hydrogen gas generated mainly by zirconium-water reactions which leaked out with steam to the reactor buildings. It is necessary to clarify the amounts of hydrogen gas generated and leak paths.

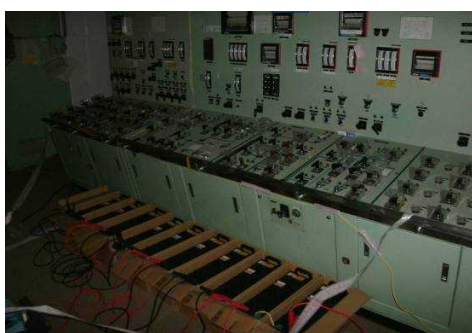
Connecting employees' private car batteries to power necessary instrumentations

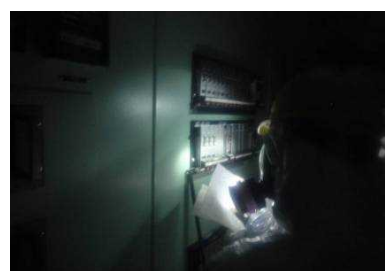
Indicator readings being checked with a flashlight in total darkness

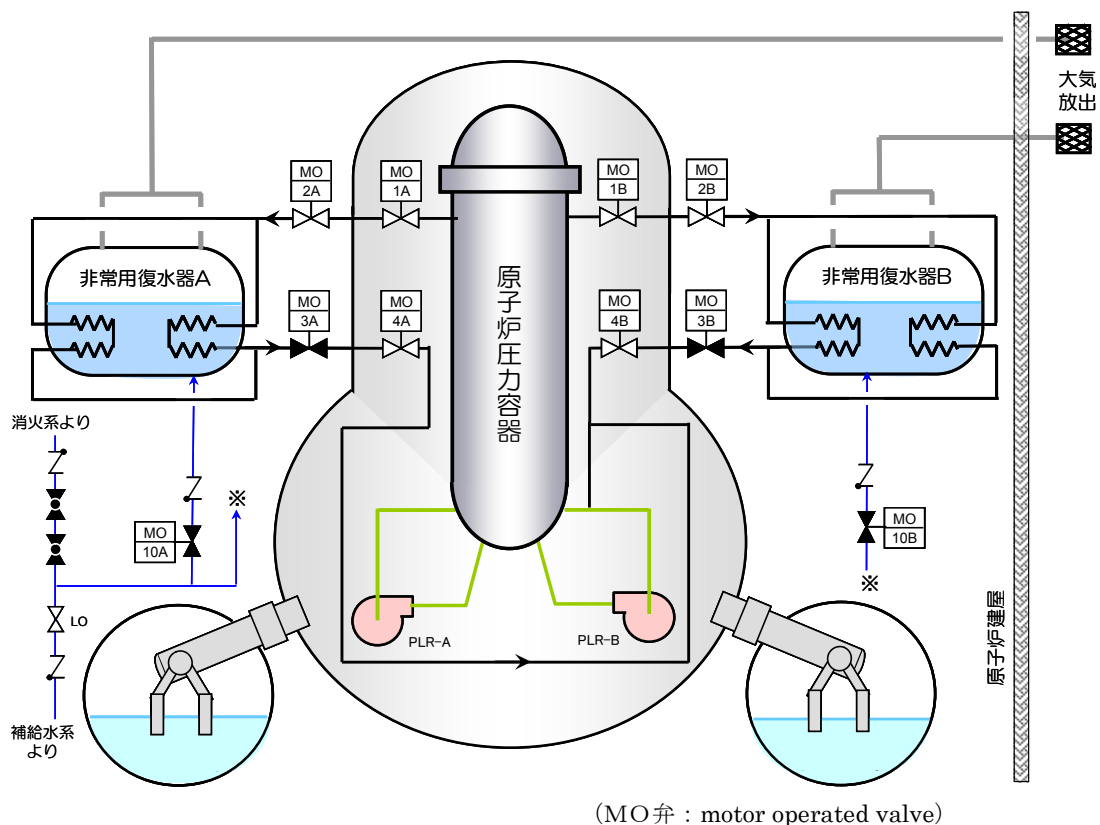
Figure Schematic illustration of IC systems

At Unit-1, the reactor pressure was being controlled after the earthquake by intermittent operation of the emergency isolation condensers (ICs). Immediately before all power supplies were lost due to the tsunami, the IC operation had been incidentally in a halted situation. In the station blackout condition, the shift operators in the MCR noticed the display lamps indicating the IC (Sub-system A) isolation valves (MO-2A, MO-3A) as “Closed” outside the PCV at around 18:00 on March 11th. They took opening action of the valves at 18:18 on March 11th, and confirmed the steam generating sounds and saw the steam when looking above the reactor building, but the amount of steam was limited and it stopped a while later. Concerned about the water inventory left in the IC shell side tank, at 18:25 the operators closed the isolation valve (MO-3A) on the return line.

It is considered that the non-condensable hydrogen gas generated by the water-zirconium reactions upon decrease of the reactor water level deteriorates the heat removal performance when it mixes in the IC cooling tubes. According to the analysis results, the reactor water level was slightly below TAF as of 18:18, and hydrogen gas might not have been being generated in large amounts. But hydrogen might have been generated by radiolysis as well. It is necessary to clarify how much the heat removal capability was actually deteriorated.

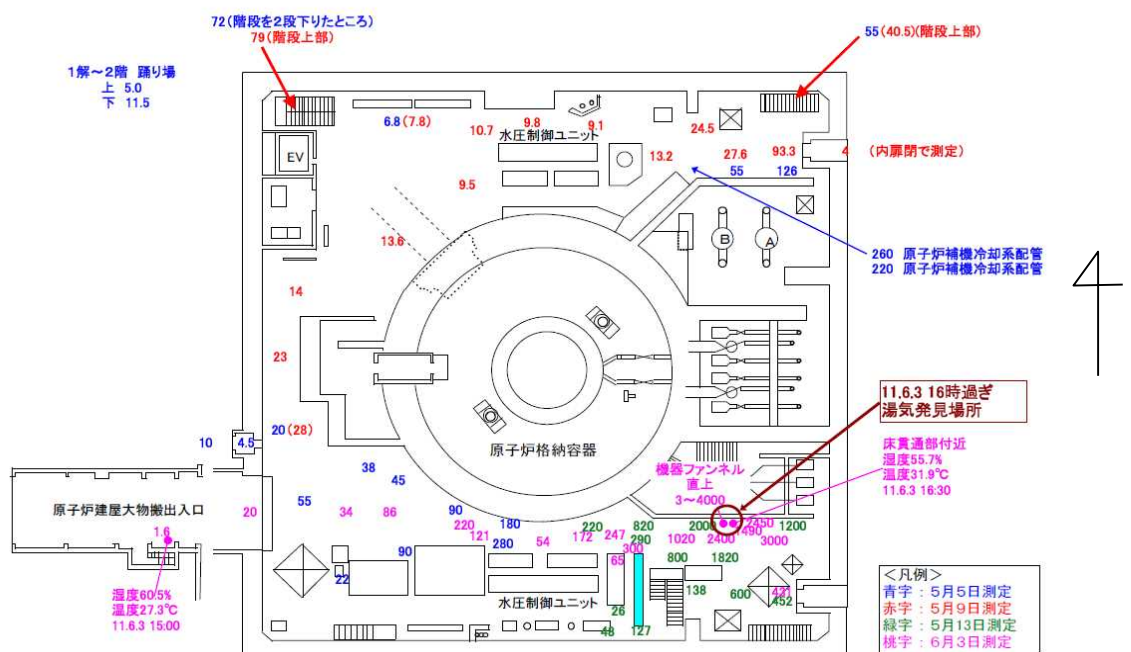
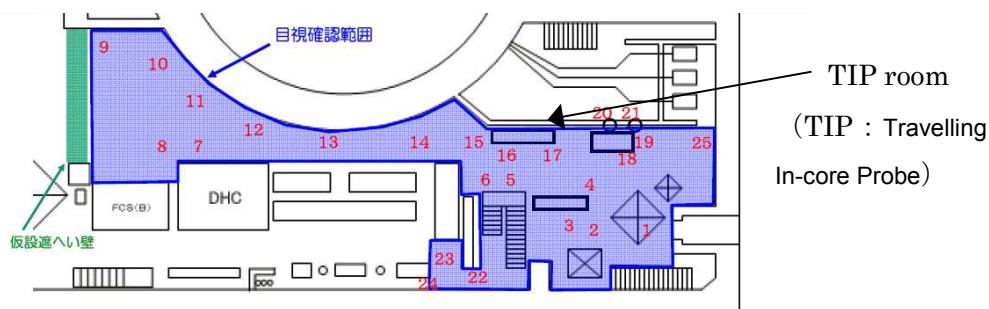
The investigations in May, June and October of 2011, and in July of 2012 located high dose rate areas of several thousand mSv/h in the southeast area of Unit-1 reactor building. In the June 2011 investigation, steam was also confirmed to be blowing out from a penetration of the floor in the area. In the July 2012 investigation, a robot attempted but failed to unlock the traveling in-core probe (TIP) room door in the area. The inside of the TIP room has not been investigated yet.

The high dose rate in the southeast area of the reactor building ground floor may be related to the steam blown from the floor penetration of the S/C venting line or possible damage of the TIP dry tubes due to the uncovered and overheated core. The causes of the high contamination are to be investigated.

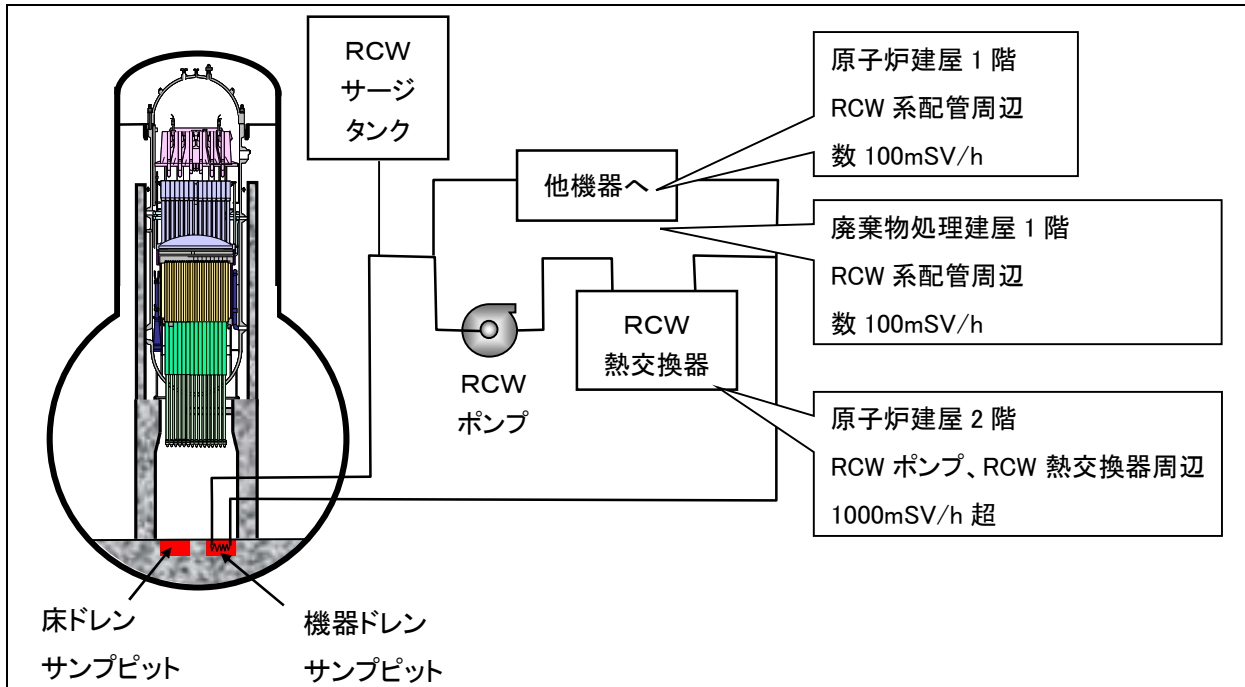
Unit-1/Issue-9	Unit-1	Category B⑤	Class (2)	Safety measures in [1]: pp.40, 43, 44 (strengthening of venting means)
Causes of high dose contamination around the Unit-1 RCW piping			Results: Attachment 1-9	
<p>The investigation of Unit-1 in May 2011 confirmed high dose rate contamination of several hundred to several thousand mSv/h near the RCW piping. No such high dose rate has been noticed near the RCW piping at Unit-2 and Unit-3.</p> <p>The RCW is a closed-loop system to cool auxiliary equipment and is unlikely to experience such high contamination in normal situations. However, the RCW also has a role to cool the equipment inside the PCV and it has piping to cool the drain in the equipment drain sump at the bottom of the pedestal.</p> <p>Therefore, there may be a possibility that part of the molten fuel fell into the equipment drain sump and damaged the RCW piping, allowing the transfer of high dose rate steam or water containing radioactive materials into the RCW piping. Identification of the causes of high dose rates in the RCW piping may help to estimate the conditions of the core and the PCV.</p>

RCWサージタンク	RCW surge tank
他機器へ	To other systems/equipment
RCW熱交換器	RCW heat exchanger
RCWポンプ	RCW pump
原子炉建屋 1 階 RCW 系配管周辺数 100mSV/h	R/B first floor Several hundred mSv/h around RCW piping
廃棄物処理建屋 1 階 RCW 系配管周辺数 100mSV/h	RW/B first floor Several hundred mSv/h around RCW piping
原子炉建屋 2 階 RCW ポンプ、RCW 熱交換器周辺 1000mSV/h 超	R/B 2nd floor More than several hundred mSv/h around RCW pump and heat exchanger
床ドレンサンプピット	Floor drain sump pit
機器ドレンサンプピット	Equipment drain sump pit

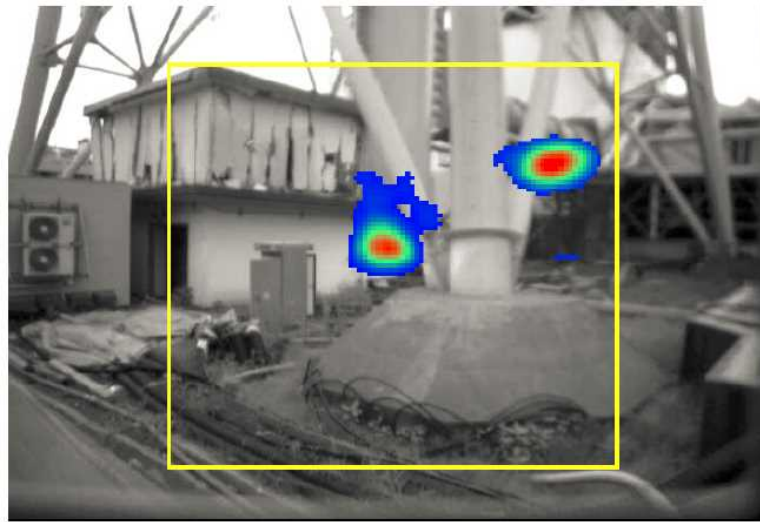
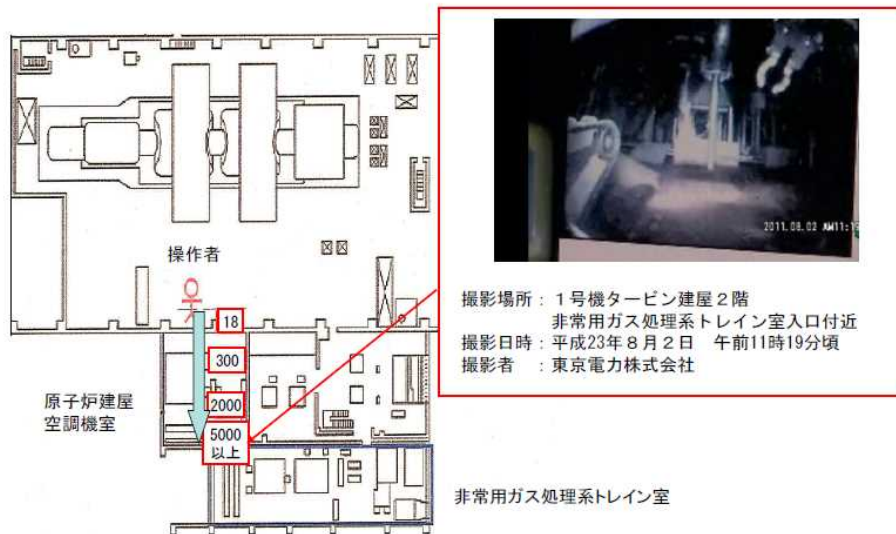
The high dose rates near the SGTS piping can be considered to be caused by the deposited radioactive materials which were released from the damaged core. The detailed causes of the contamination are to be clarified.

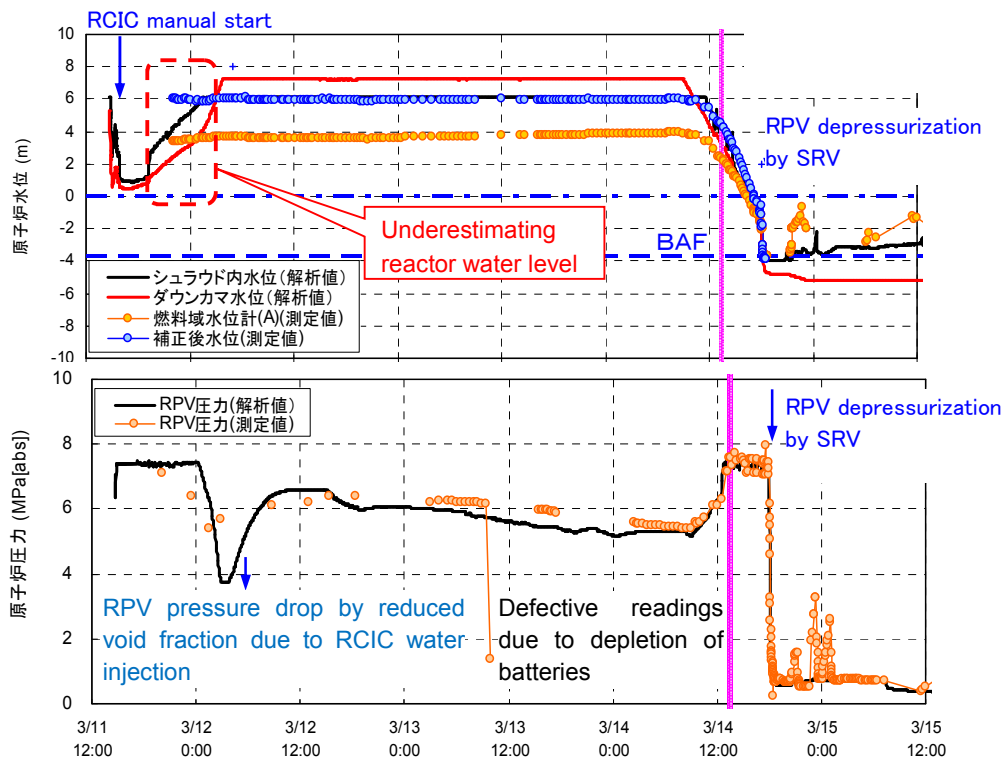
Figure Reactor water level and pressure changes at Unit-2

The measured reactor pressures after the tsunami arrival were maintained below the normal operating pressures, lower than the SRV working pressure. The RCIC operating conditions, which could cause such plant conditions, could be such that the RCIC had been driven by a mixture of steam and water, because the elevated reactor water level above the main steam lines had allowed water to flow into the main steam lines which had been designed to transfer only steam. In the MAAP analysis, the amount of water injected to the reactor was set at 30m³/h, one third of the rated value so that the measured reactor pressures could be reproduced. The overall plant behavior while the RCIC was in operation could be well reproduced in this simulation.

The RCIC operational conditions need to be clarified after the loss of the control power supply due to the tsunami.

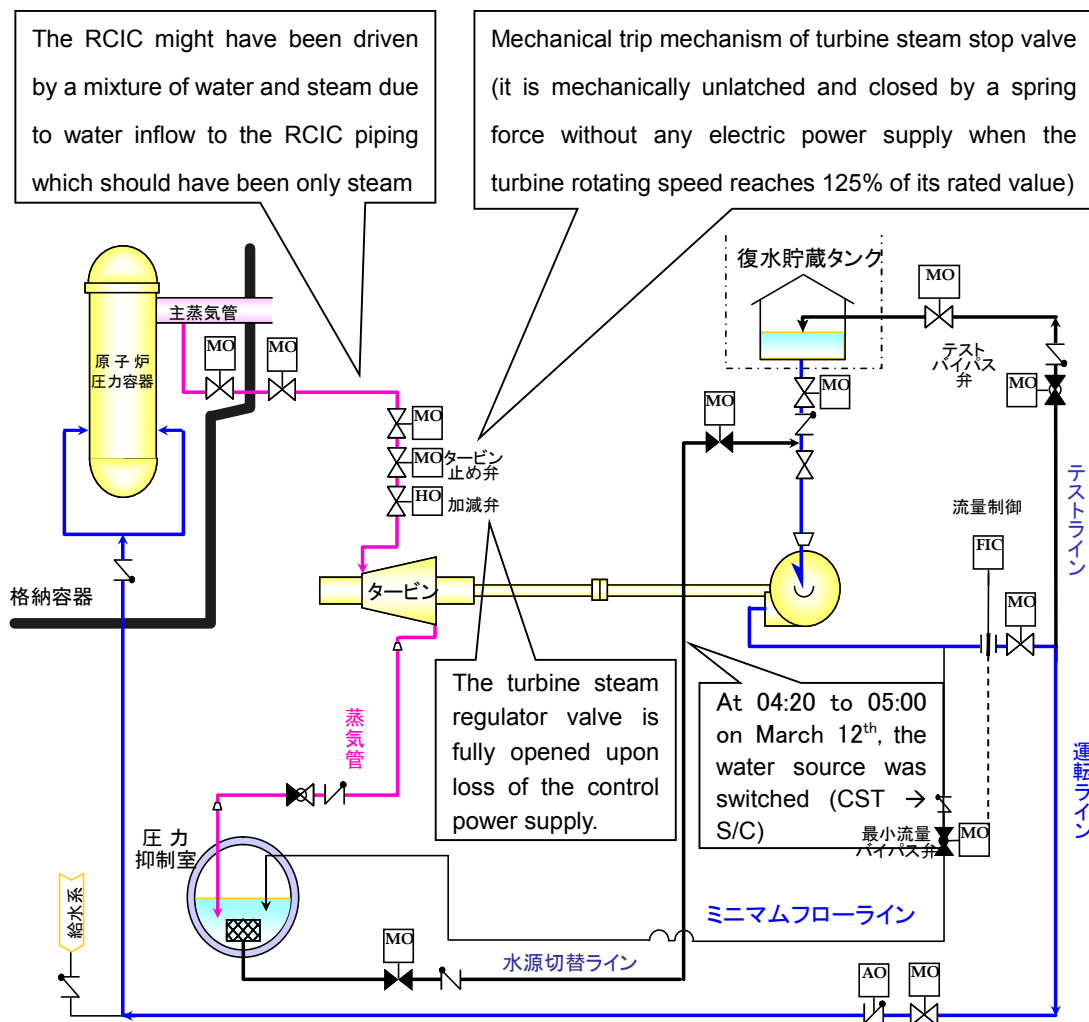
Figure RCIC schematic diagram

At about 09:00 on March 14th, the reactor pressure showed an increasing trend, and at about 12:00 noon the reactor water level showed a decreasing trend. The Emergency Response Center at the Fukushima Daiichi NPS concluded at 13:25 that the RCIC had lost its functions, but it is necessary to clarify why it lost them.

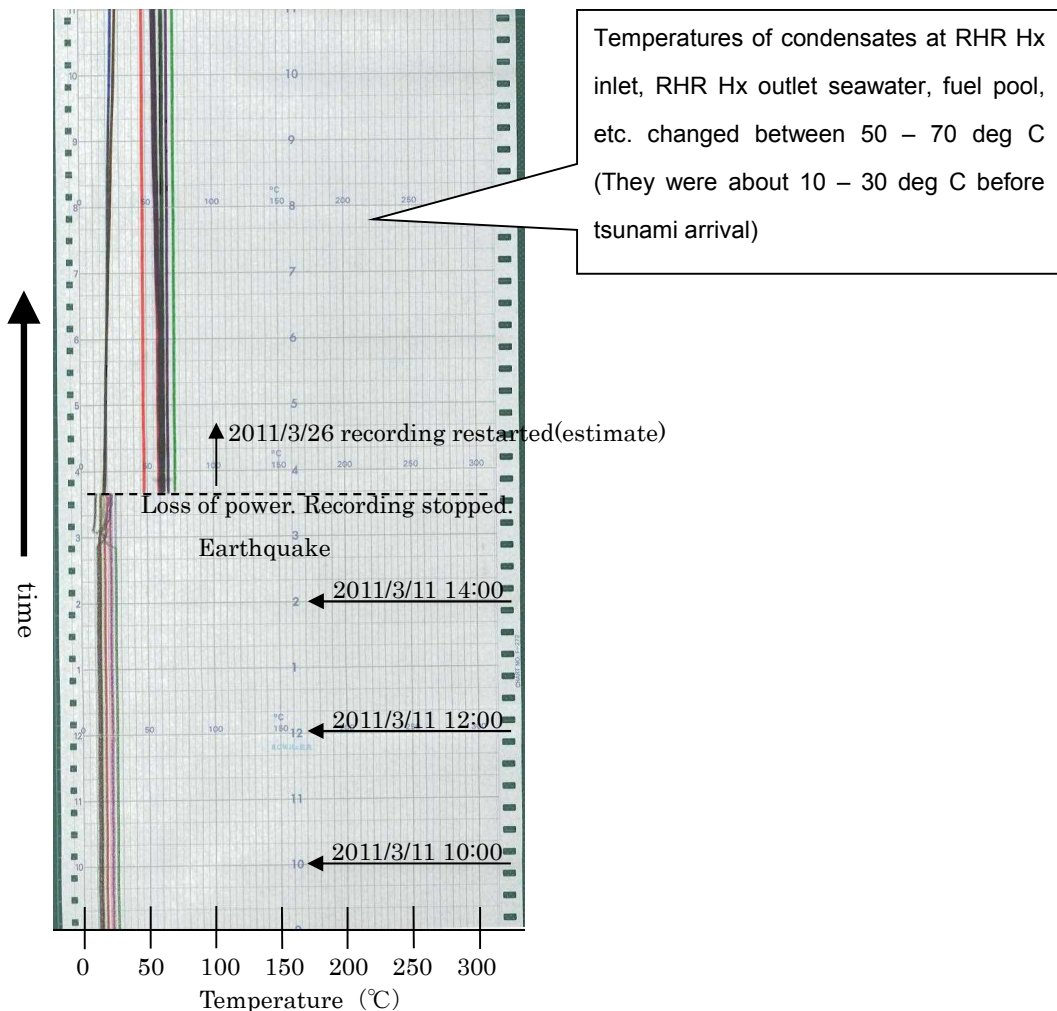
Figure Temperature recorder chart of Unit-2 (RHR and fuel pool temperatures)

Examination will be done on the reason for the temperature increase and its possible connection to the post-earthquake RHR operation. , No temperature records are available for comparison at Unit-1 and Unit-3.

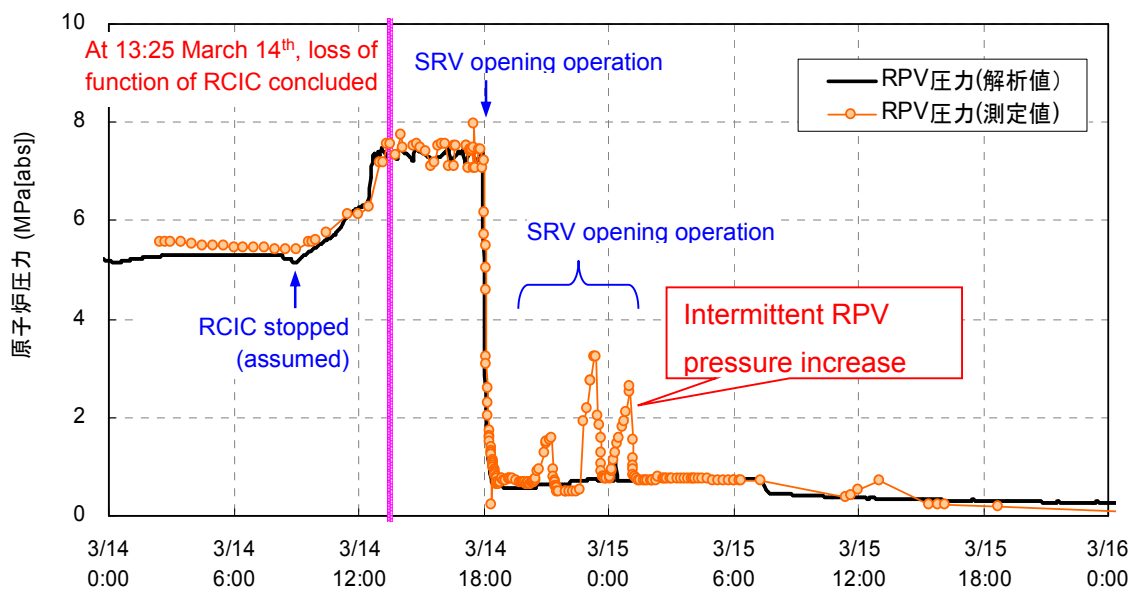
Figure RPV pressure changes at Unit-2

After the forced depressurization of the reactor, fire engines continued to inject water. Therefore, possible causes of the pressure increase are: steam production due to the increased water level; steam production due to corium slumping to the lower plenum; steam production by the zirconium-water reactions; or even the SRV closures. RPV and PCV pressure behavior after the reactor forced depressurization is to be examined.
